**Air, Maritime and Railway Traffic Accident Investigation Agency**  
**Air Traffic Accident Investigation Department**

## **FINAL REPORT**

### **ON ACCIDENT OF THE AIRCRAFT SHARK UL, registration D-MMKV**

**Hvar Channel, 14 June 2019**

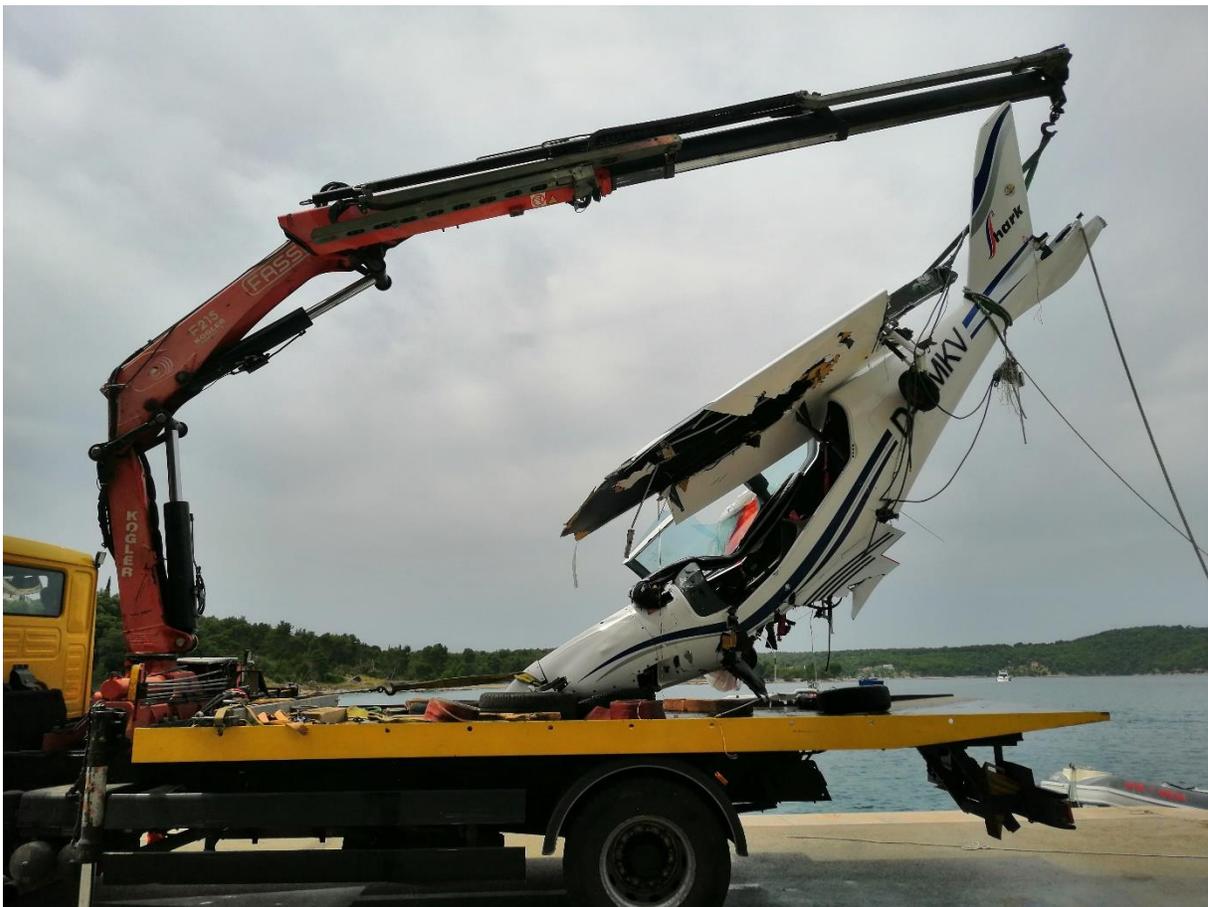
In this accident the aircraft was destroyed.

Picture 2 – Wreckage of the aircraft D-MMKV after being pulled out of the sea

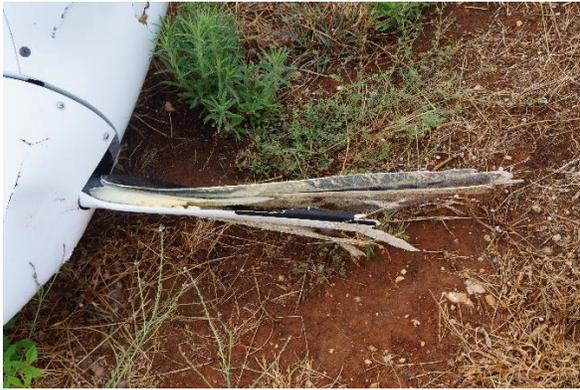
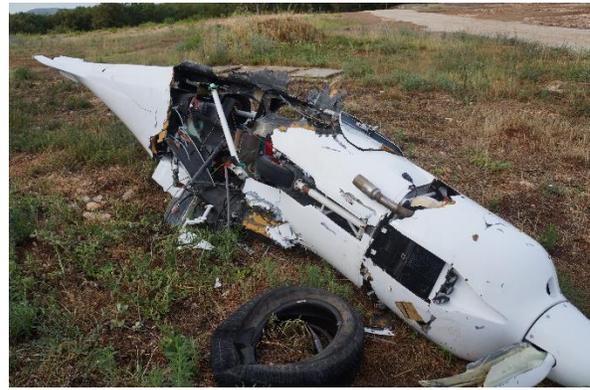
Pictures 5 and 6 – Damage to the propeller and fuselage

Considering the damage of the aircraft, it can be concluded that the aircraft touched the water surface at a low angle and at high speed, while the engine was running.
