FINAL REPORT

**ON SERIOUS INCIDENT OF THE AIRCRAFT CESSNA 172,
REGISTRATION 9A-DMG**

**21 SEPTEMBER 2019,
ON ROUTE LDZL-LDLO NEAR RIJEKA AIRPORT**

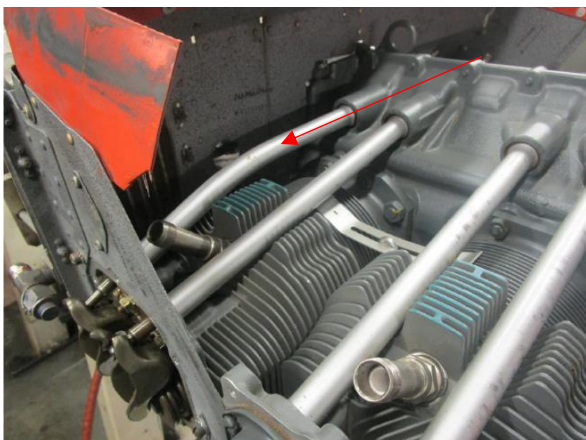
Picture 2 – Bent pushrod of the intake valve lifter

By the inspection of the engine at the company Loma Air it was established that the rocker arm of the exhaust valve had been poked and that the pushrod of the intake valve on cylinder no. 3 had been bent (Picture 2 and 3).

The company Loma Air requested an opinion from the engine manufacturer, the company Lycoming. In its conclusion, the engine manufacturer stated the following: *“What happens is, the pushrod pokes through the exhaust rocker arm. Combustion occurs in the cylinder but because the pushrod has gone through the rocker arm the exhaust gasses cannot escape the cylinder. The next stroke would be intake opening, but the intake valve cannot open because of the exhaust gasses still in the combustion chamber causing the intake pushrod to bend”*.

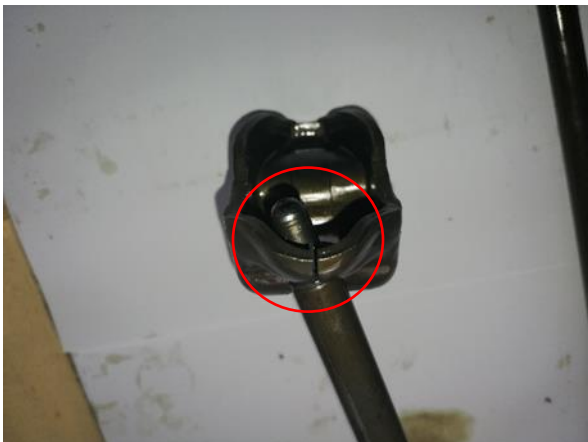
Picture 4 – Damaged exhaust rocker arm

AIA investigators inspected the aircraft and the engine at Rijeka Airport. By the inspection of the aircraft and the engine, it was established that the push rod of the exhaust valve poked the exhaust rocker arm on cylinder no. 1 (Picture 4). On the surface of the canal where the hydraulic lifter of the intake valve is located on the cylinder no. 1, surface damage in the form of scratches was visible, and it was not possible to remove this lifter from the pertaining canal (Picture 5).

It was also concluded that the exhaust rocker arm fractured in fatigue. Beach marks are present on all fracture surfaces. The rocker was likely initially split by the pushrod, resulting in a fracture roughly parallel to the side walls of the rocker before the fracture running roughly perpendicular to the sidewall took place. The fracture surfaces running roughly perpendicular have an extremely coarse texture and widely spaced beach marks, indicating high stress, low cycle fatigue. The fracture surfaces running roughly parallel to the side walls of the rocker possess finer beach marks and are relatively flat, indicating a relatively lower stress, higher cycle fatigue. All beach marks visible on fracture surfaces appear to propagate out of the socket region of the rocker arm; the socket region is too marred by

Burrs are present ringing the convex side of the oil hole on both rocker arms. The burr of the fractured exhaust rocker arm was measured as approximately 0.016" high using the Keyence Digital Microscope. These burrs are ragged and thin enough to likely be through hardened during the case hardening process for the rest of the part. The burrs surrounding the oil holes on both rocker arms examined in the investigation presumably underwent vibrator deburring and remained attached. The engineering drawing for the part specifies "burrs resulting from manufacturing processes are permissible providing they are securely attached and do not interfere with function of the part". While the oil hole burrs do not contact any surface during use of the rocker arms, it may function as a stress concentrator, encouraging crack initiation and propagation.

By the analysis of mechanical damages on the rocker arm it was established that there were two types of cracks. The parallel crack was the result of low stress and large number of cycles. The vertical crack was caused by high stress and small number of cycles. In the mentioned analysis of the technical accuracy of the engine, the manufacturer did not state the order in which mechanical damages occurred.

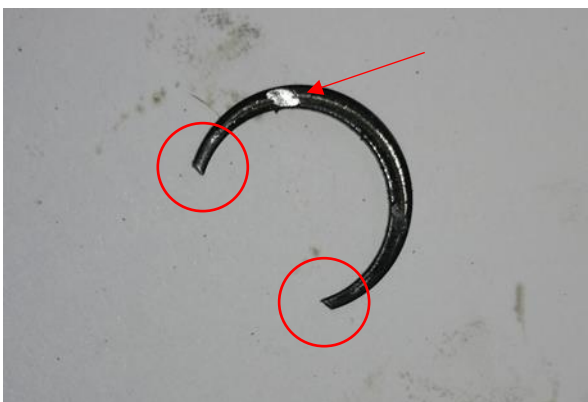
Picture 6 – Cracked safety ring

Also, a crack in the snap ring was also found, which prevents the spring, the socket and the plunger from falling out of the canal of the hydraulic lifter of the intake valve on cylinder no. 1 (Picture 6 - marked with a circle). Surface damage in the form of a scratch was also visible on the safety ring (Picture 6 - marked with a red arrow).

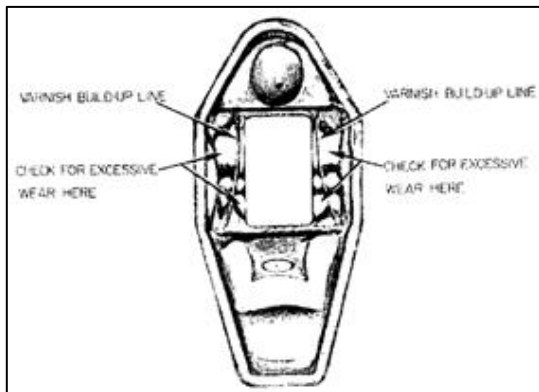
Picture 7 – Rocker arm

At the beginning of 1978, the manufacturer issued Service Bulletin No. 424 due to wear of the material on the hydraulic lifter surface. It was described how the new lifters improve the lubrication of the camshaft lobes surface and allow longer life of components (Pictures 7 and 8).

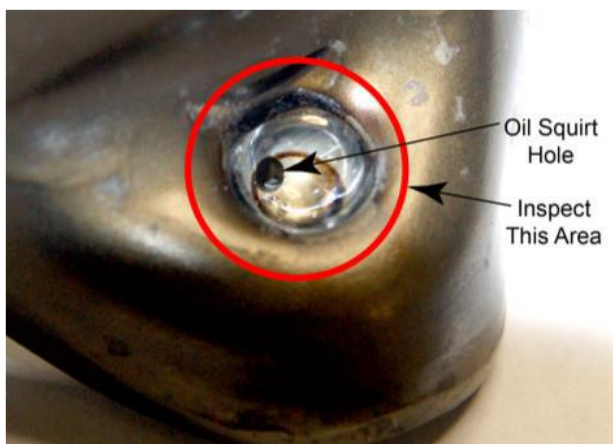
Picture 9 – Pushrod socket side of the rocker arm

On 17 January 2020, the engine manufacturer issued a Mandatory Service Bulletin No. 639. In the said bulletin, the manufacturer describes possible rough engine operation caused by cracks on the pushrod socket side of the rocker arm, around the oil squirt hole, as well as how to check the correctness of the socket during the next regular oil change and every 50-hours of engine service.
