Air, Maritime and Railway Traffic Accident Investigation Agency

FINAL REPORT

**ON SERIOUS INCIDENT OF THE AIRCRAFT PIPER PA-44,
REGISTRATION OM-ARC**

**28 MAY 2021,
EN ROUTE LZKZ-LDRI**

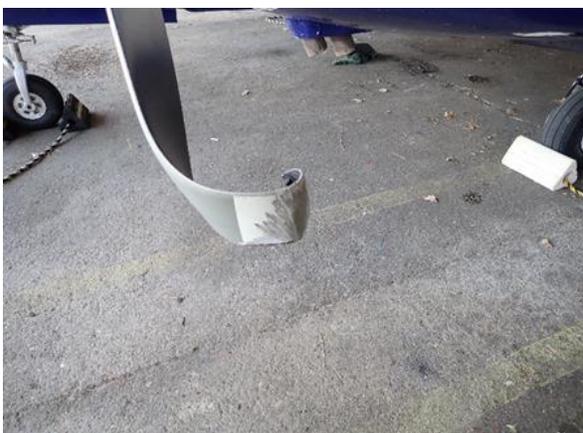
At Rijeka Airport, the aircraft was inspected by AIA investigators during which the following damages common to landing without a landing gear extended were determined. The stringers on the underside of the fuselage and both propeller blades on both engines were damaged.

Picture 1 – Damage to the tip of the propeller blade

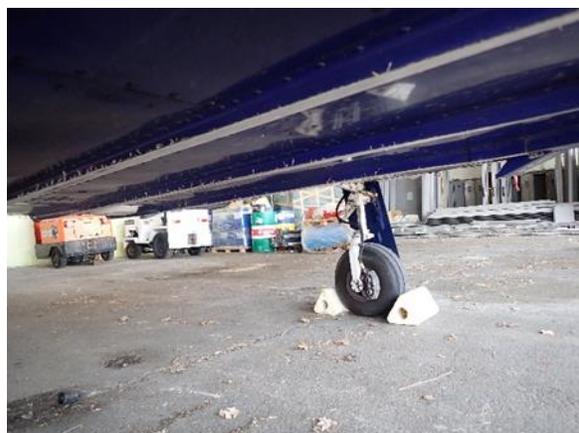
Picture 2 – Damage to stringers of the fuselage

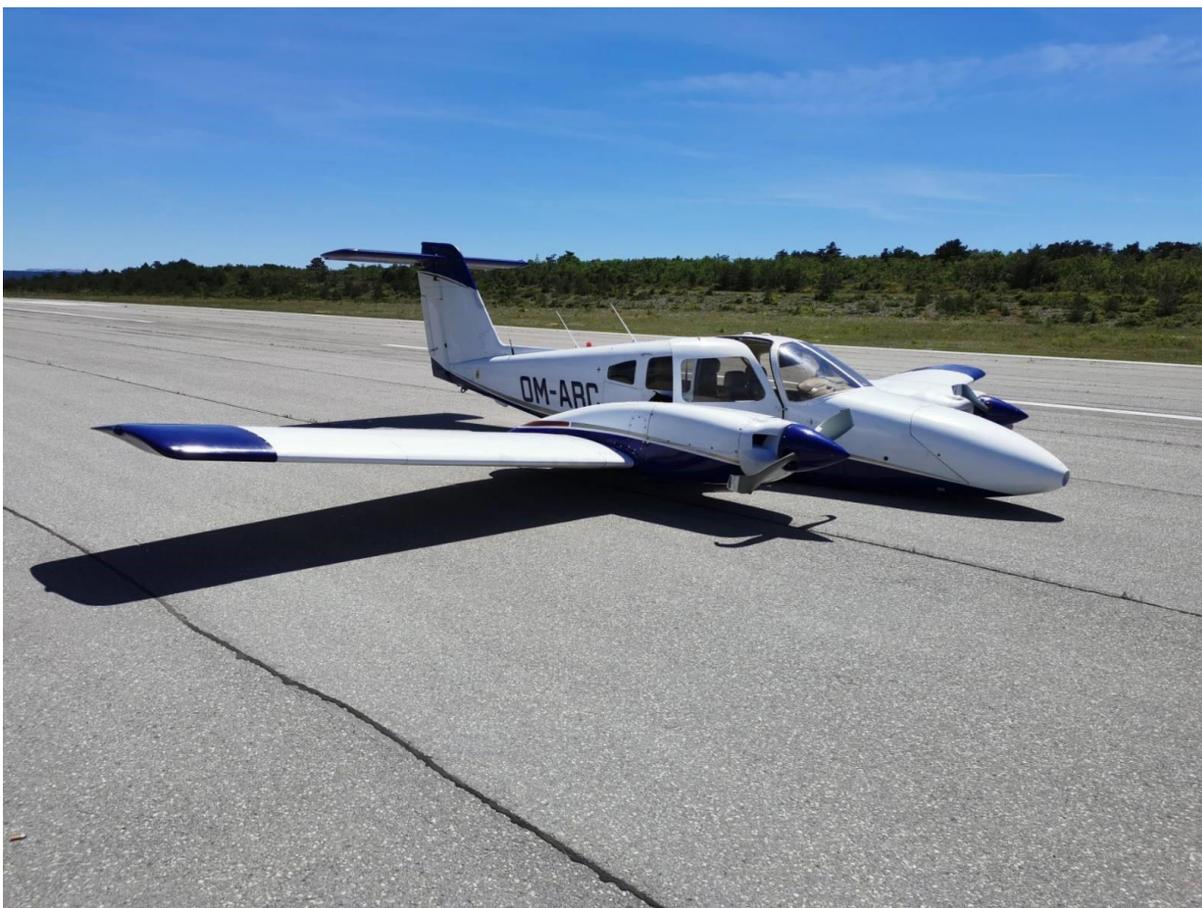
Picture 2 – Aircraft OM-ARC at the site of the serious incident

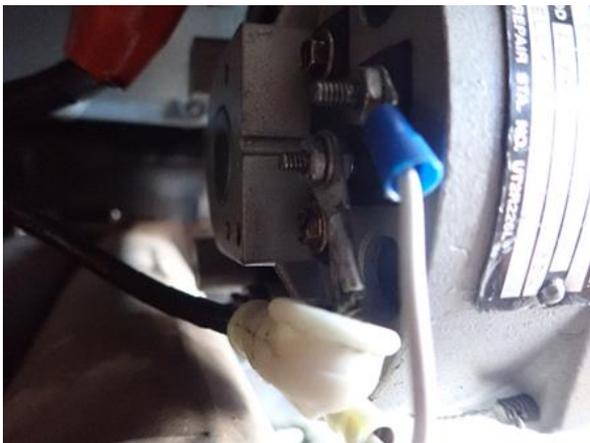
It was determined that there was a poor connection of all electrical conductors on the alternator no. 1, especially on the alternator field conductor. The presence of surface corrosion on the conductors themselves was also visible. In addition to the above on the alternator no. 2 there was a complete separation of the field wire from the terminal itself attached to the alternator.

Picture 19 – Poor connection of field wire and contact

The inspection determined that the loss of power supply occurred due to poor connections of electrical installations on alternator no. 1, and a completely interrupted connection of the excitation of alternator no. 2. Such technical condition is not sufficient to supply the electrical system with electricity. Furthermore, the voltage of the main battery during the technical inspection was at a low level, insufficient to start the radio devices or the hydraulic pump of the landing gear, which is a significantly higher consumer. Also it was determined that both alternator belt tension lever bolts were not properly installed.

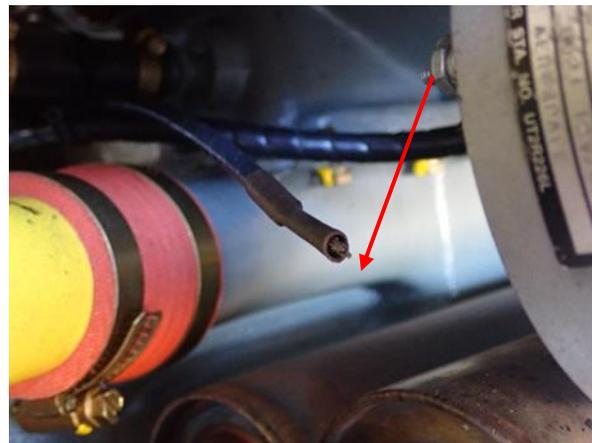
Picture 21 – Alternator field wire separated from contact

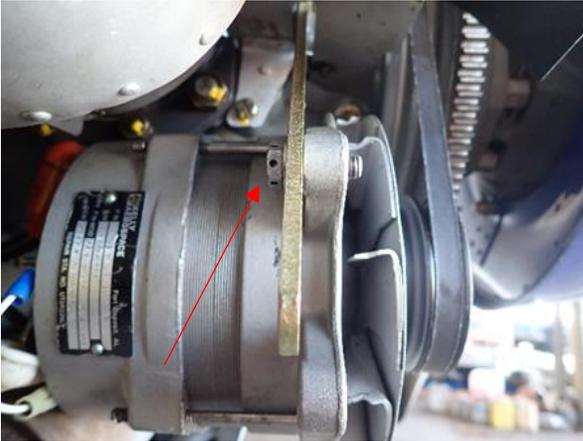
It was also determined that one of the bolts on the alternator no.1 belt tensioning lever was not secured with safety wire (Picture 20). The number of threads outside the nut on the alternator bracket bolt was out of the standard. One of the bolts on the alternator no. 2 bracket was completely missing the nut (Picture 22).

Picture 20 – Bolt without safety wire

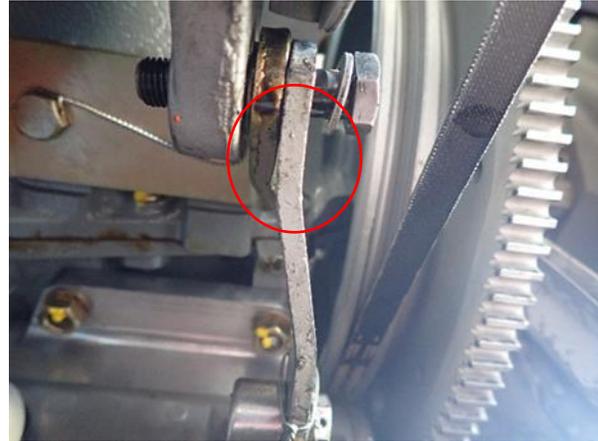
Picture 22 – Bracket bolt without nut
