**Air, Maritime and Railway Traffic Accident Investigation Agency**

# **FINAL REPORT**

**ON ACCIDENT OF THE AIRCRAFT CESSNA 182 D, SKYLANE  
REGISTRATION HA-TUB  
3 JUNE 2021, ON RPUS POREČ**

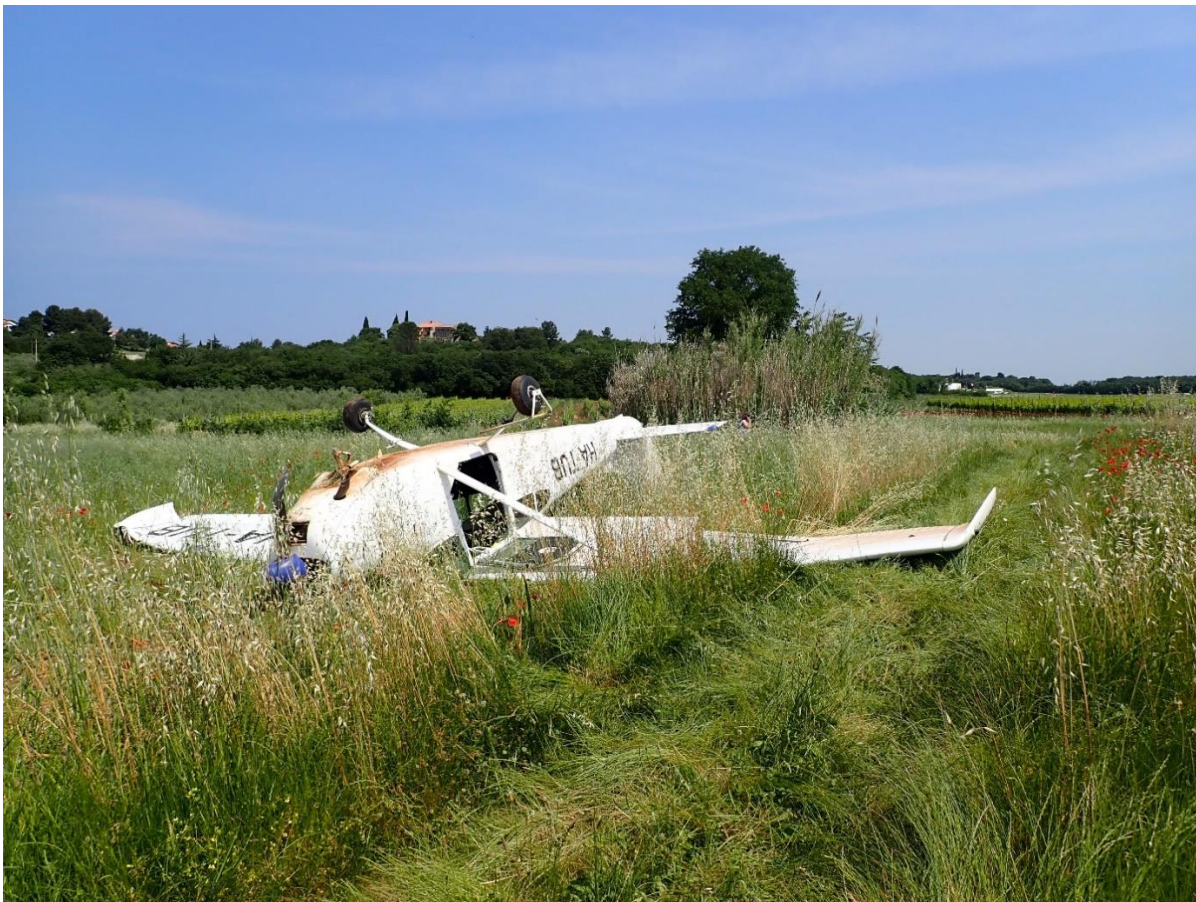
At RPUS Poreč, the aircraft was inspected at the accident site by AIA investigators. At the accident site, 230 meters before the threshold of the runway 01, the aircraft was found turned on its back. There was a smell of 100LL of gasoline around the aircraft. Damage to the aircraft fuselage skin and longerons were determined. Damage to the spar and the skin were found on the right wing. On the left wing, there was a rupture of the strut, which was completely bent, and the top of the wing was damaged. The front landing gear was found separated from the fuselage.

All determined aircraft damage corresponds to landing on uneven terrain and turning over the nose of the aircraft on its back. After the inspection at the accident site, the aircraft was turned to the upright position, and was moved in front of the hangar of the aeroclub, where a detailed inspection was performed.

Picture 1 – Aircraft HA-TUB at the accident site

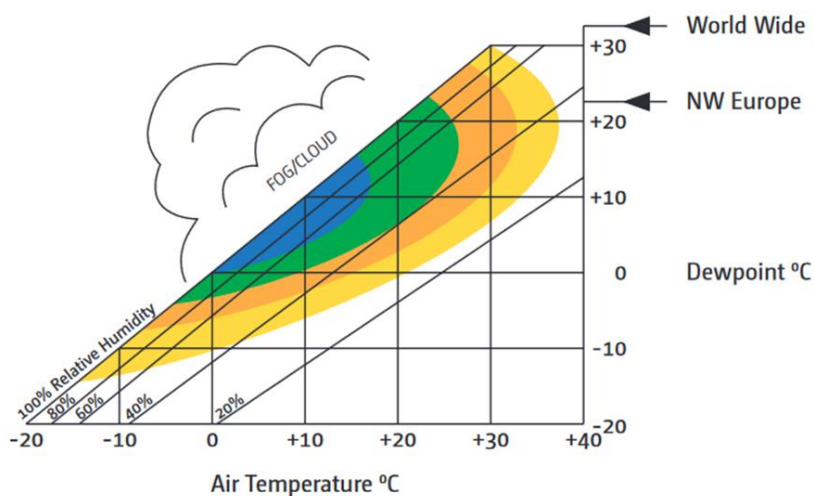
Atmospheric conditions of possible carburettor icing are shown in Picture 7. Aeronautical meteorological reports usually do not contain specific meteorological warnings of possible icing; therefore, pilots' knowledge and transfer of experience is very important. The reason for the lack of possible warnings about the conditions of possible icing is that in many cases it is impossible to measure individual values, such as humidity at certain flight altitudes, and it is very likely that these values significantly differ from those measured at the airport or at other measuring station on the ground.

Picture 7 – Chart of atmospheric conditions for carburettor icing

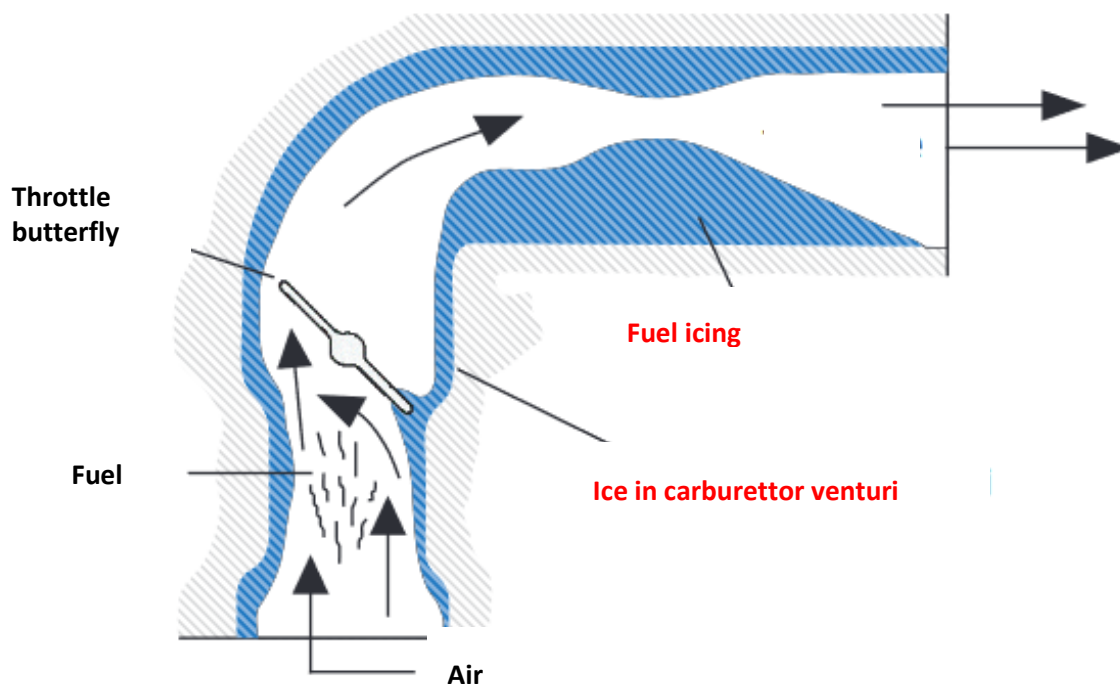
If the air temperature inside the carburettor drops below the dew point, moisture condenses and ice accumulates on the inner walls of the carburettor or on the throttle butterfly, which directly regulates the engine power (Picture 8). Accumulations of ice inside the carburettor block the air flow, thus changing the ratio of air and fuel in the mixture, which can result in constant, equal loss of engine power, rough engine operation, and ultimately engine failure.

Picture 8 – Carburettor cross-section with possible icing points
