Air, Maritime and Railway Traffic Accident Investigation Agency

INTERIM STATEMENT

**ON ACCIDENT OF THE HELICOPTER
type Alouette II, SE-313B,
registration 9A-HAT**

Zlarin, 3 July 2018

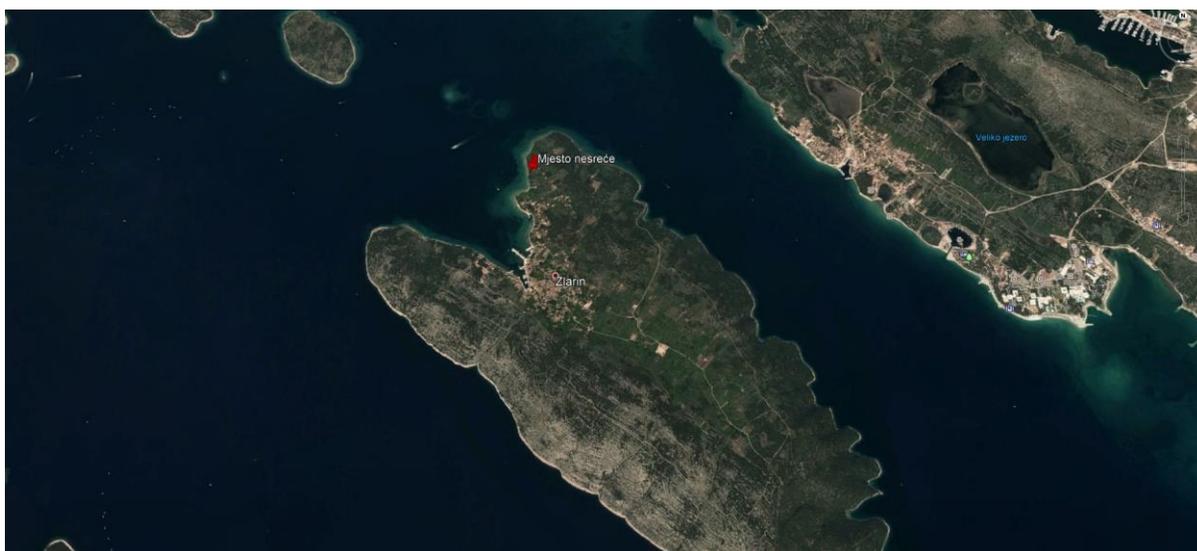
Picture 1. Accident site marked with a red mark

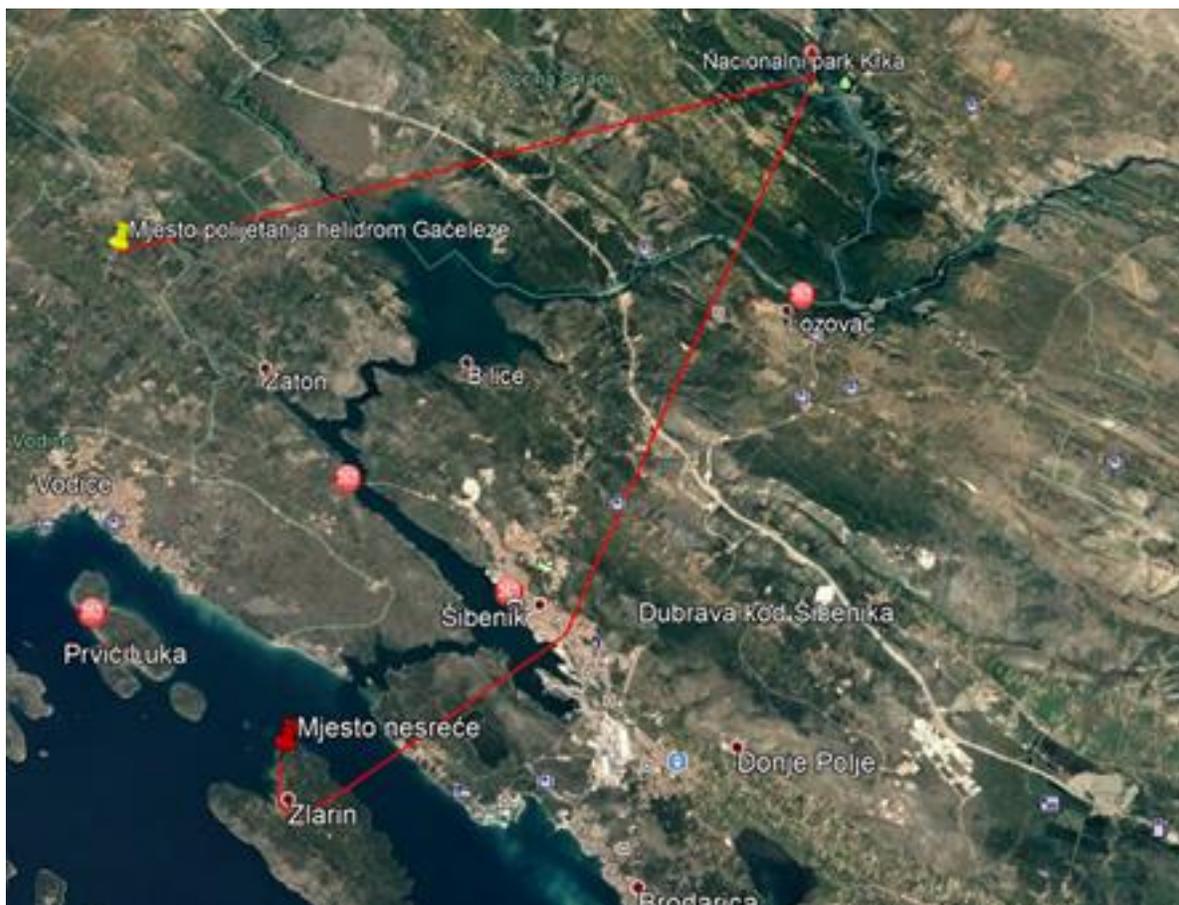
Picture 2 – Flight route of the aircraft

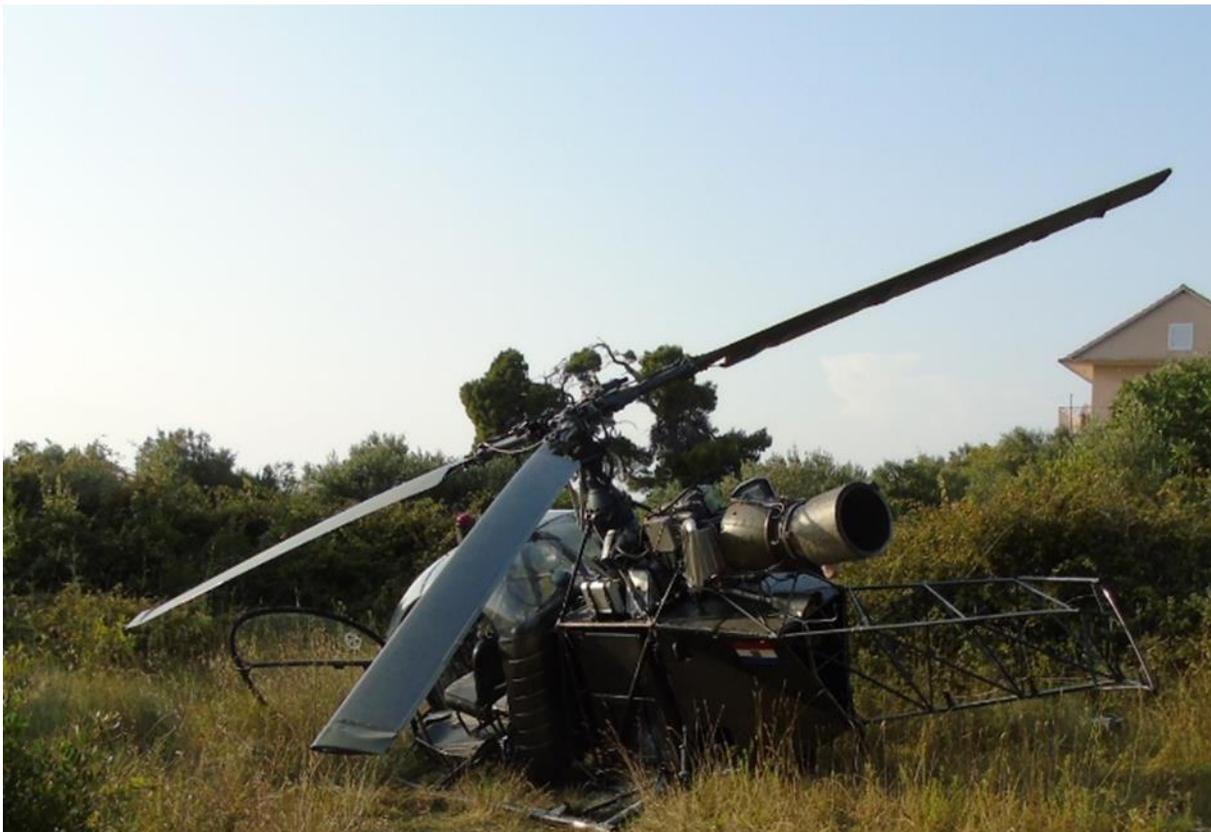
In this accident the helicopter was significantly damaged (Picture 3). Damages were present on parts of the construction, landing gear, power transmission system, controls, and single units around the powertrain and the main gearbox. The tail construction was found next to the helicopter. During the landing there was a minor fire on the helicopter, which was extinguished thanks to the rapid reaction of the pilot. No signs of birds or other flying objects such as drone were found on the helicopter.

Picture 3 – Helicopter at the accident site
