Air, Maritime and Railway Traffic Accident Investigation Agency
Air Traffic Accident Investigation Department

FINAL REPORT

ON ACCIDENT OF THE AIRCRAFT CESSNA 180, registration N36362

Brač Airport, 8 June 2018

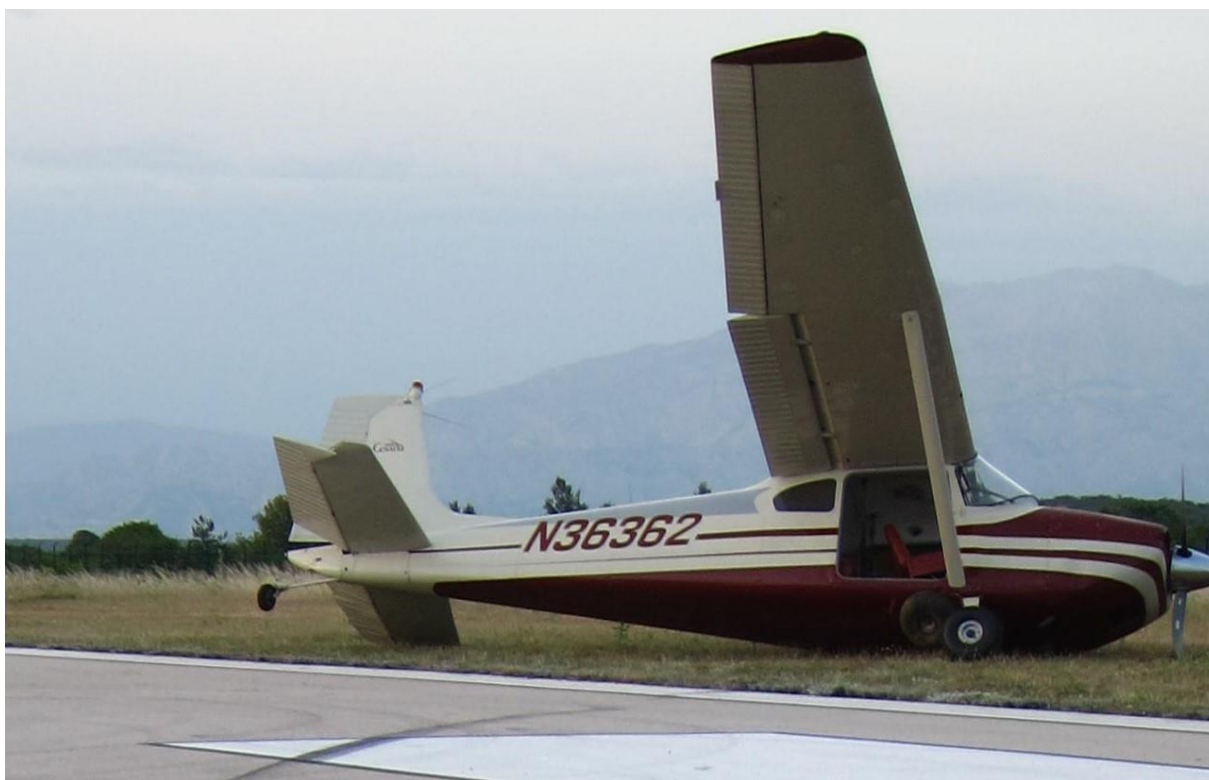
The aircraft was significantly damaged in this accident. The left wing and the left horizontal stabilizer were significantly damaged, and the left strut was broken. The propeller blades were deformed due to impact on the ground. The left landing gear was broken. The windscreen was moved from its base and the right door was separated from the fuselage.

Picture 1 – Aircraft N36362 at the accident site

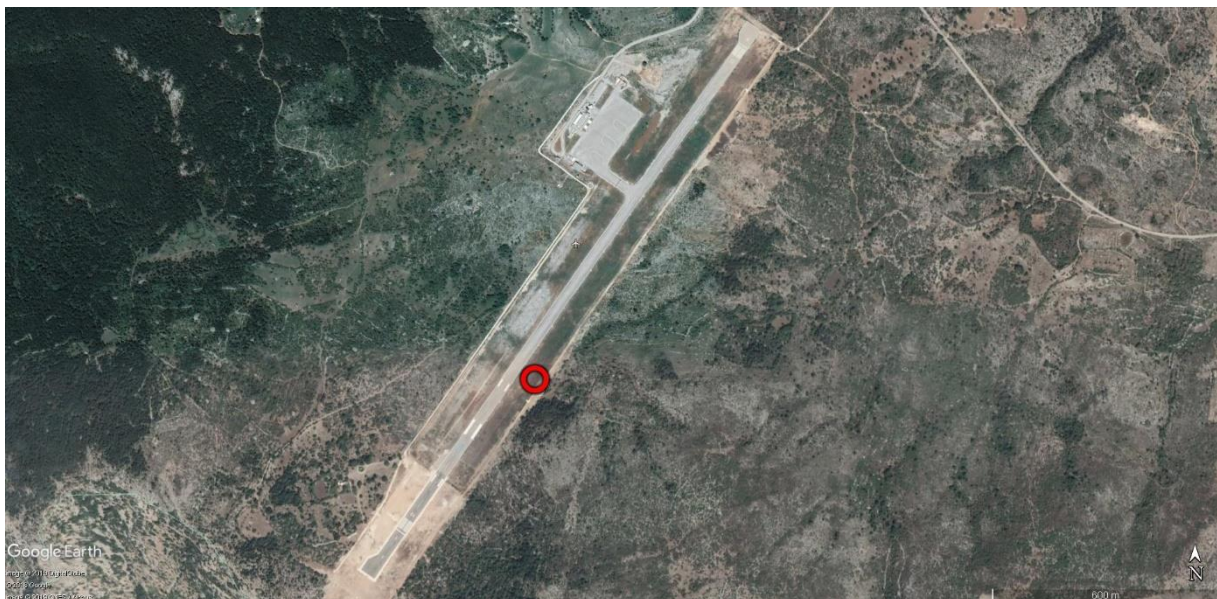
After exiting the runway, the aircraft stopped on the flat surface several meters away from the runway. The type of the ground along the runway is a hard ground with fine stones, covered with rare grass.

Picture 3 – Brač Airport, the red circle marks the place where the aircraft stopped after exiting the runway
