Air, Maritime and Railway Traffic Accident Investigation Agency

FINAL REPORT

**ON ACCIDENT OF THE AIRCRAFT
CIRRUS SR 20, REGISTRATION PH-YMC**

**20 MAY 2023,
MALA KAPELA MOUNTAIN**

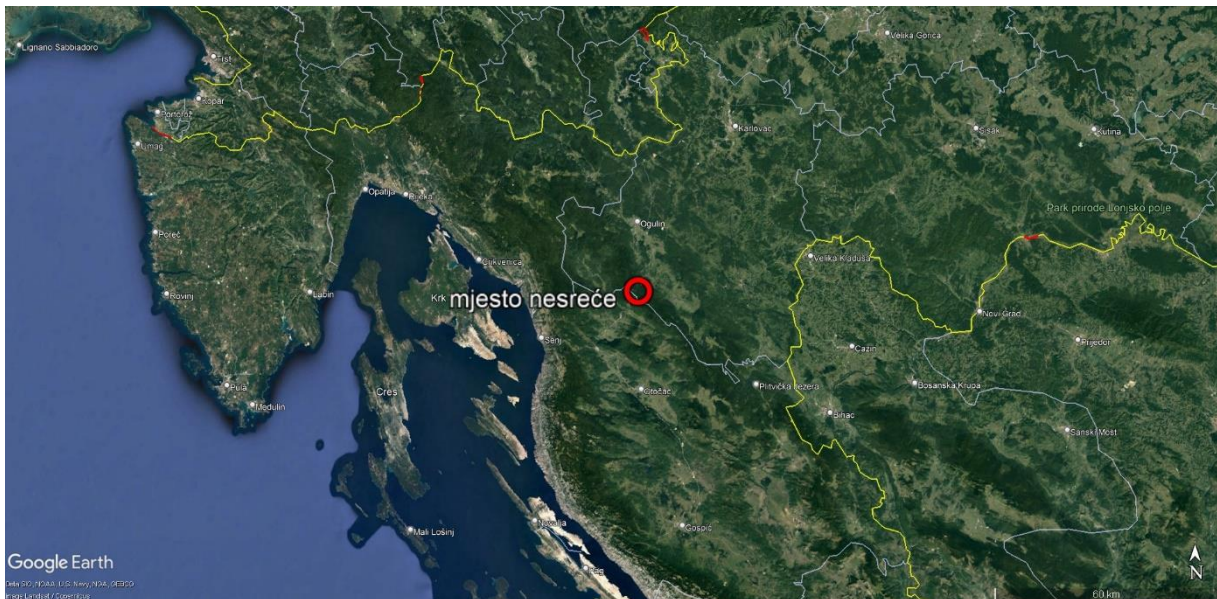
Picture 1 – the place of the accident, marked with a red circle

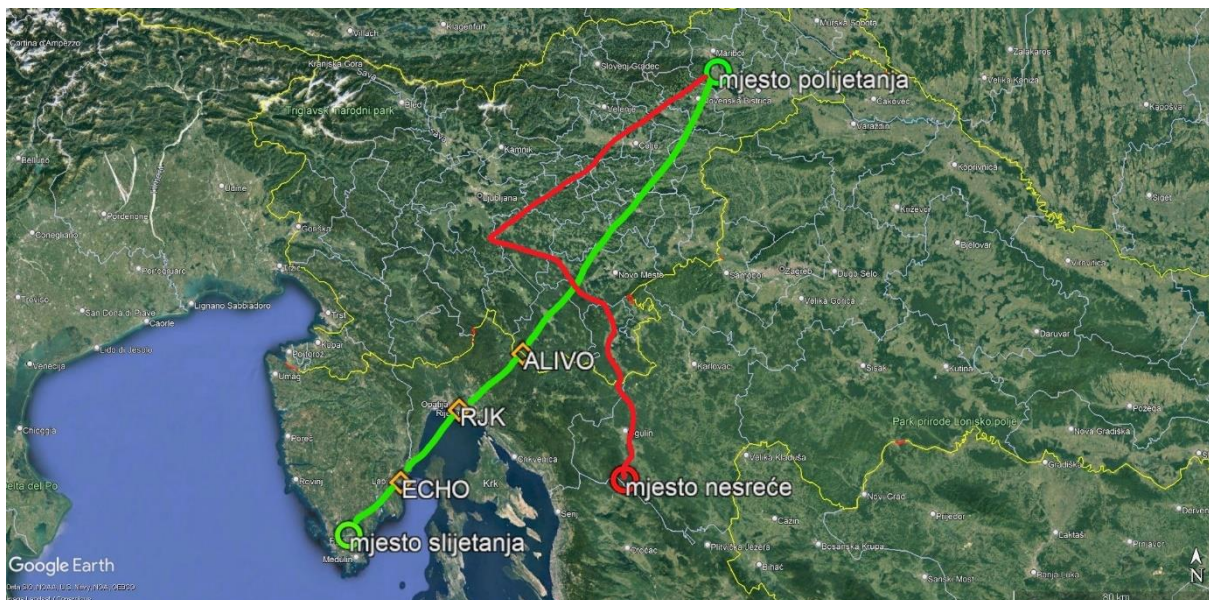
Picture 2 – the flight route that was reported by the Flight Plan with the planned landing place (green line) and the actual flight path (red line)

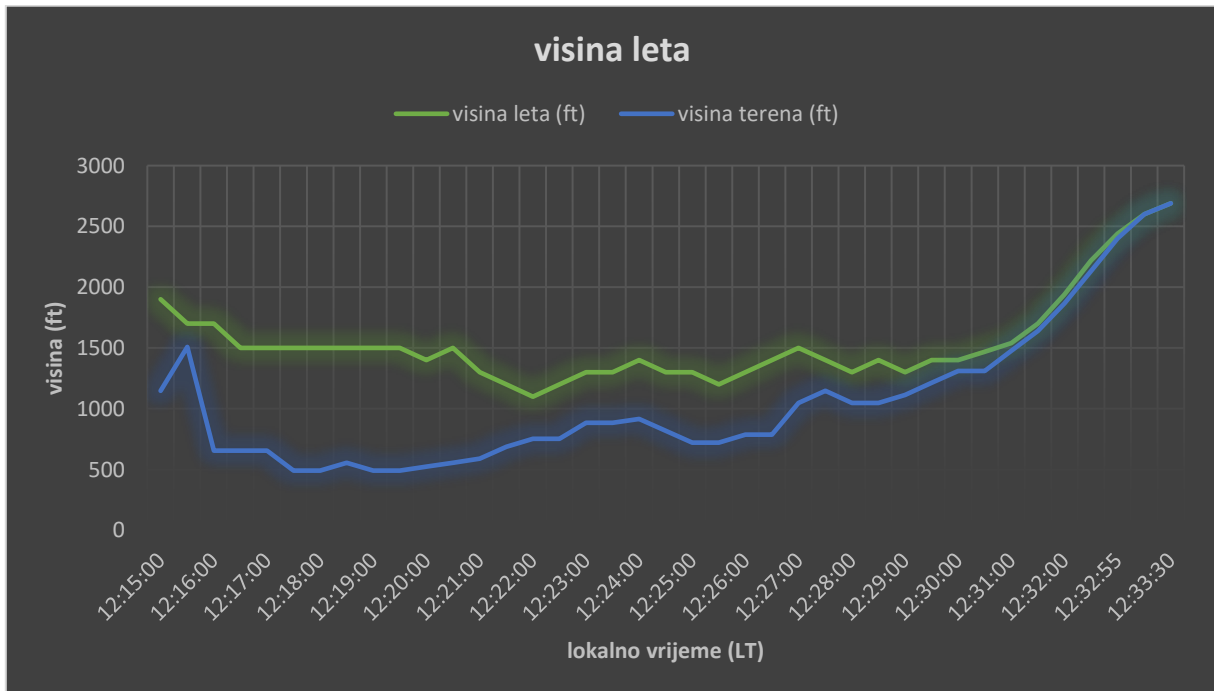
The diagram below (Figure 3, based on radar data) shows the flight altitude of the plane in question and the height of the ground below it. In the last two minutes of the flight, the ascent of the terrain on the plane's path is visible, as well as the intense climb of the plane in question.

Figure 3 – the altitude (ASL) of the PH-YMC plane in the last 18 minutes of the flight (green line) and the height of the terrain over which the plane flew (blue line)
