Air, Maritime and Railway Traffic Accident Investigation Agency

FINAL REPORT

**ON ACCIDENT OF JMB AIRCRAFT VL-3,
CALL SIGN F-JVZK**

**31 MAY 2024,
HVAR AIRPORT (LDSH), ISLAND OF HVAR**

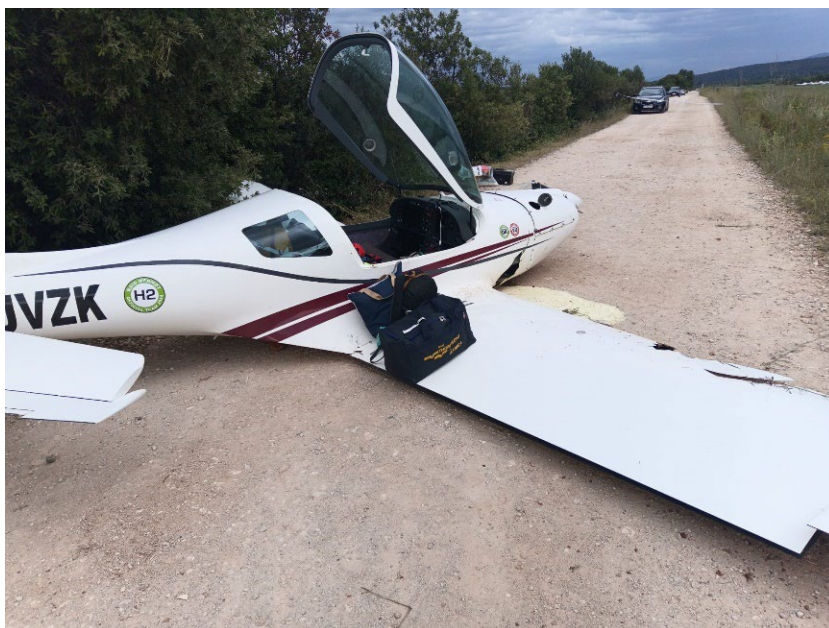
A complete rupture of the fuselage is visible at the joint with the tail surfaces. The stabilizers and rudders on the tail surfaces are not damaged.

The right wing is severely damaged. Significant damage and deformations are visible on the leading edge of the wing, and cracks are visible on the fuselage in the area of the joint with the wing. No damage is visible on the wing control surfaces.

Picture 2 – damage to the wing and fuselage

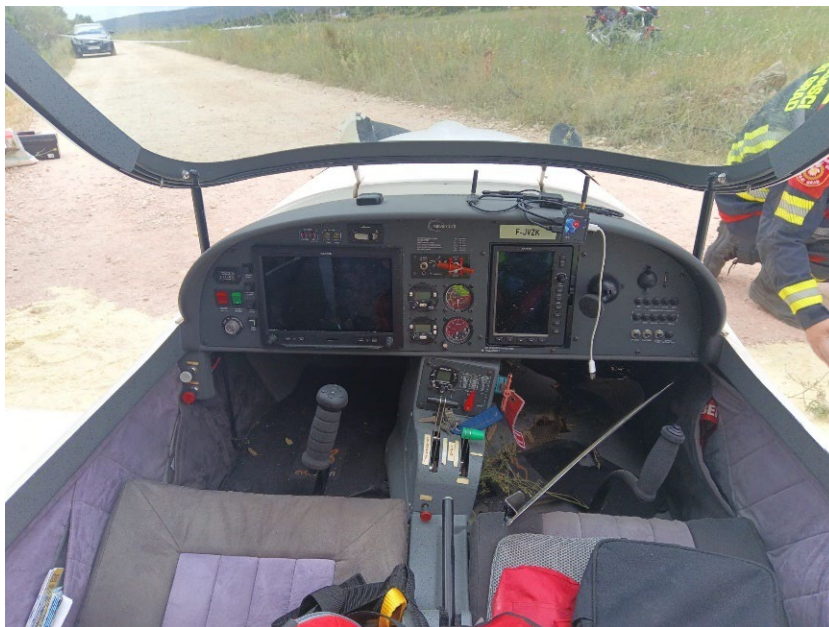
On the right side of the fuselage, behind the engine, there is a penetration caused by impact with an iron post of the airport fence. In this area, there is also visible fuel leakage, indicating that the post also tore the fuel system installations in that part. The penetration extends along the floor to the passenger footwell.

Picture 3 – damage to the interior of the cabin

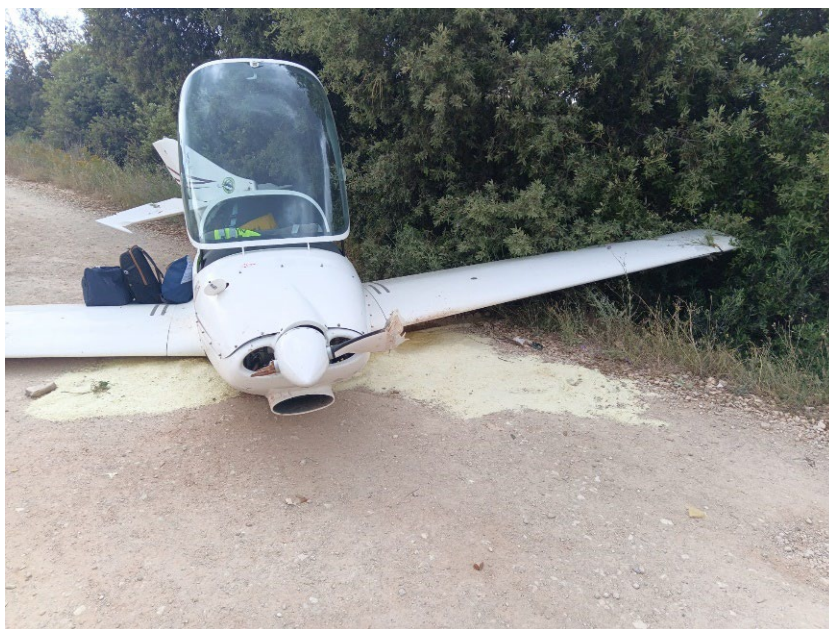
There are no visible damages on the cockpit cover, other transparent surfaces, or instrument panel. During the impact, the left main landing gear wheel broke off. The right main landing gear wheel and nose gear retracted into the fuselage. Both blades of the propeller broke off due to the impact.

Picture 4 – damage to the propeller

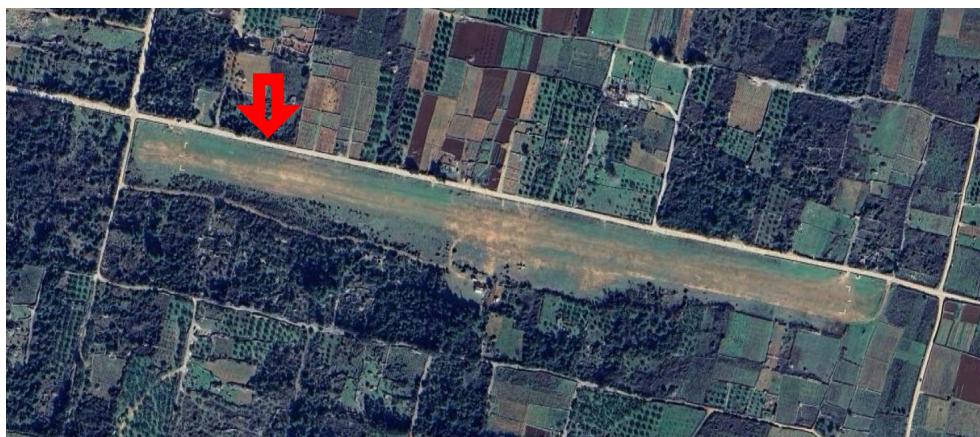
Picture 8 – Accident site

The aircraft crashed to the left of runway 10 threshold and came to a stop on the dirt road that runs along the edge of the airport parallel to the runway. Tire tracks are clearly visible from the runway to the dirt road.
