FINAL REPORT

VERY SERIOUS MARINE CASUALTY

Grounding and Total Loss of the Livestock Carrier *Deala*

Southeastern Coast of Istria, Cape Kremen, April 16, 2024

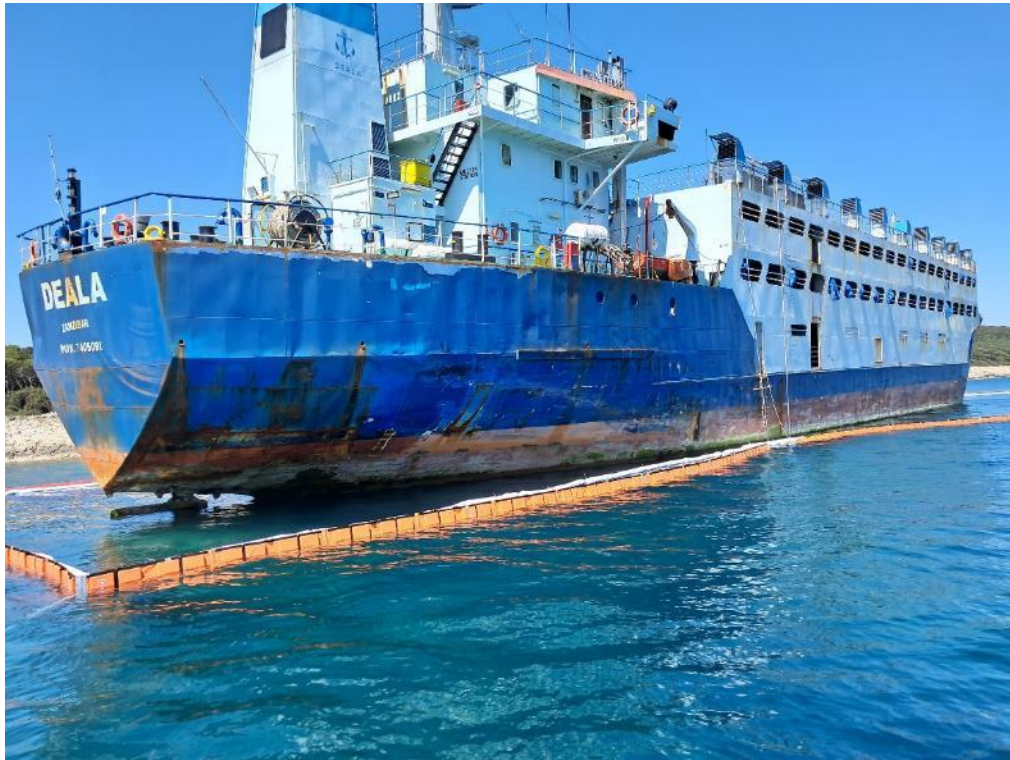
At 6:59 pm, *Deala* grounded on its port side on a shoal near Cape Kremen. Seawater flooded the engine room, causing a complete power outage (blackout). Shortly afterward, the master decided to abandon the ship with the crew. The evacuation was carried out the following day, as weather conditions prevented tugs from safely approaching the grounded vessel earlier. In the afternoon, all crew members were transferred onto tugs, unharmed, and safely brought ashore.

Figure 1. Cargo Ship Deala, after the accident
(source: AIN)

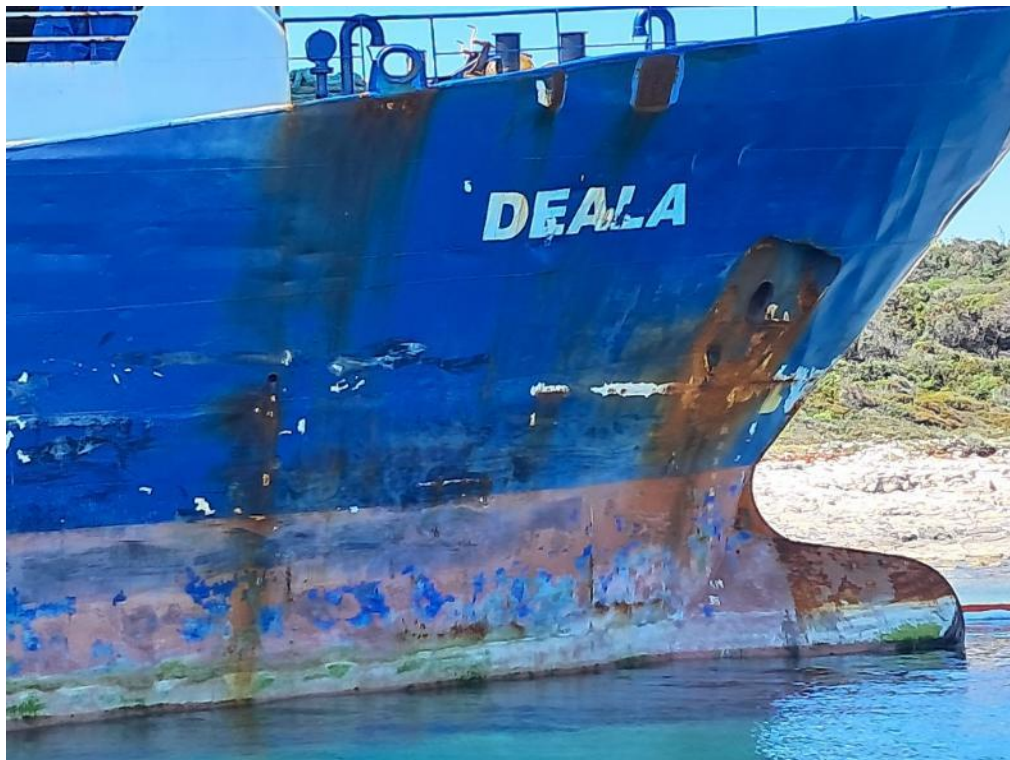
Figure 2. Cargo Ship Deala, after the accident, lost starboard anchor
(source: AIN)

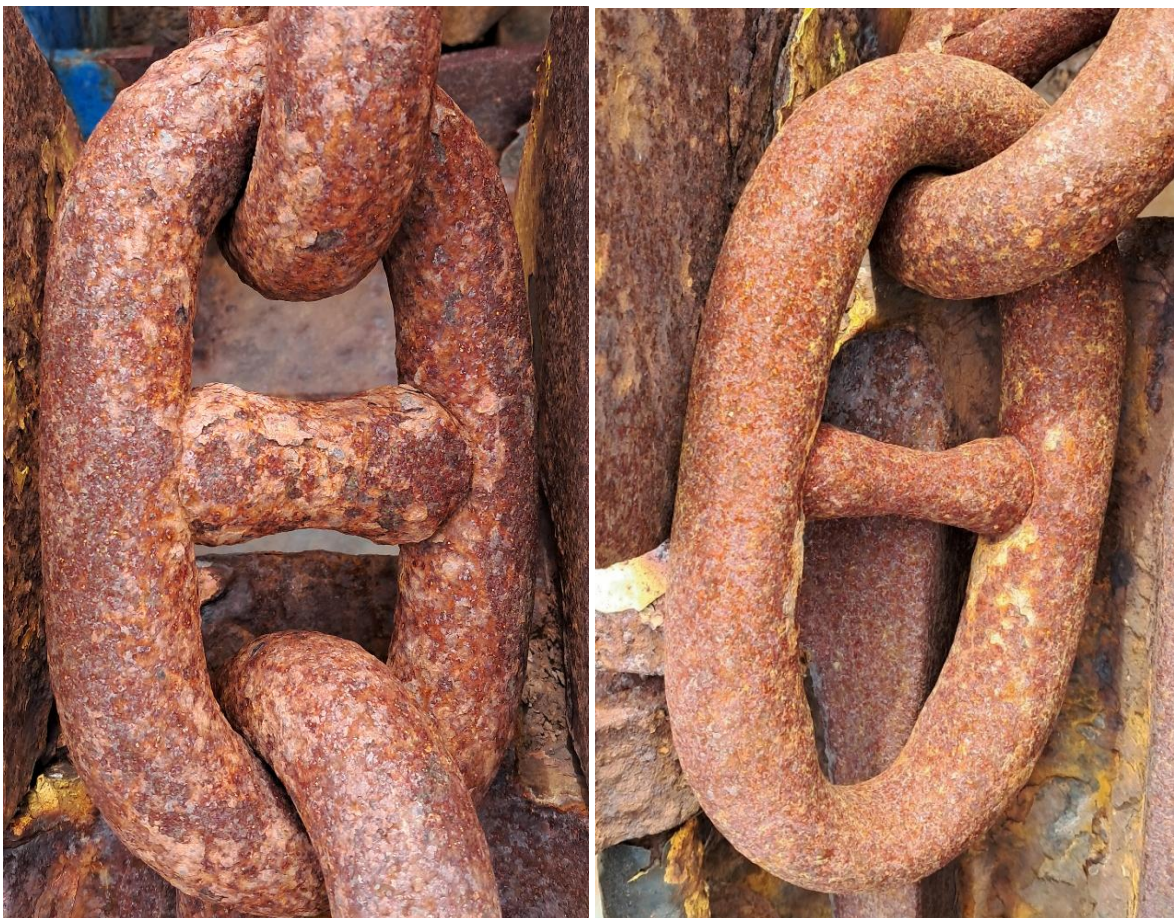
7 shackles (192.5 m) and the starboard anchor chain 8 shackles (220 m). The same document shows that the measured values exceed the permissible reduction in chain link thickness. Both chains showed such deviations, with the port chain exceeding limits to a lesser extent than the starboard one.

No records were found indicating that any measures were taken by the company in response to these findings. The lack of accompanying documentation, the general condition of the chain, and random measurements of individual links taken during the inspection suggest that no corrective actions were undertaken to address the deviations identified in the measurements. The onsite inspection also confirmed that the starboard and port anchor chains were not identical; the crossbars of the starboard chain links measure approximately 75 mm, while those on the port anchor chain are larger, approximately 130 mm.

Figure 3: Comparison of shackles of port and starboard anchor chain (source: AIN)

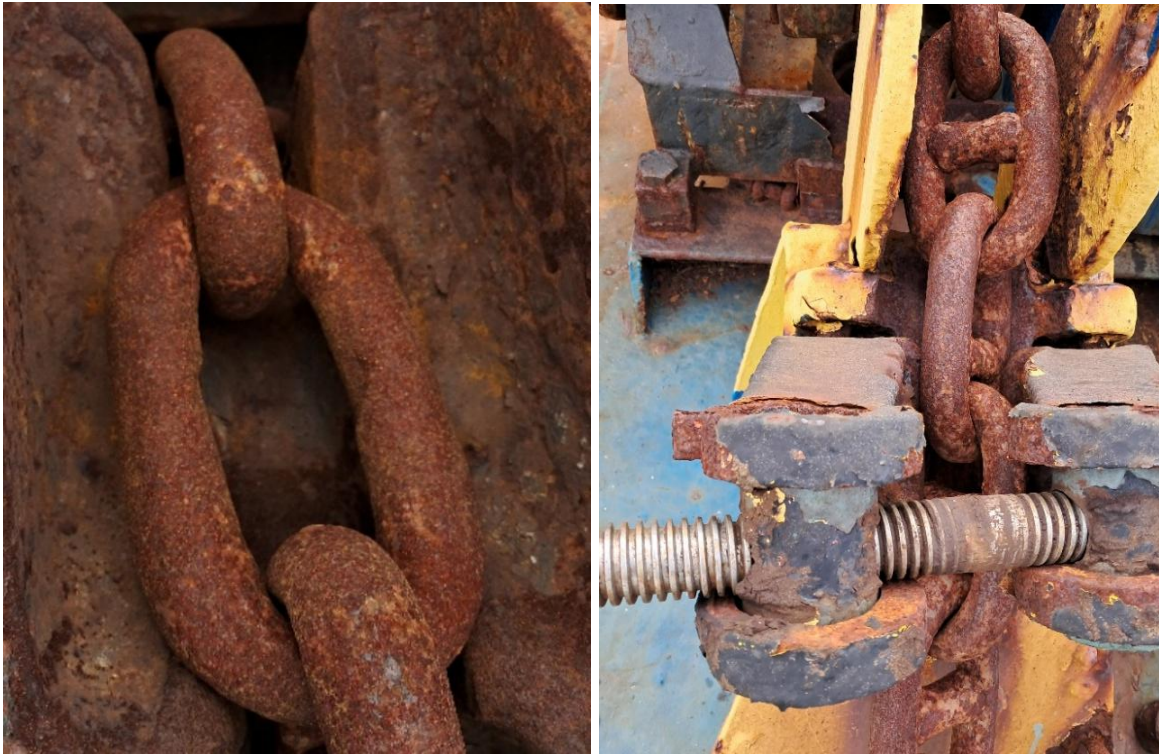
The entire anchor system – windlass, brake components, chain stopper, brake pads, and both anchor chains – are in poor condition, significantly affected by corrosion. There are no signs of lubrication on the moving parts. Some links are missing crossbars, just like the appropriate markings for individual shackles. No records were found regarding the maintenance of these systems or a maintenance plan for the anchor system. Such state of the anchor system, as well as the deck equipment in general, is consistent with the testimonies of certain crew members who held responsible positions on this ship

Figure 4: Shackle with no crossbar and anchor stopper of the port anchor system (source: AIN)

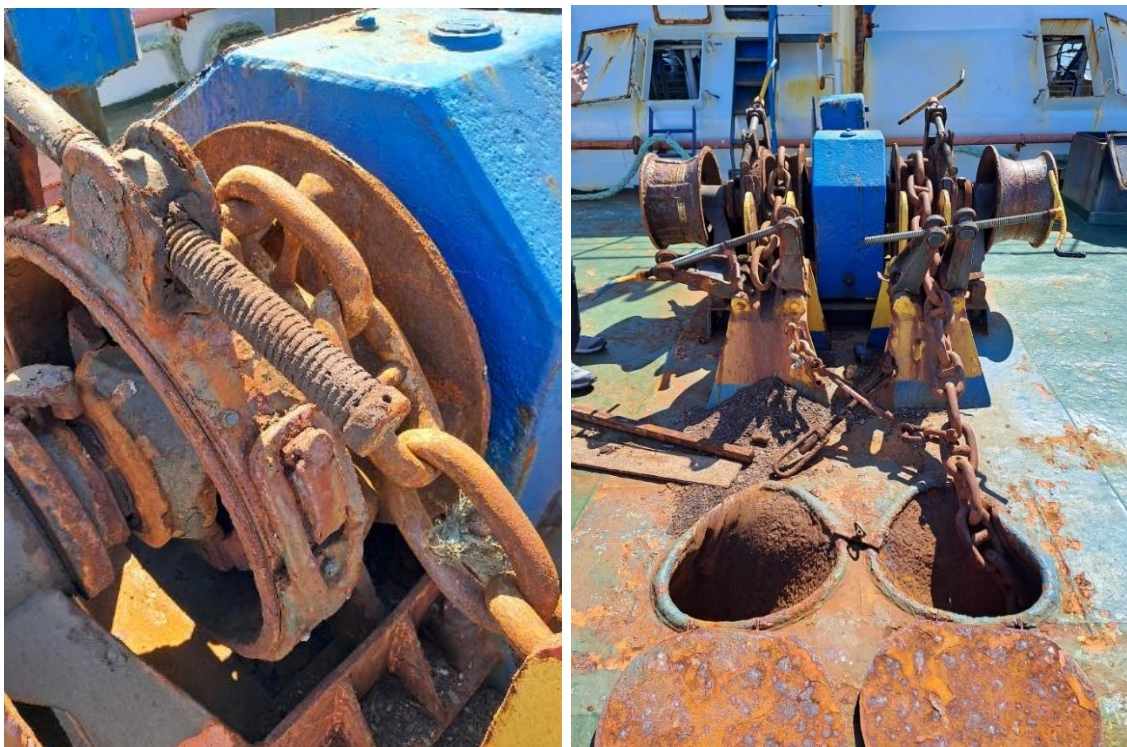
*Figure 5: Cargo ship *Deala* after the accident – the brake on the starboard windlass (source: AIN)*

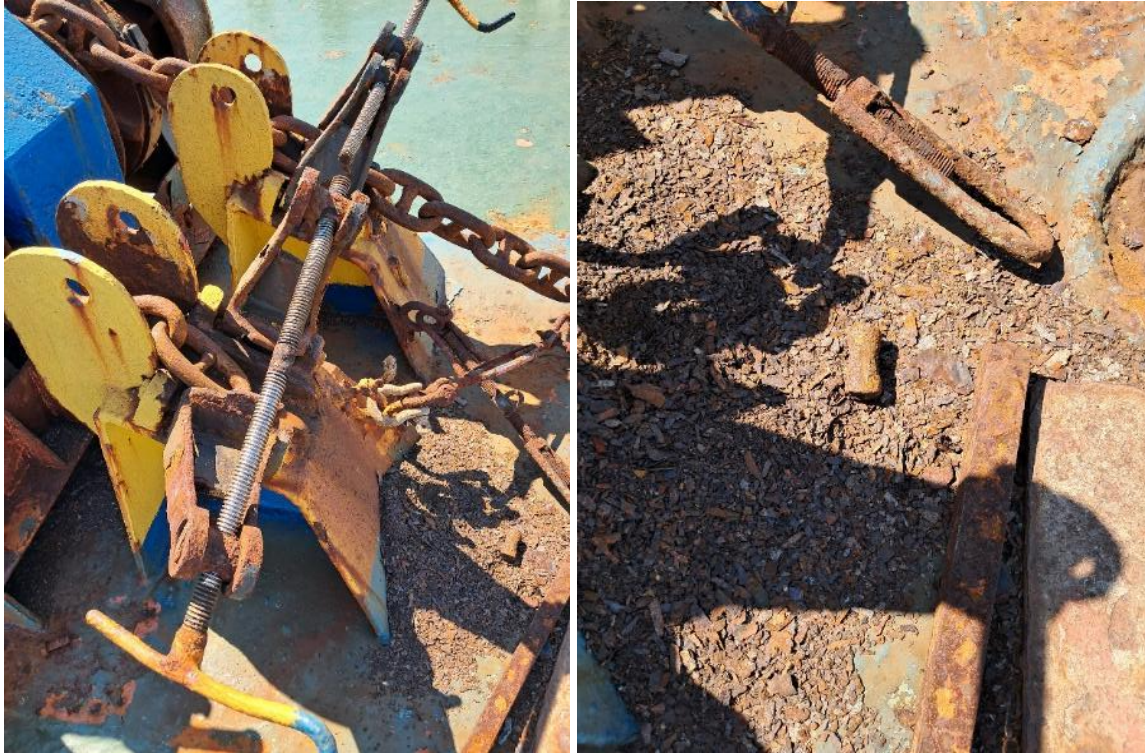
The right anchor chain broke exactly at the position where it was held by the chain stopper.

Figure 6: Breakage of the right anchor chain (source: AIN)

There were no direct witnesses of the breakage, but crew members who were at different locations within the superstructure reported hearing a sudden and loud noise resembling an explosion. Following this, a team led by the chief officer proceeded to the ship's forecastle. The chain breakage is also evidenced by the remains of a broken anchor chain link scattered beneath the right chain stopper (Figure 6). The stopper itself was also damaged, indicating that it was engaged at the time of the breakage. The anchor windlass brake was engaged (tightened) when the chain broke, although it is unclear how accurately it could be tightened, given that there are no markings on the windlass to indicate the correct braking force application.

The exact point of chain breakage clearly suggests that there was significant stress on the anchor chain link resting against the chain stopper. This overload was caused by external factors such as wind, waves, and currents, but possibly also by some slippage of the brake, which further transferred the load onto the chain stopper and the link it was pressing against. Considering the poor condition of the anchor chain system and its associated components, which are designed to withstand tensile forces, it can be concluded that this deterioration contributed to the incident under conditions of increased material stress due to the aforementioned external factors.

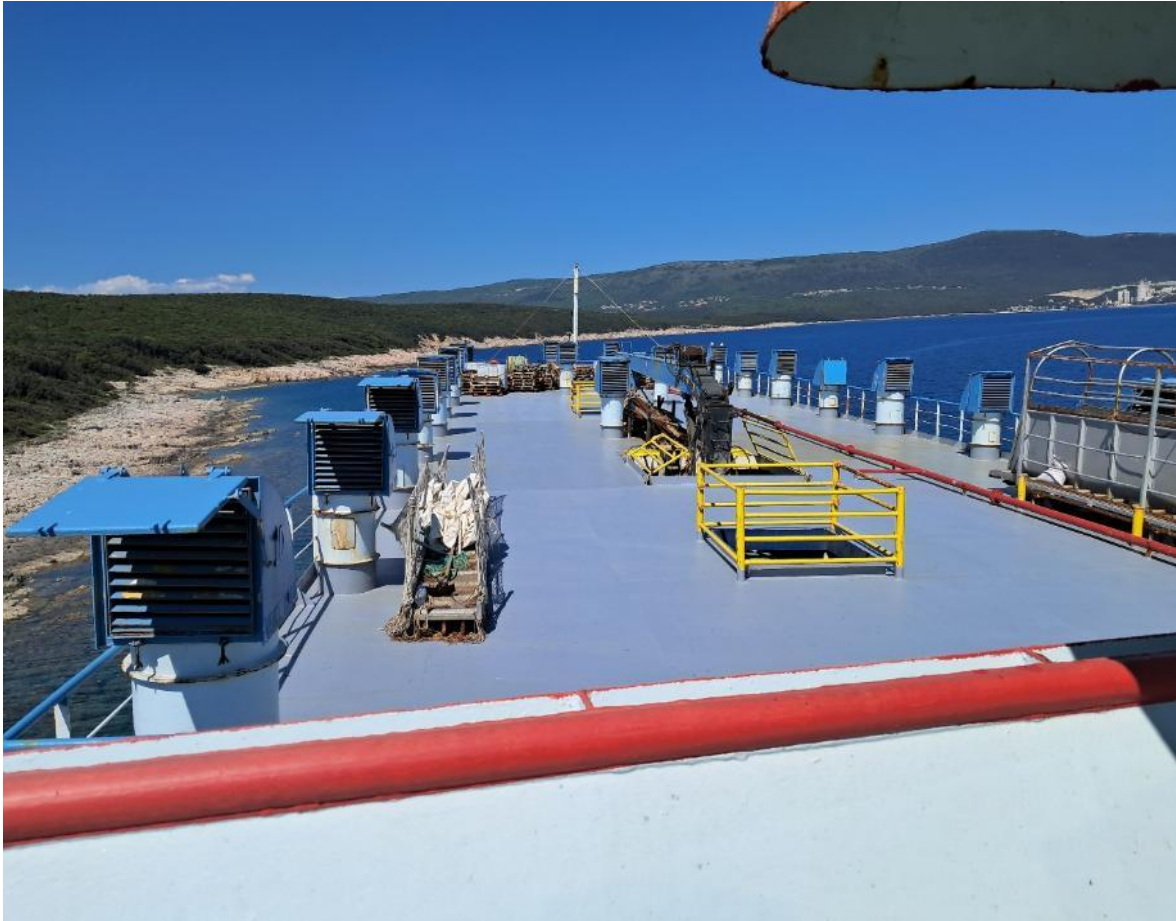
The navigation bridge is typically located at the top of the superstructure, with the view toward the foredeck significantly obstructed by cargo hold structures. As a result, there is no visual contact between the area around the anchor windlass and the bridge (Figure 7), nor are there any cameras that would allow the duty officer to monitor that part of the ship.

Figure 7: View from the port wing of the navigation bridge (source: AIN)

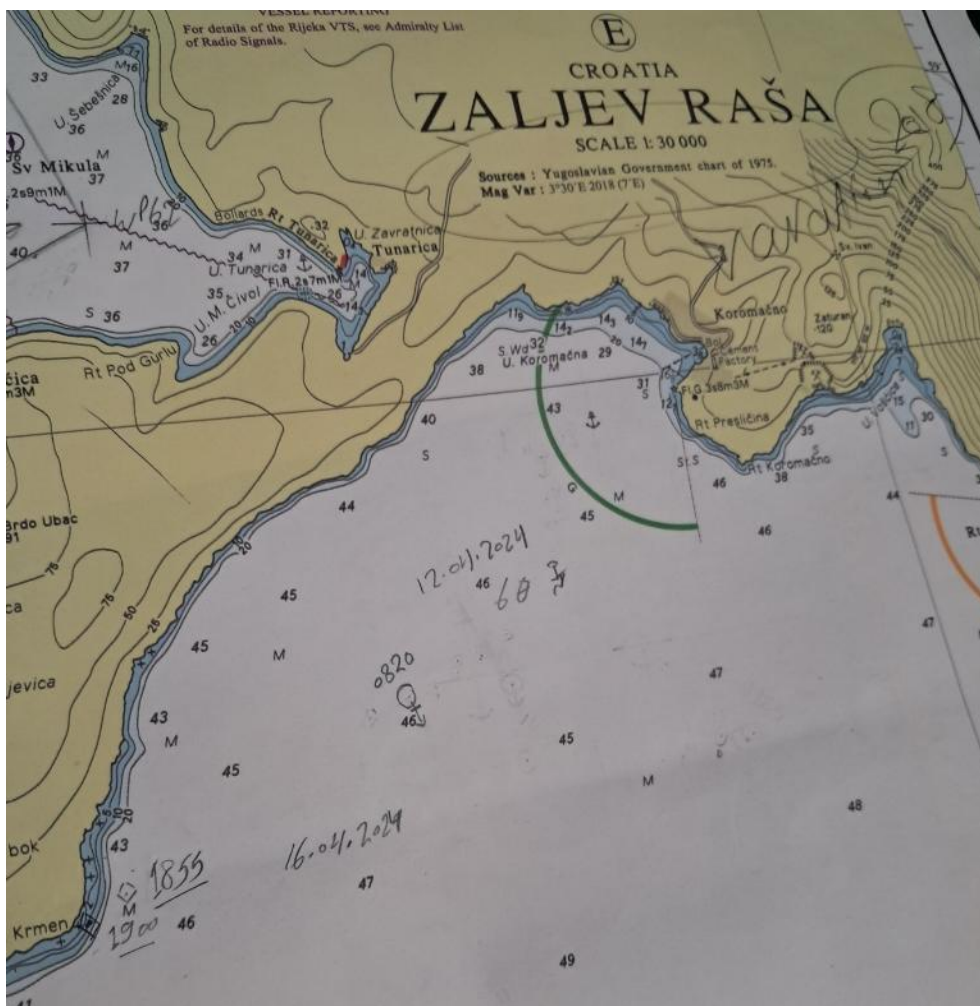
Figure 8: Nautical chart BA1426, part „Zaljev Raša“, located on the bridge (source: AIN)

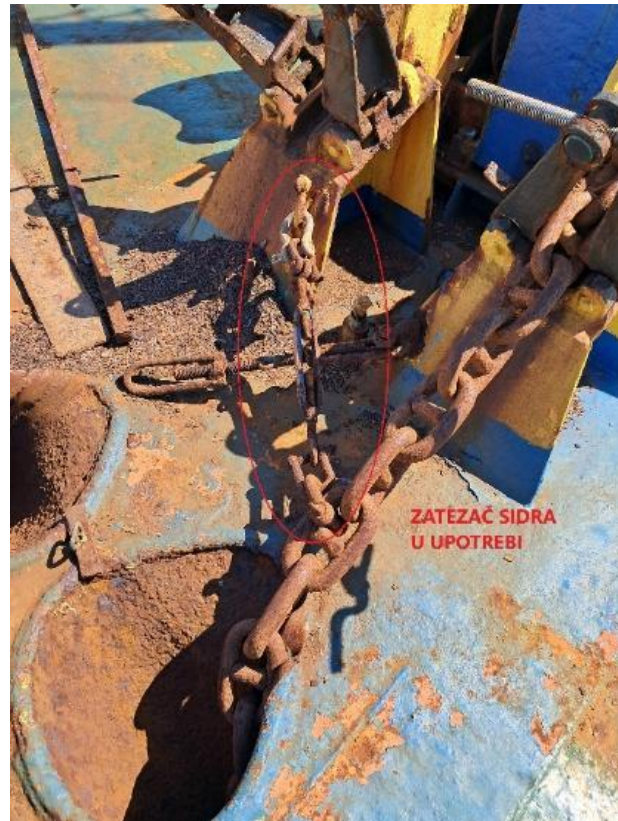
Figure 9: Port chain lashing (source:AIN)

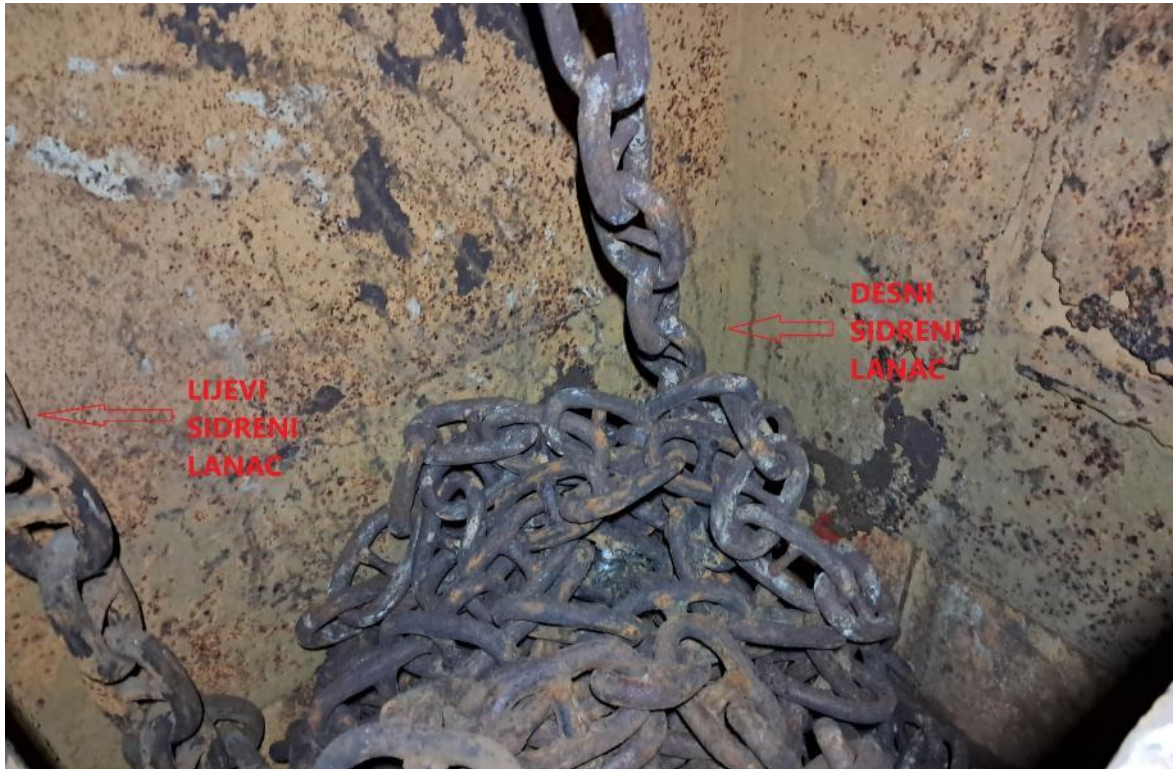
The length of the starboard anchor chain remaining on board is estimated at approximately up to three shackles, although it should be noted that this figure cannot be verified due to the absence of shackle markings and the condition in which the chain was found stored (Figure 10).

Figure 10: Anchor Chain (source: AIN)

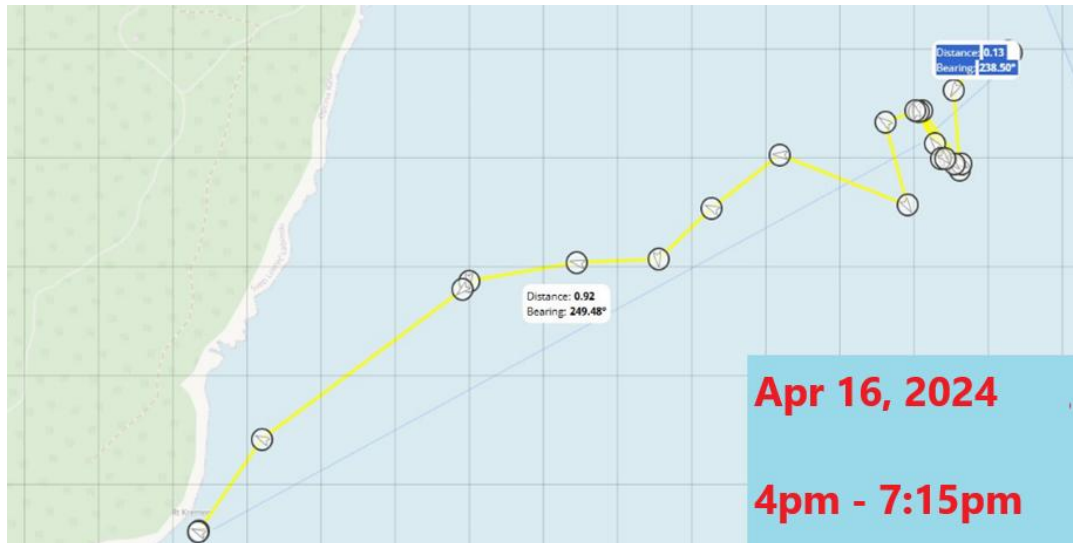
Figure 13 illustrates the vessel's movement from the moment the wind intensified and changed direction until the ship's keel grounded on the seabed.

Figure 13: SEG extract (1) (source: EMSA SEG System)

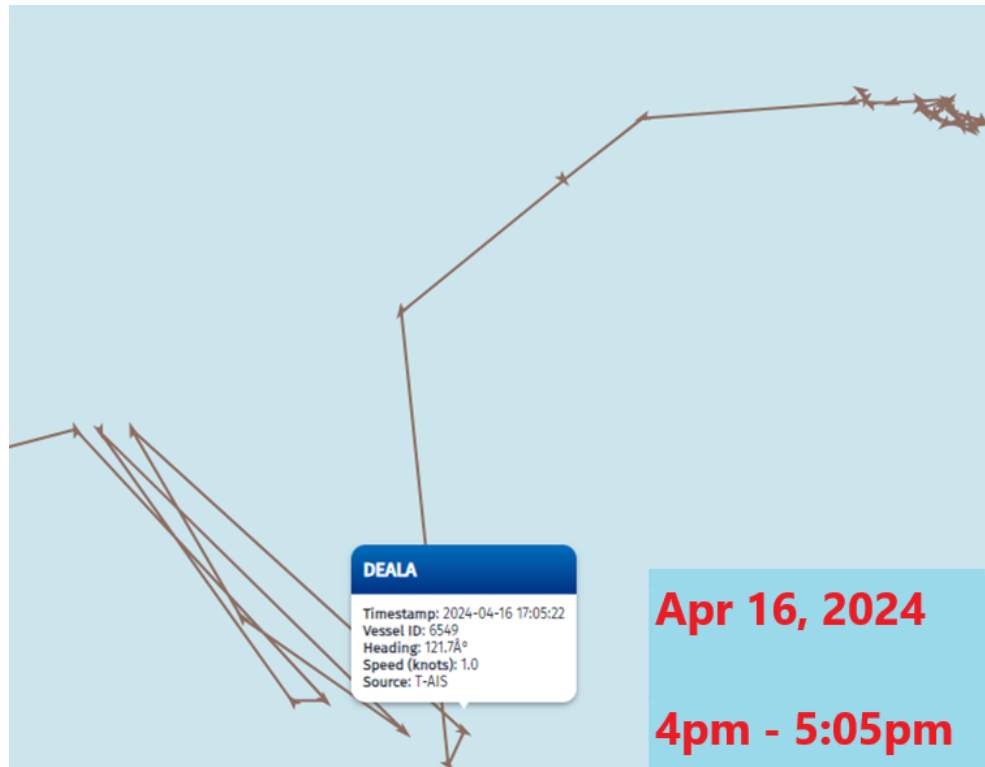
Figure 14: SEG extract (2) (source: EMSA SEG System)

At around 4:00 PM, the vessel's bow was facing west (4:05 PM – 252.6°; 4:11 PM – 298.3°). An hour later, under the influence of changing wind conditions, the vessel turned southeast (4:56 PM – 139.6°; 5:05 PM – 121.7°). This indicates that the recorded shift of 0.13 nm between 4:00 PM and 5:05 PM remained within expected values, confirming that the anchor had not yet dragged (Figure 14).

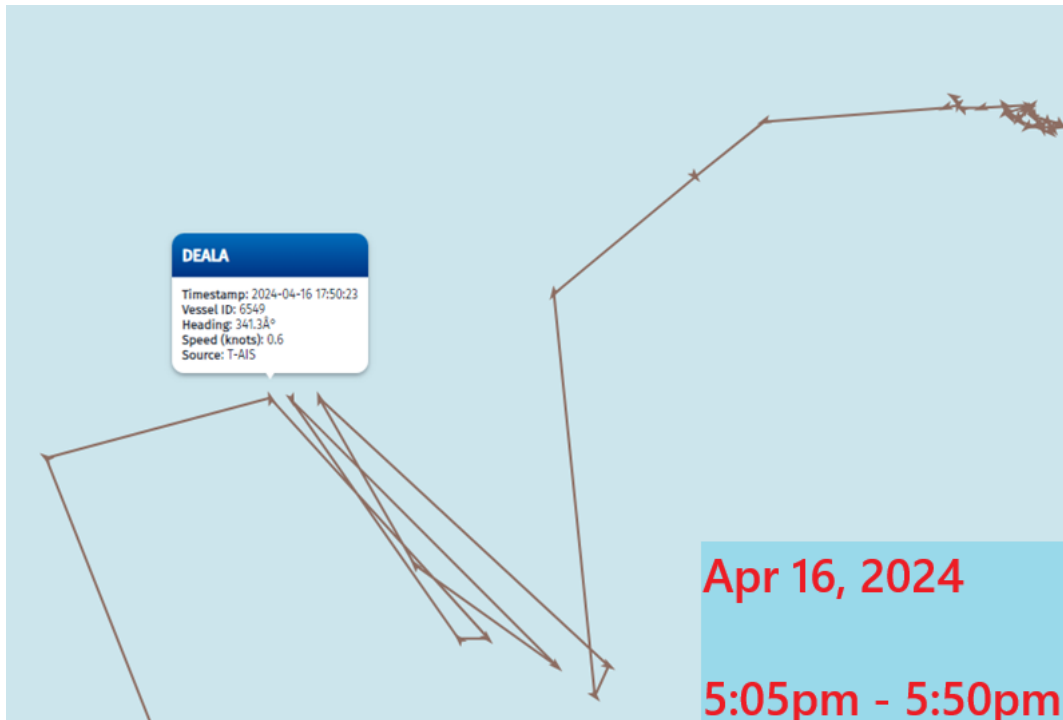
Figure 15: SEG extract (3) (source: EMSA SEG System)

Between 5:50 PM and 6:05 PM, in addition to lateral movement, the vessel also recorded a displacement of 0.07 nm (130 m) from its original anchoring position. This indicates that the anchor chain was fully stretched and judging by the changes in the vessel's bow direction and the recorded displacement, the anchor began dragging along the seabed.

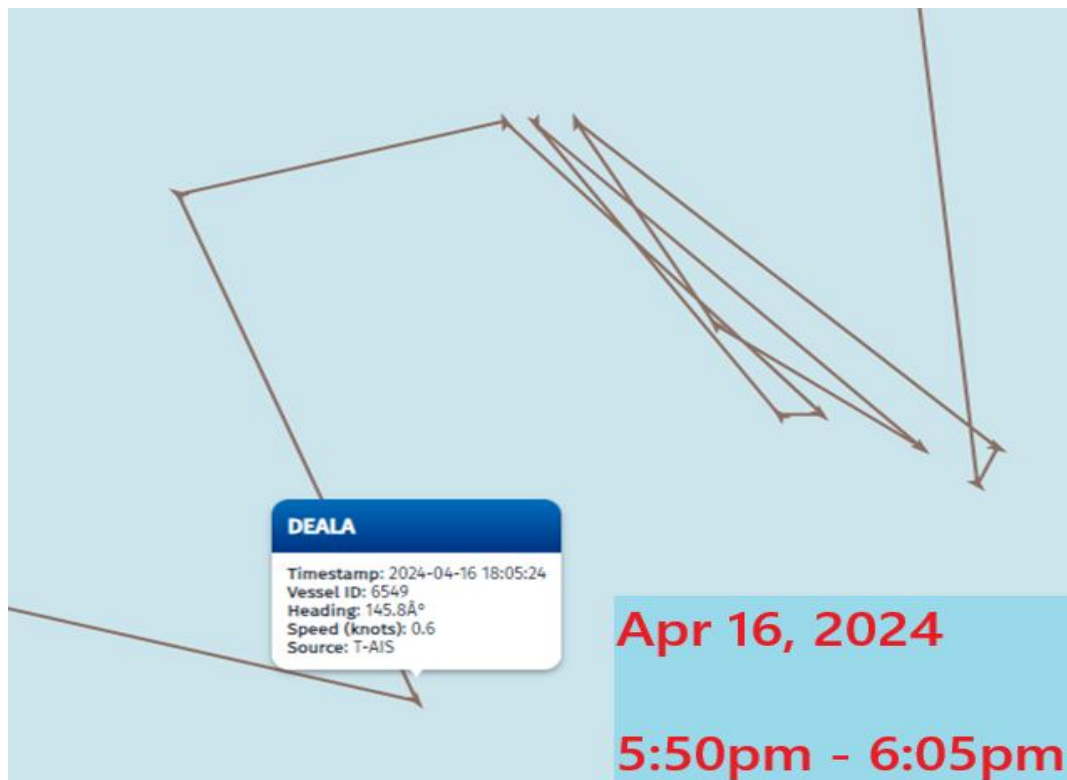
Figure 16: SEG extract (4) (source: EMSA SEG System)

Between 6:05 PM and 6:11 PM, the vessel's drifting speed increased, clearly indicating the breaking of the anchor chain. The sudden change in the vessel's drift is also clearly visible in Figure 17, where the transition of the marked track from yellow to blue indicates the acceleration of the drift, thereby identifying the moment the anchor chain broke.

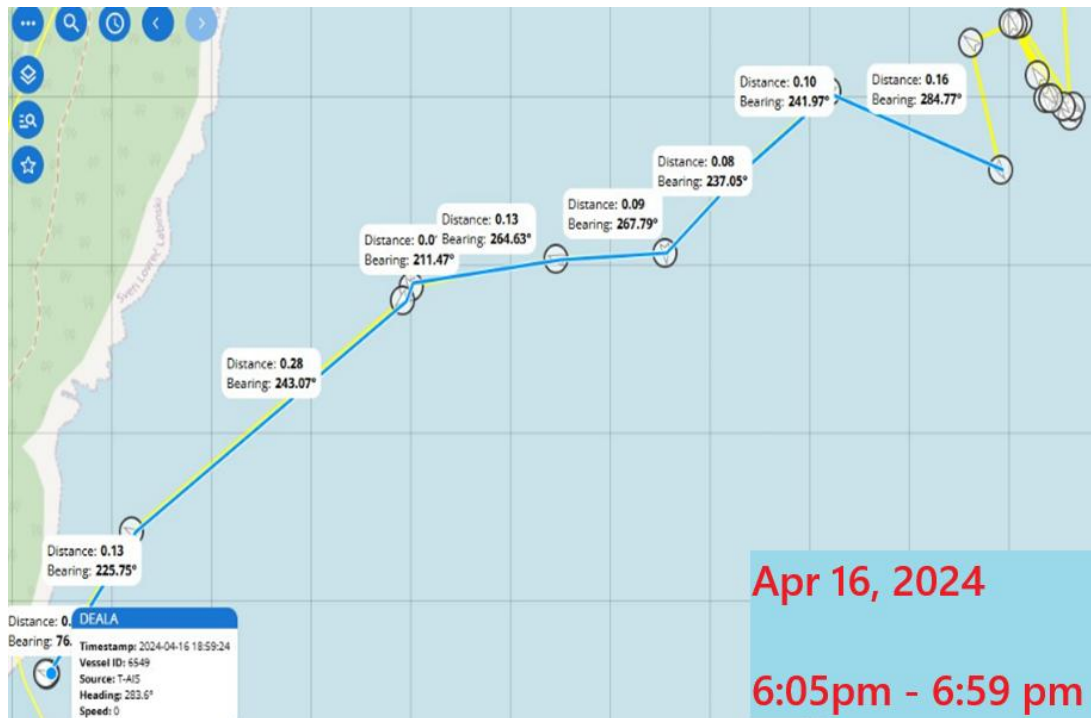
Figure 17: SEG extract (5) (source: EMSA SEG System)

After the chain broke, the lateral component of the vessel's speed significantly decreased, and the ship drifted away from the anchoring position. At the moment of the sudden chain failure, the vessel was 0.8 nautical miles east-northeast of hazardous shallow waters. As previously established, the vessel's position was not being monitored using a fixed coastal object, nor was a swinging circle plotted — both of which are key tools for determining position near the coast and for early detection of changes in dynamic conditions of the ship while at anchor.
