## PRELIMINARNO IZVJEŠĆE / PRELIMINARY REPORT

1. OPĆENITI PODACI / ACCIDENT/SERIOUS INCIDENT IDENTIFICATION		
a	MJESTO NESREĆE ILI OZBILJNE NEZGODE	The village of 'Krivi put', near the town of Senj, Croatia
	AREA OF ACCIDENT OR SERIOUS INCIDENT	
b	DATUM NESREĆE ILI OZBILJNE NEZGODE	13 November 2025
	DATE OF ACCIDENT OR SERIOUS INCIDENT	
c	VRIJEME NESREĆE ILI OZBILJNE NEZGODE	16:37 LT (15:37 UTC)
	TIME OF ACCIDENT OR SERIOUS INCIDENT	
d	PROIZVOĐAČ ZRAKOPLOVA	Air Tractor
	AIRCRAFT MANUFACTURER	
e	TIP ZRAKOPLOVA	
	AIRCRAFT TYPE	
f	MODEL ZRAKOPLOVA	AT 802A
	AIRCRAFT MODEL	
g	DRŽAVA PRIPADNOST ZRAKOPLOVA	Republic of Turkiye
	STATE OF REGISTRY	
h	REGISTRACIJSKE OZNAKE	OR 2025
	REGISTRATION	
i	OPERATOR ZRAKOPLOVA	Ministry of Agriculture and Forestry, Republic of Turkiye
	AIRCRAFT OPERATOR

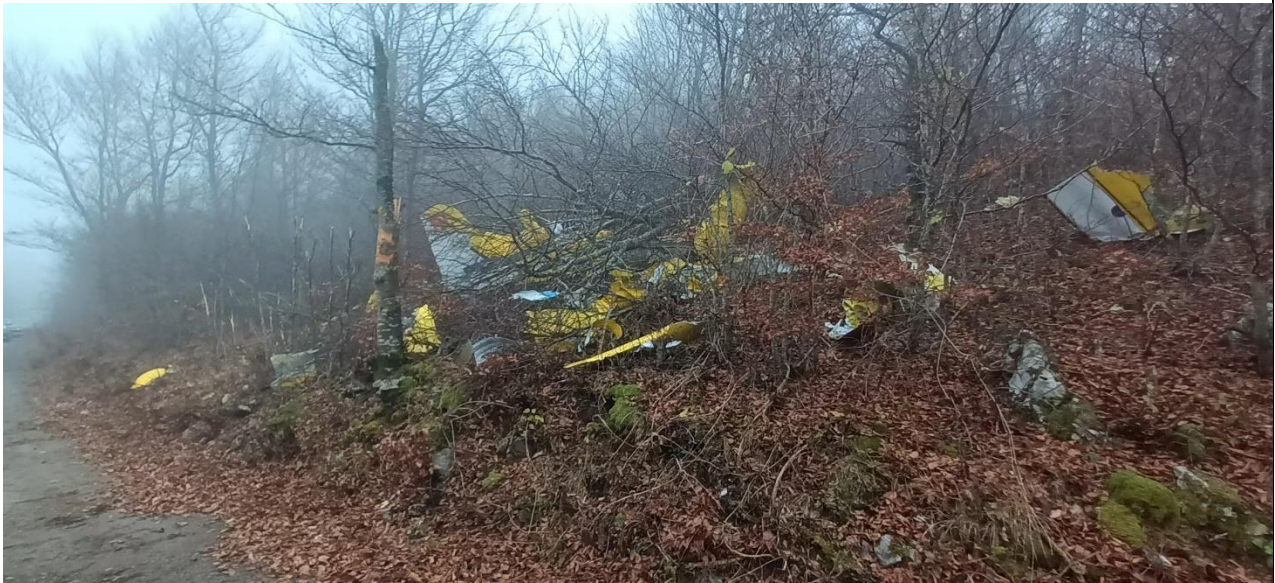
AIN received notification of the missing aircraft from the Ministry of Interior Operations Center and Croatian Air Traffic Control. The wreckage was located later the same evening. The aircraft was completely destroyed by impact and post-impact fire, and the pilot died.

Image 2 – plane wreckage at the crash site

Loss of spatial orientation in conditions of insufficient visibility.
