# **FINAL REPORT**

## **VERY SERIOUS MARINE CASUALTY**

### **Fire and Total Loss of the Yacht *Acceptus***

**28 June 2024**

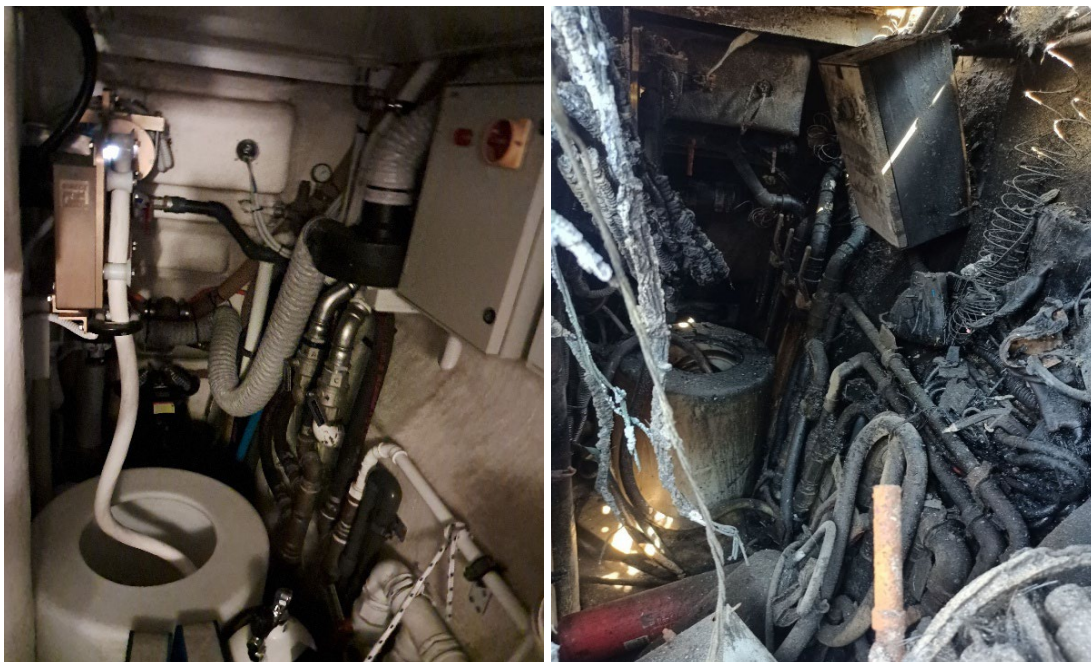
Figure 5. Technical area – aft section, on the sister yacht and on the burned yacht (source: AIA<sup>1</sup>)

In the technical area, equipment located closer to the exit doors sustained more significant damage. All equipment in this area, including the electrical cabinets of the gyroscopic stabilization system and the sanitary water treatment system, was completely burned on the outside.

Evidence that these cabinets were not the source of the fire is shown by the uniform external burning of their surfaces, with PVC cladding displaying signs of melting rather than combustion.

The flame impact was more pronounced in the upper part of the compartment, while damage intensity decreased toward the stern; cabinets at the aft end of the space remained nearly unaffected by fire and heat, despite being made of plastic.

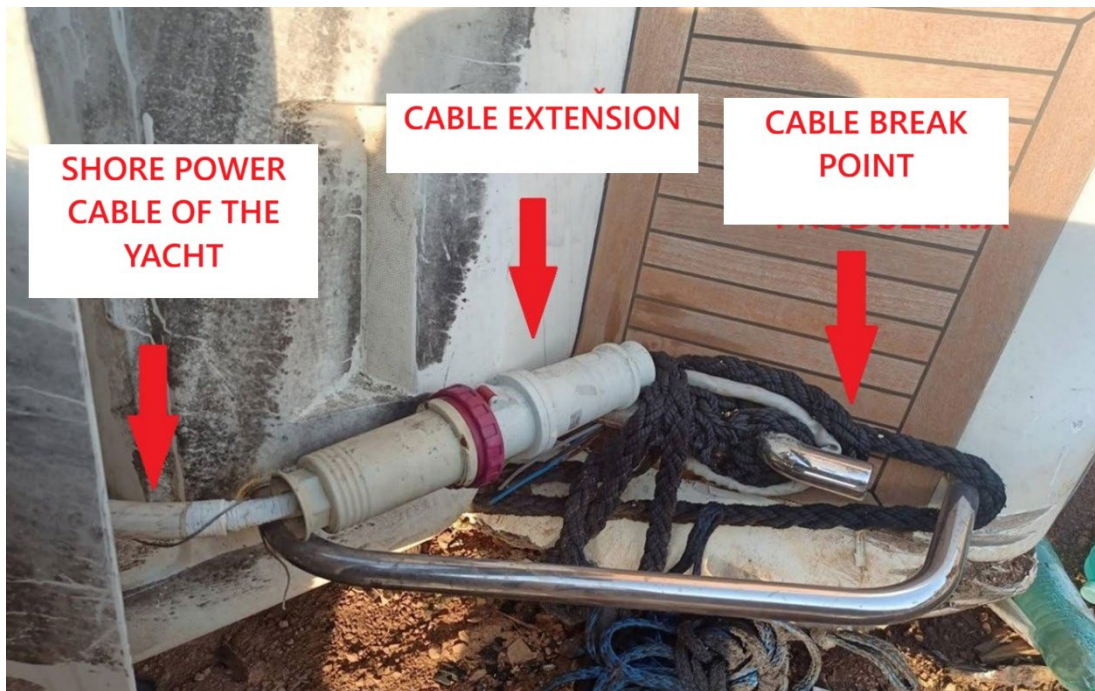
Figure 6. Shore connection cable with the installed extension cable (source: AIA)

During the inspection, a segment of the shore connection power cable that remained after the fire was examined. The shore connection power cable passes through power outlet opening on the exterior wall of the yacht toward the shore connection and continued via an additional extension cable connected to the shore-side distribution cabinet. This additional extension cable was found to be severed during the inspection (Figure 6).

Next is the point where the cable enters the vessel, i.e., the technical area of the lower deck. The cable passed over the hydraulic winch guide rails before entering a PVC container where it was coiled. At the bottom of the container, there was an opening through which the cable exits. Immediately after exiting, a break in the cable was observed. The cable end retained the shape intended for mounting in the cabinet. The cable still had the cable gland through which it entered the PVC cabinet. Up to this point, the cable had not been fire-damaged or thermally deformed. Behind the rubber gland, which was partially heat-damaged, the cable separated into conductors that were completely burned; the conductor insulation and copper wires had melted and fused together near the gland (at the bottom of the box). The ends of the conductors, found without insulation, still showed screw connectors.

Of the equipment that had been in the junction box, only the screw connectors for joining the two cables – supply and outgoing – were preserved. No remnants of switching or protective equipment were found, suggesting that none had been installed. The junction box was intended solely for joining the two cables and was located immediately adjacent to the hydraulic winch in the technical area. Further inspection traced the end of another segment of the shore connection cable, leading to the isolation transformer in the control room.

The final 50 cm segment of the shore connection power cable was analyzed in detail. It was found that the conductors were intact, indicating that no insulation between conductors had been destroyed. Therefore, there was no overload or short circuit at this location that would have left traces on the individual wires. Two instances of cable insulation damage were identified. The first was mechanical crushing, as part of the insulation was scraped off. The second damage was not visible, but a 30 cm section of the cable was wrapped with white insulating tape. Beneath this tape were several layers of other colored insulating tapes, and the cable insulation itself was cut over a length of approximately 7 cm. The tape layers were not well-adhered or had come loose during use and bending. The cable conductors inside the cable were not visibly damaged.

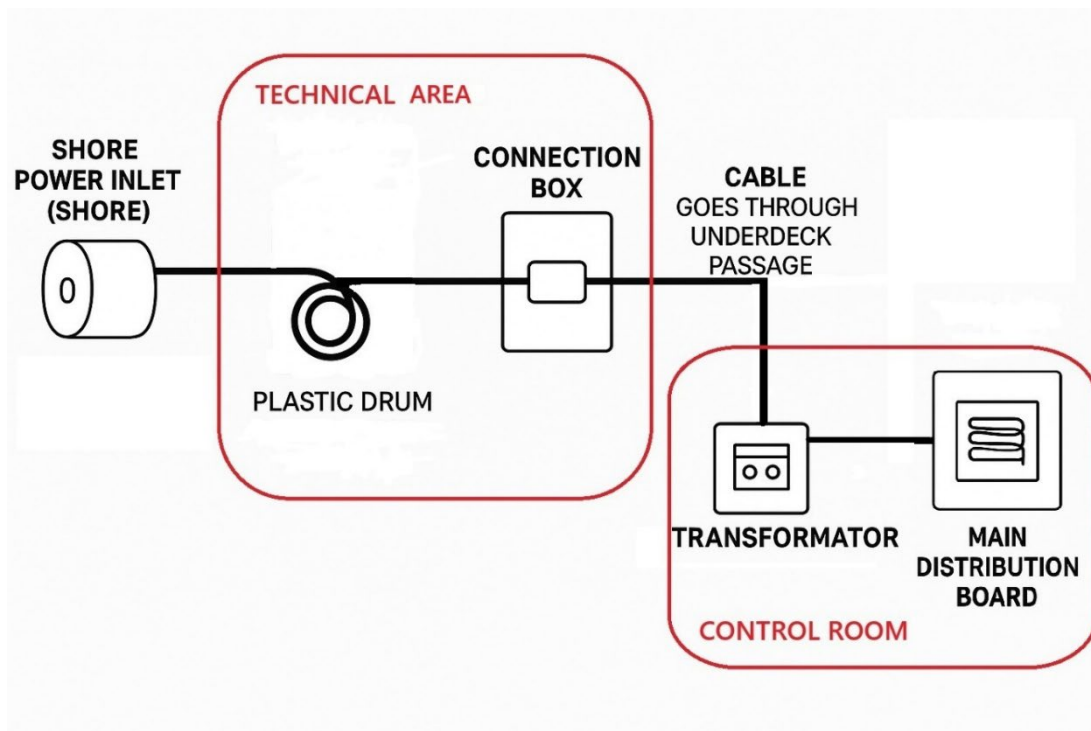
Figure 7. Shore connection cable (Source: AIA)

The shore connection power cable on the yacht *Acceptus* (Figure 7) consisted of two segments. The first segment begins at the connection equipment for linking to the shore-side electrical cabinet. The cable then passes through a gland on the hull and enters the technical area, where it connects to the PVC junction box. Before entering this box, the cable is coiled in a barrel-shaped PVC container, which is wound via the hydraulic winch to regulate the cable length toward the shore. Using the cable while it is coiled creates an inductive loop that increases heating of the cable and connections, which over prolonged operation likely imposed additional thermal stress on the cable.

The PVC junction box housed the electrical equipment for connecting the two cable segments. The cabinet was mounted on the inner wall of the technical area, in close proximity to the hydraulic winch. This segment of the cable is frequently exposed to mechanical stress and potential damage during use, as confirmed by the damages identified during the inspection, described in Section 4.2.1.

The second segment of the shore connection power cable starts at the PVC junction box in the technical area and continues through the floor installation duct to the isolation transformer in the control room. Along its route, the cable was installed in an electrical conduit and fixed in place, preventing exposure to mechanical damage. The position of the floor installation duct exposes this segment of the cable to the marine environment, making the untinned copper conductors more susceptible to the effects of salt and moisture, which increases material corrosion.

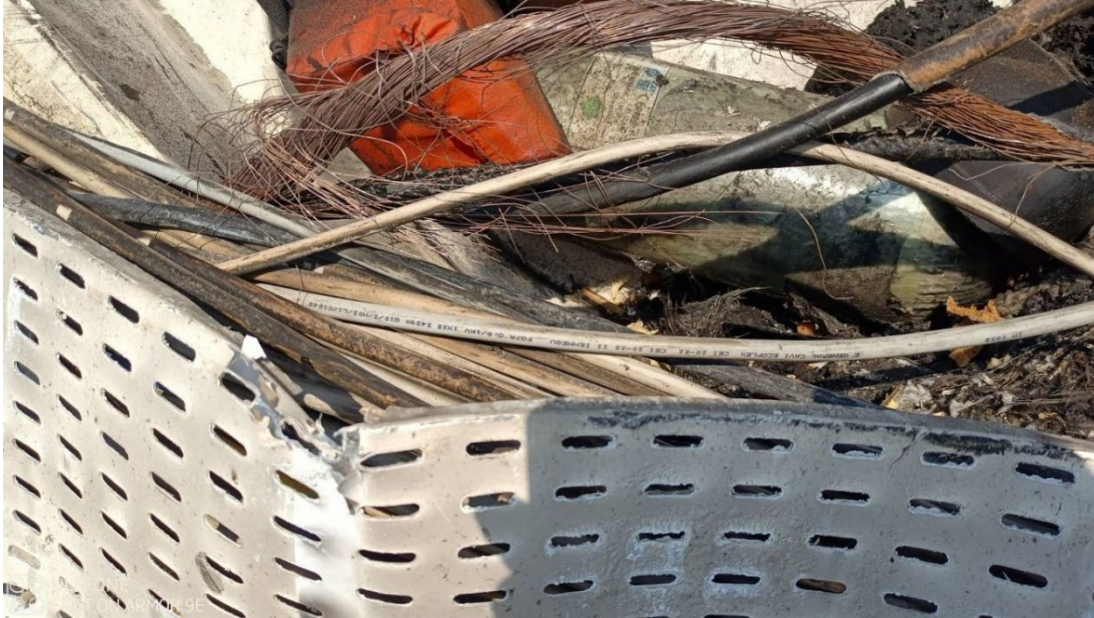
Figure 8. Routing of cable bundles in a metal cable tray (source: AIA)

The electrical cables on the vessel were routed along at least three main cable runs, using metal cable trays. The trays were perforated to reduce weight and allow cooling of the cables. The cables were laid in bundles along these trays (Figure 8).

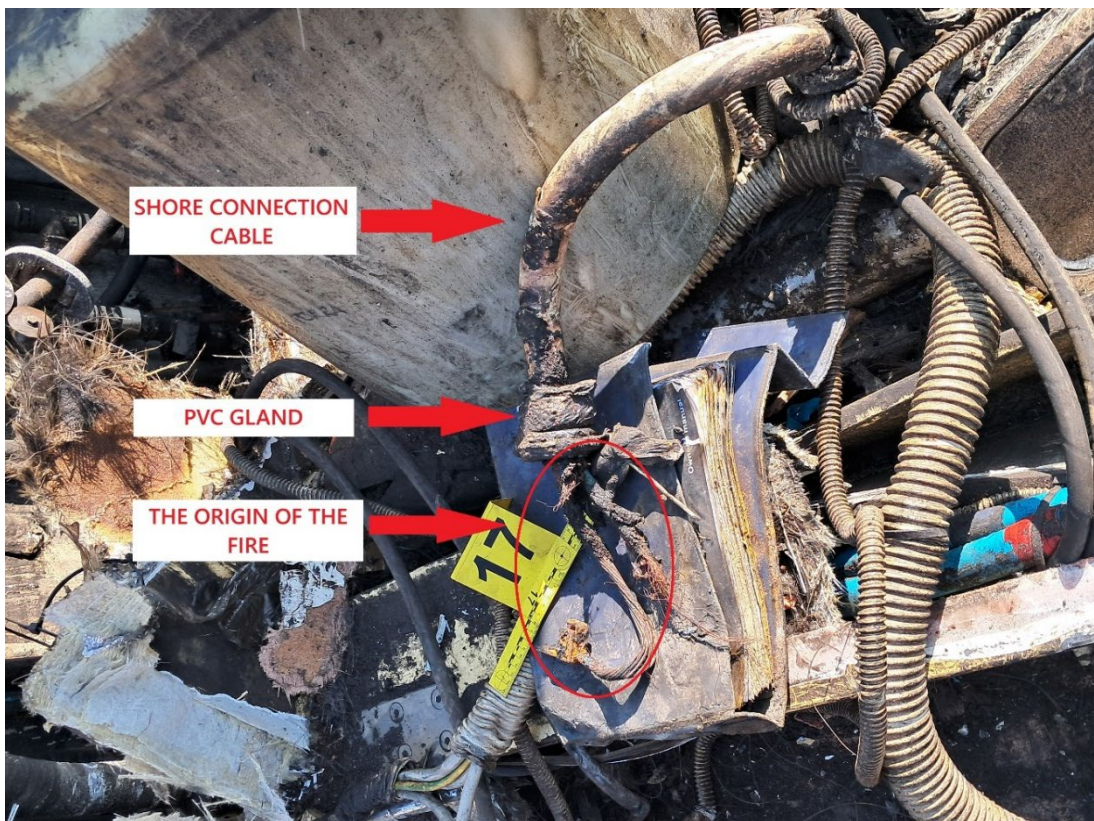
Figure 9. The origin of the fire on the shore connection cable (source: AIA)

The investigation established that the fire started inside the PVC junction box of the shore power cable, located on the inner bulkhead of the technical area. At the very center of the fire, a distinctive trace of conductor breakage and fusion of the multi-stranded copper conductor was observed, clearly indicating a technical failure of the shore power connection cable (Figure 9).

This failure is the result of the absence of tinned copper conductors on board (see Section 4.3.2) and the improper connection of the two segments of the shore power cable within this box.

Such connection inside the box led to the heating of the connection point, resulting in cable melting and smoke generation. As the melting process progressed, sparking occurred.

The appearance of open flame suggests that the decomposition products came into contact with combustible materials and got ignited. Since the bare cable conductors located immediately behind the PVC gland were found fused together, it can be assumed that the thermal process had advanced long enough for the insulation melting to reach the cable entry zone into the box. In this section, the

conductors are positioned side by side, which led to a short circuit, during which the strong transient event caused fusing of the wire strands.

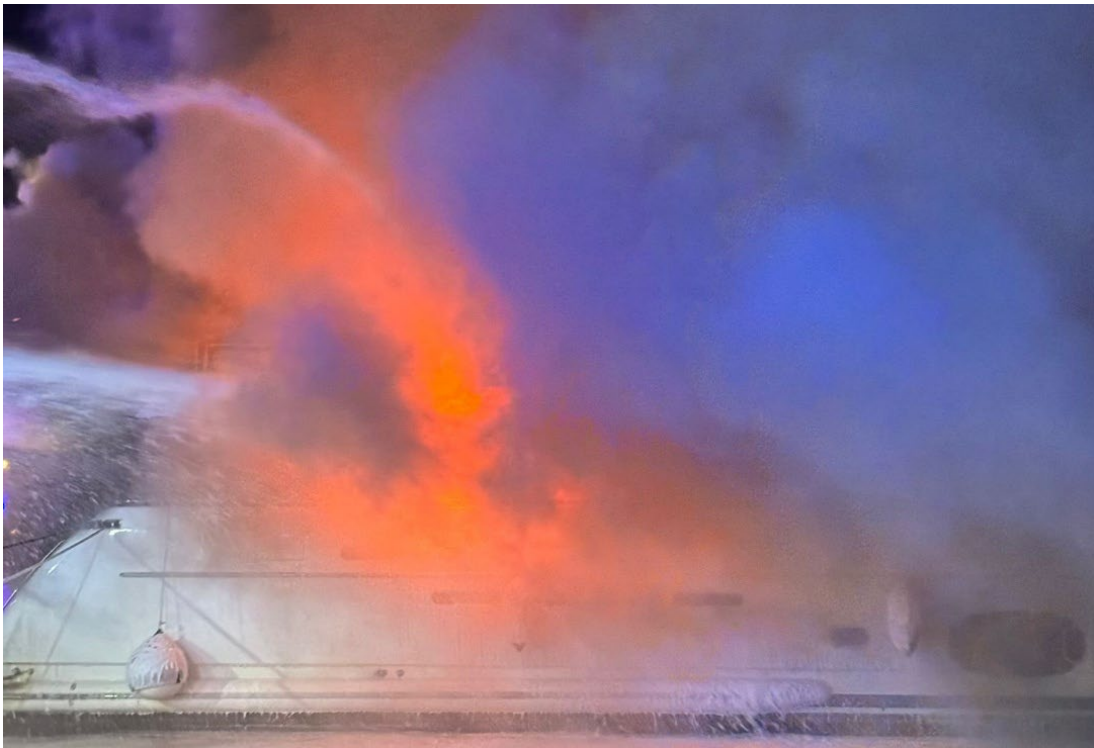
*Figure 10. Fire spread to the structural component of the yacht (source:DP)*

Fire propagation throughout the vessel begins once the flames reach the structural and other surfaces, as spread occurs through smouldering and burning of the construction (Figure 10). When the fire involves the vessel's structure itself—specifically the inner layer of the sandwich panels and vinylester—the fire can spread uncontrollably to other areas of the yacht.

Under such conditions, flames can continue to spread even if the hull surface is heavily sprayed with coolant, as the fluid cannot reach the combustible materials within the sandwich construction.

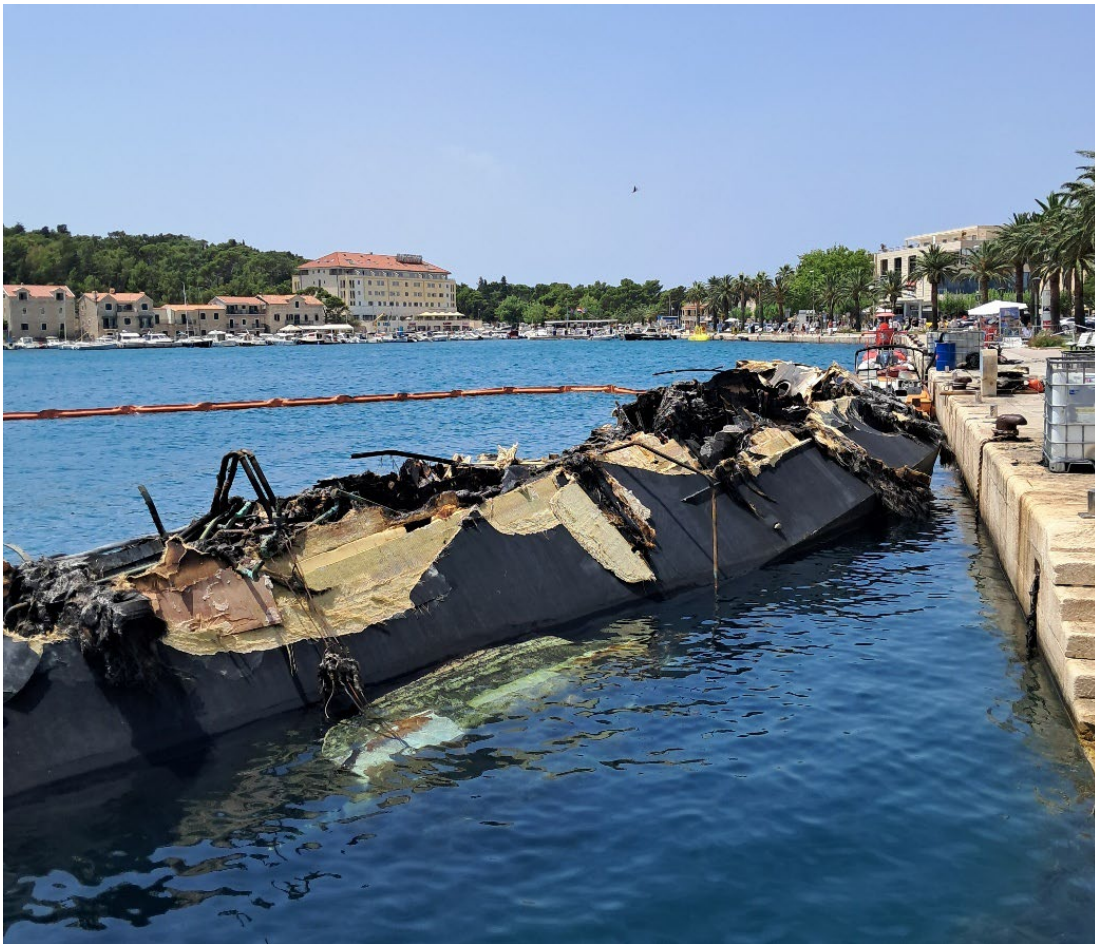
*Figure 12. Submerged yacht Acceptus after the burning stopped (source: AIA)*

As water was continuously applied to the port side, the vessel gradually listed. The fire affected the starboard side more intensely, while the port side increasingly submerged in seawater until it eventually reached the bottom (Figure 12).
