FINAL REPORT

**ON SERIOUS INCIDENT OF AIRCRAFT CESSNA C525,
REGISTRATION 9A-JIM**

JUNE 8th, 2025

ZAGREB INTERNATIONAL AIRPORT FRANJO TUĐMAN

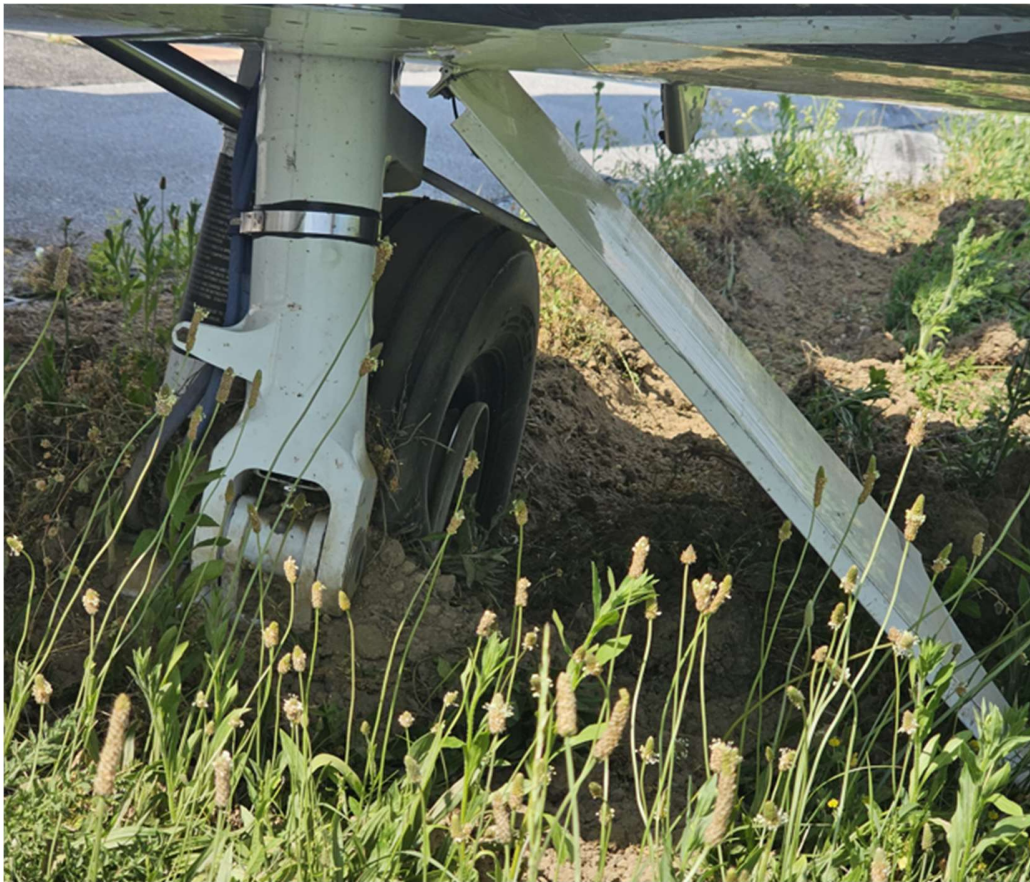
As the left main wheel exited onto the grass, the wheel created a shallow groove in the soft surface, approximately ten metres long, about thirty to fifty centimetres wide, and up to around ten centimetres deep. On the asphalt, a pair of dark, nearly parallel braking marks remained, beginning at the centreline of the runway and curving gently toward the edge, following the aircraft's path after the tyre burst. The marks are only superficial, with no visible cracks or deformation of the asphalt itself.

Picture 1 – damage to the grass surface

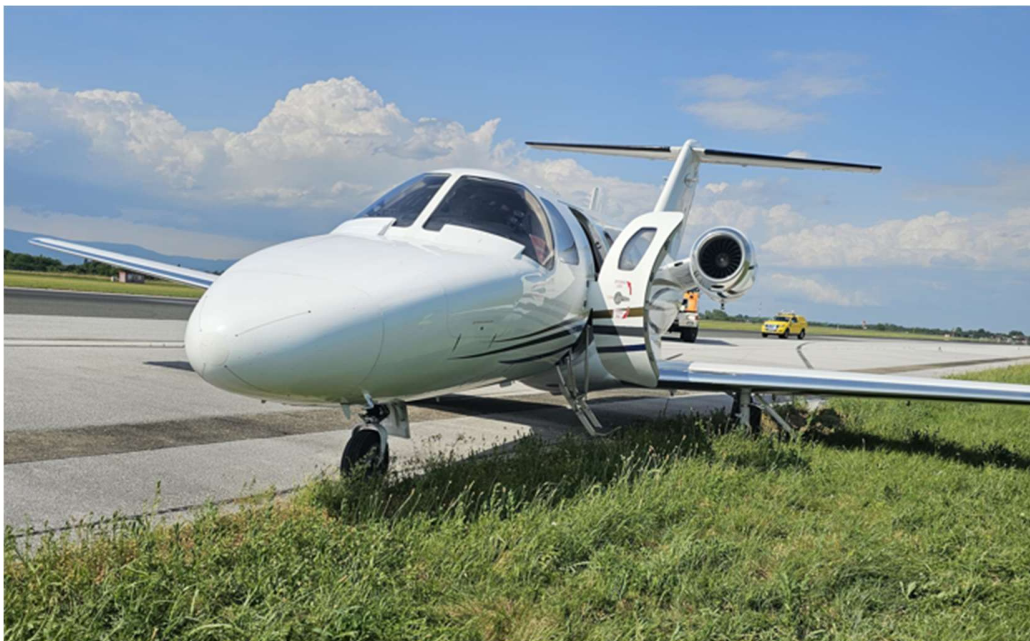
The aircraft completely stopped between taxiways C and D at 15:21 LT. Due to the partial excursion, one main wheel entered the grass area along the runway edge. The crew shut down the engines, secured the aircraft, and requested the arrival of a follow-me vehicle to assess the situation.

Picture 4 - position of the aircraft after stopping

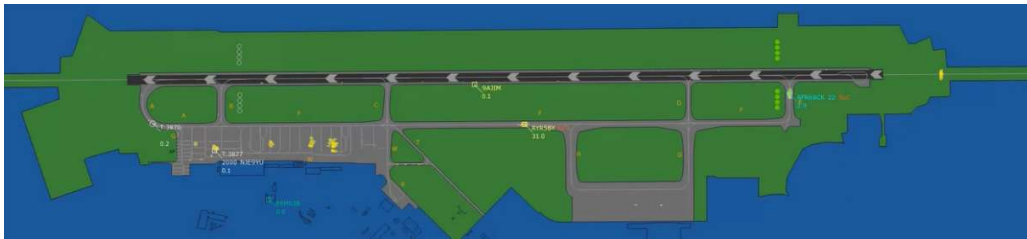
The incident occurred on the runway of Franjo Tuđman Airport (LDZA), approximately one hundred metres beyond the runway's midpoint, between the exits for taxiways C and D. The aircraft stopped with the nose wheel and the right main wheel on the asphalt, while the left main wheel was on the grass, about twenty centimetres outside the runway edge marking. A shallow groove about ten metres long remained on the grass surface, and on the asphalt two dark braking marks, curving gently from the runway centreline toward the edge.

Picture 5 – incident site

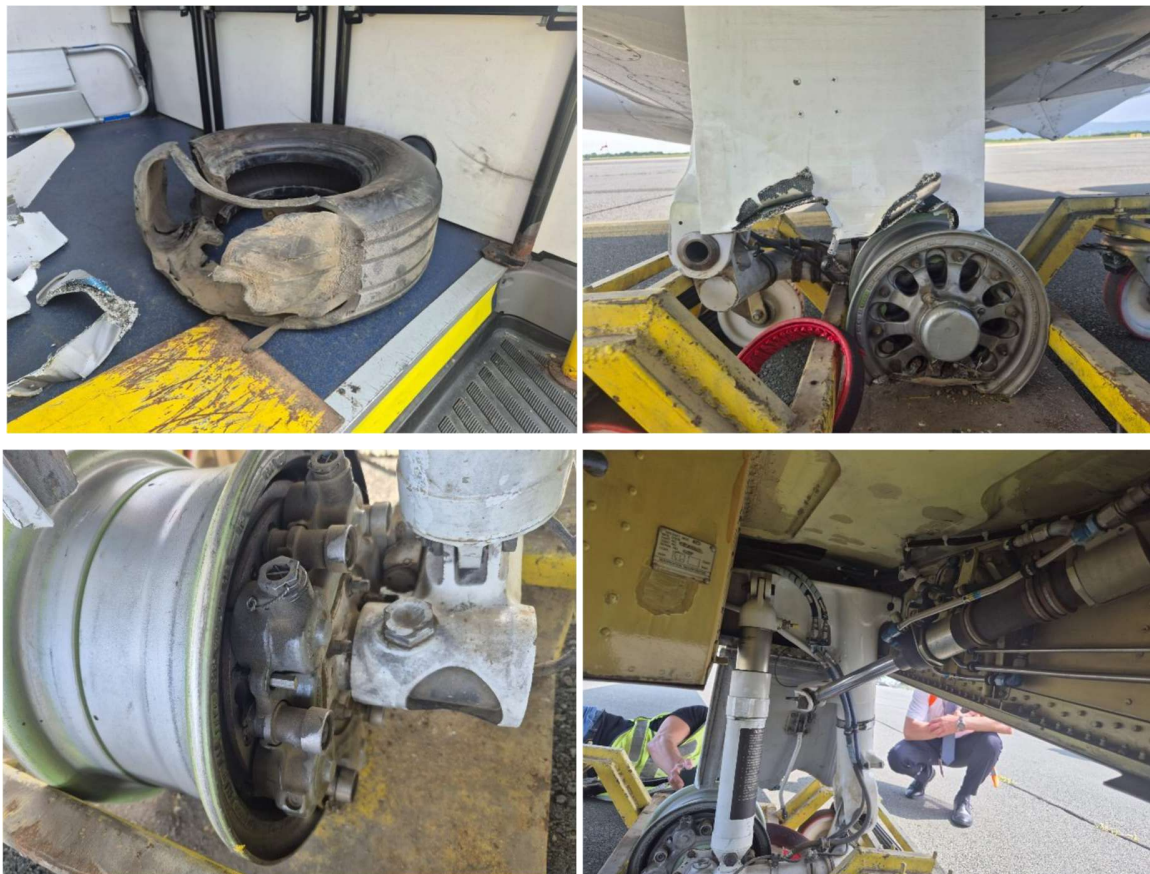
A detailed inspection of the left main landing gear revealed mechanical damage to the wheel rim, tyre, brake and landing gear doors. The landing gear mechanism itself, including the actuators, wiring and hydraulic lines of the braking system, showed no signs of malfunction or leakage. The brake wear indicator was within the prescribed limits, and the anti-skid system was found in the correct position (switched on, circuit breaker engaged).

Picture 7 - the tyre, wheel rim, brake and other components of the left landing gear

The damage to the wheel rim, tyre and brake of the left main wheel shows a pattern typical of the high forces occurring during landing. Minor mechanical damage was identified on the brake, but with no signs of hydraulic fluid leakage. The brake wear indicator was within the prescribed limits, and the anti-skid system was switched on and functioning correctly.

The post-incident inspection of the aircraft revealed no technical deficiencies that could have directly caused the tyre burst or wheel lock-up. It was determined that the primary cause of the event was the bursting of the tyre on the left main wheel, while it was not possible to establish with certainty whether a wheel lock-up or other factors contributed to the burst, nor the sequence in which they may have occurred.

Following the incident, the left wheel, left brake and the wheel-speed sensor were replaced. No reason was recorded for the replacement of the sensor, as no damage to it had been identified during the inspection. After these works, an anti-skid system test was carried out, and no additional deficiencies were found.

Following the incident, the left wheel, left brake (which showed minor mechanical damage during the inspection) and the wheel-speed sensor were replaced. No reason was recorded for the replacement of the sensor, as no damage to it had been identified during the inspection. After these works, an anti-skid system test was carried out, and no additional deficiencies were found.

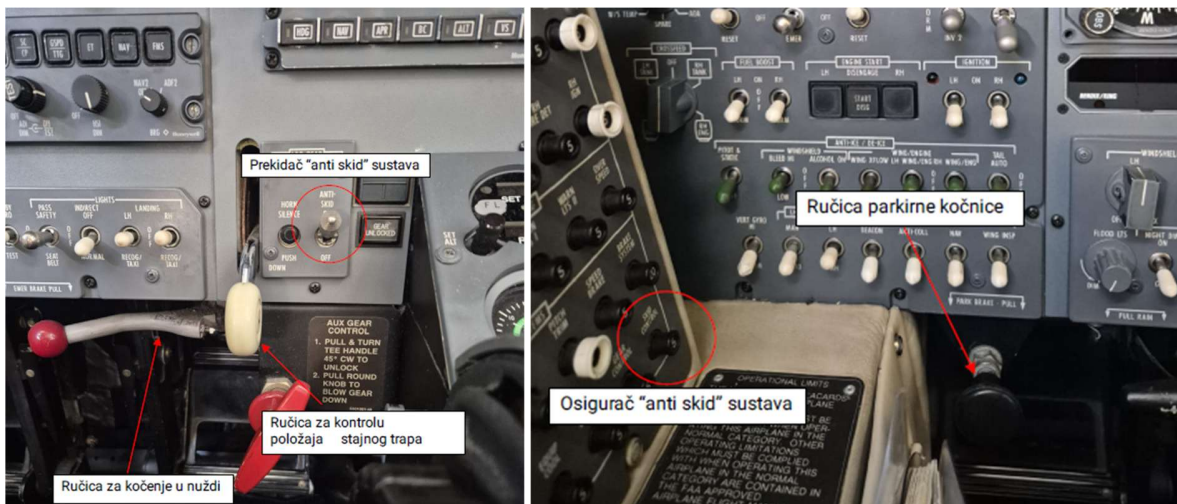
- the landing gear selector was in the DOWN position (gear extended),
- the anti-skid system switch was in the “ON” position,
- the anti-skid system circuit breaker was pushed in (engaged),
- the parking brake handle was in the retracted position (off),
- the emergency brake handle was retracted (off).

Picture 8 - position of the landing gear and brake system controls

All stated control and circuit breaker positions were consistent with normal operation and did not indicate any irregularities in handling.
