PRELIMINARNO IZVJEŠĆE / PRELIMINARY REPORT

Description of the event

On June 4, 2026, in the morning, a Beechcraft G36 Bonanza aircraft, registration D-ENTT, was flying from the city of Lienz in Austria to Istria in Croatia, with a landing plan at Medulin Airport. There were four adult male persons, Austrian citizens, on board the aircraft.

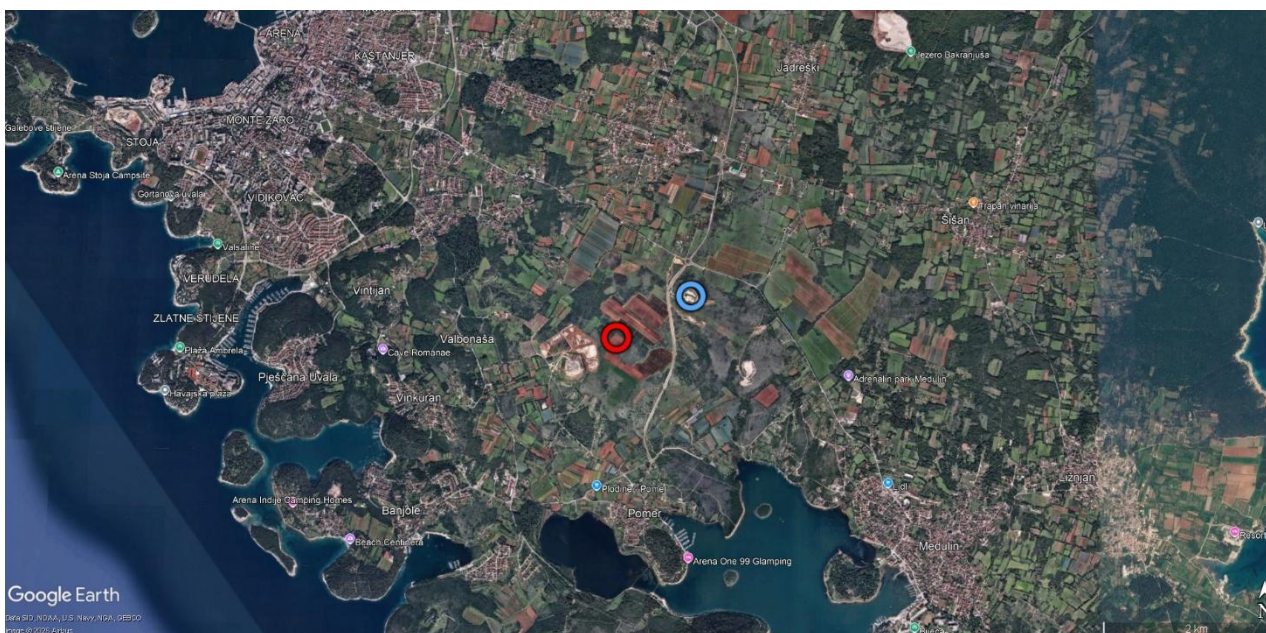
Image 1. – The red circle marks the crash site. The blue circle marks Medulin Airport.

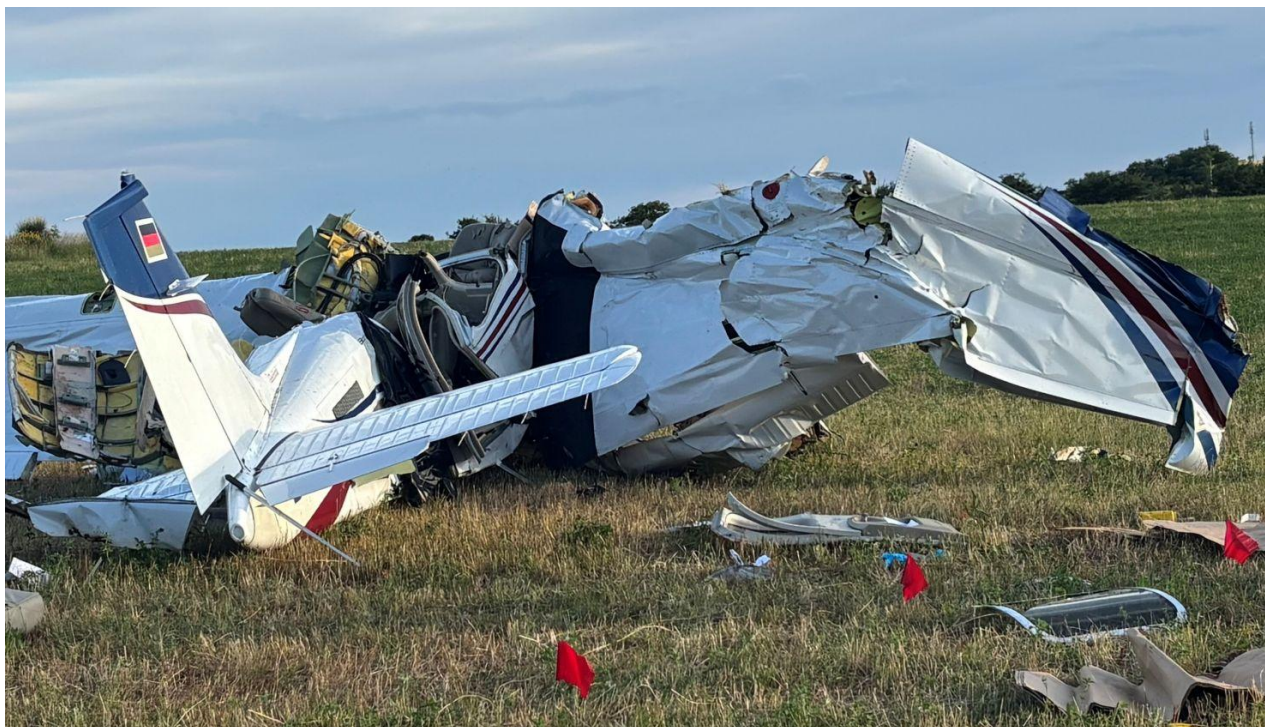
The crash site is located on a large flat grassy area about 1 km southwest of Medulin Airport. Tracks indicate the direction of the plane's approach before impact in a south-north direction. Most of the wreckage of the completely destroyed plane was in one place, while smaller parts, mostly debris, were scattered around.

Deformations on the propeller indicate that it was not rotating at the time of impact. No fuel was found in the tanks, nor in other elements of the fuel system. There was no spillage of fuel on the ground. There was no burning or fire.

Image 3. – Wreckage at the crash site

Aircraft engine failure due to lack of fuel and failed emergency landing.
