## PRELIMINARNO IZVJEŠĆE / PRELIMINARY REPORT

| 1. OPĆENITI PODACI / ACCIDENT/SERIOUS INCIDENT IDENTIFICATION | | |
|---|---|---|
| b | DATUM NESREĆE ILI OZBILJNE NEZGODE<br>DATE OF ACCIDENT OR SERIOUS INCIDENT | 21 August 2026 |
| f | MODEL ZRAKOPLOVA<br>AIRCRAFT MODEL | HK-36TC-100 Super Dimona |
| h | REGISTRACIJSKE OZNAKE<br>REGISTRATION | D-KWZE |

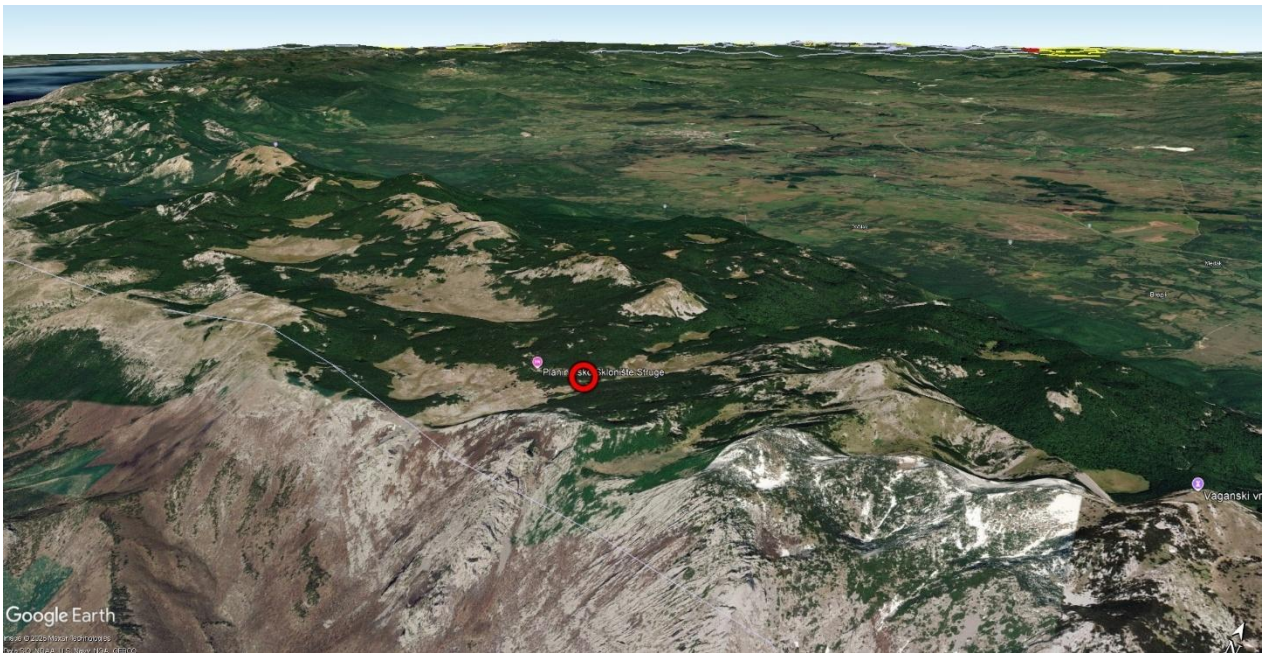
Figure 1 – accident site (red circle)

The crash site is located on a gentle slope covered with deciduous forest, at an elevation of approximately 1.450 meters. The area surrounding the crash site is a mountain ridge extending southeast–northwest, which widens in this section into a vast, undulating plateau. This plateau is covered in places by forest vegetation and elsewhere by meadows and dwarf pine scrub, while the ground is partially rocky.

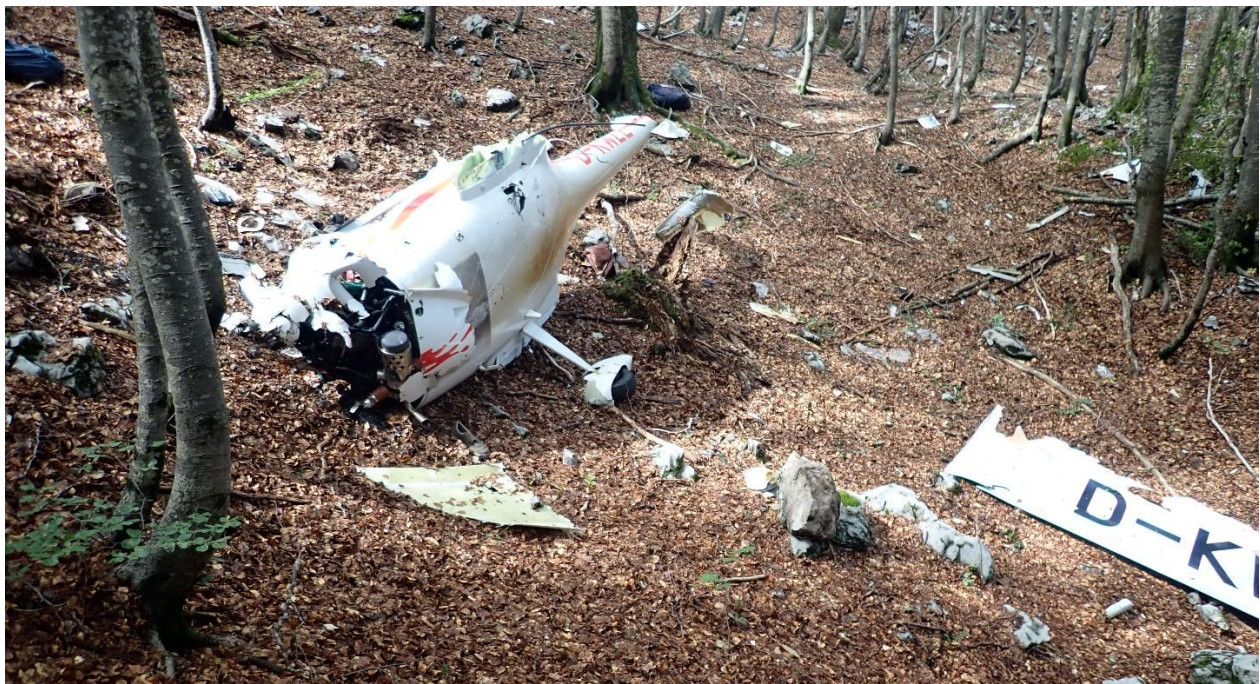
Traces at the crash site indicate that the aircraft entered the forest at a shallow angle from the northwest. As a result of passing through the tree crowns and impacting the ground, the aircraft was completely destroyed.

There are no signs of fuel spillage into the ground. No fire occurred.

Figure 3 – Wreckage at the crash site
