## PRELIMINARNO IZVJEŠĆE / PRELIMINARY REPORT

## 6. OPIS NESREĆE ILI OZBILJNE NEZGODE / DESCRIPTION OF ACCIDENT OR SERIOUS INCIDENT

**Airbus 320-214**

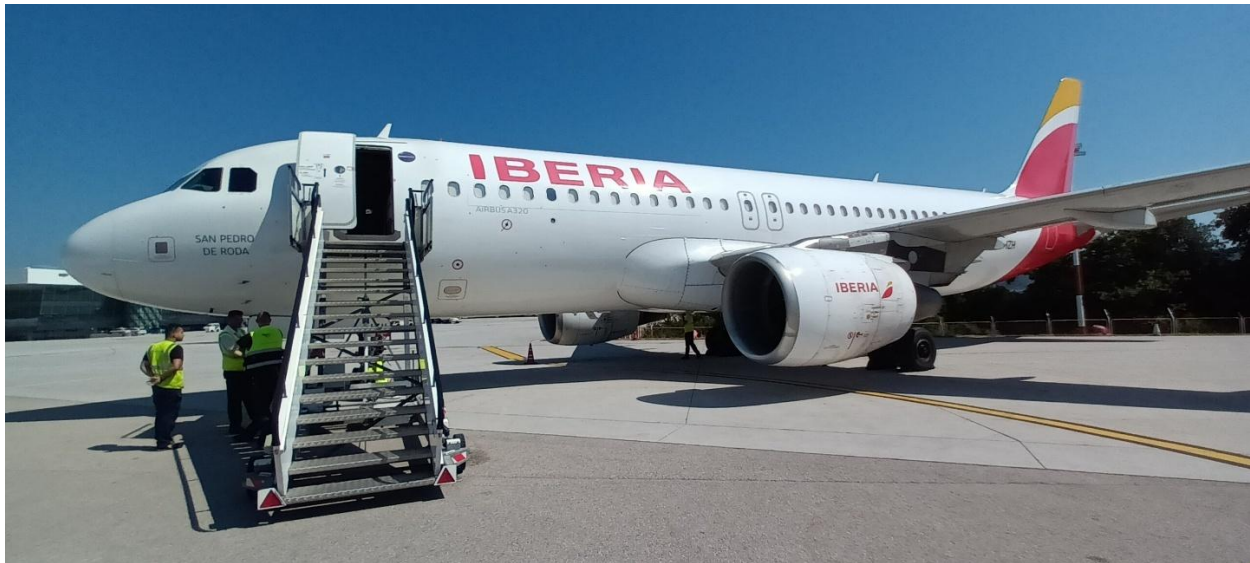
Figure 1 – the aircraft in question after a serious incident

After stopping, the nose gear was rotated 90° relative to the longitudinal axis of the aircraft, i.e. relative to the position it should be in. Both nose gear tires were destroyed.

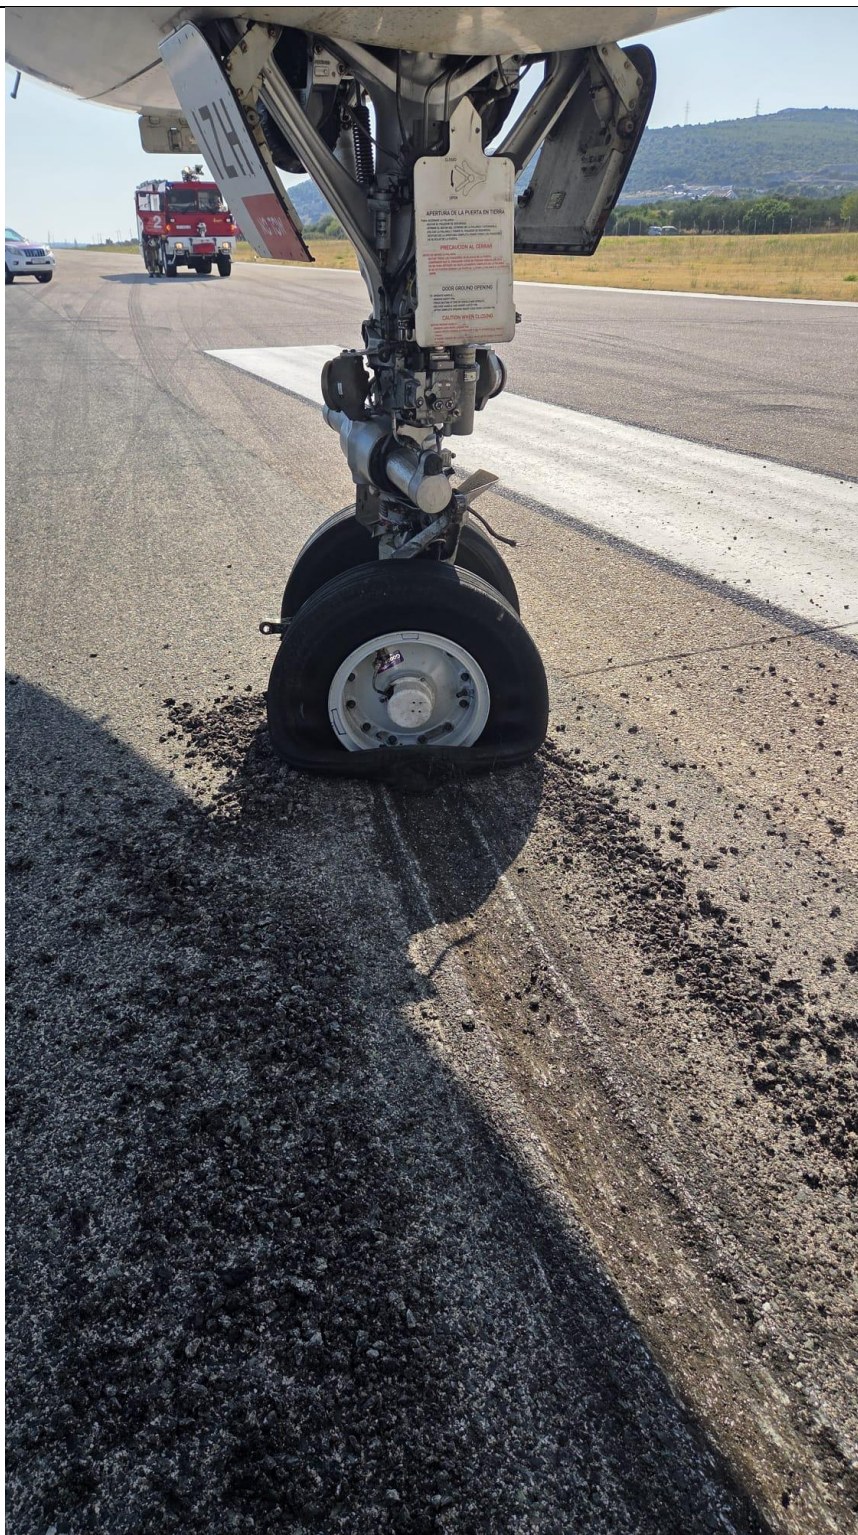
After the removal of the plane, Split Airport staff check the condition of the runway so that it would be safe for flight operations before it was opened back for traffic. On that occasion, an apex pin (a bolt that connects the moment links of the nose leg of the landing gear) was found on the runway and had fallen off the nose leg of the aircraft in question.

The nose leg was damaged. Both nose leg tires were significantly damaged due to skidding.

Figure 2 – nose gear after the aircraft stops on the runway

Technical failure on the aircraft's nose landing gear.
