**Air, Maritime and Railway Traffic Accident Investigation Agency**

## **FINAL REPORT**

### **ON THE ACCIDENT OF THE AIRCRAFT Air Tractor 802A, OR-2025**

**Krivi put, City of Senj, 13 November 2025**

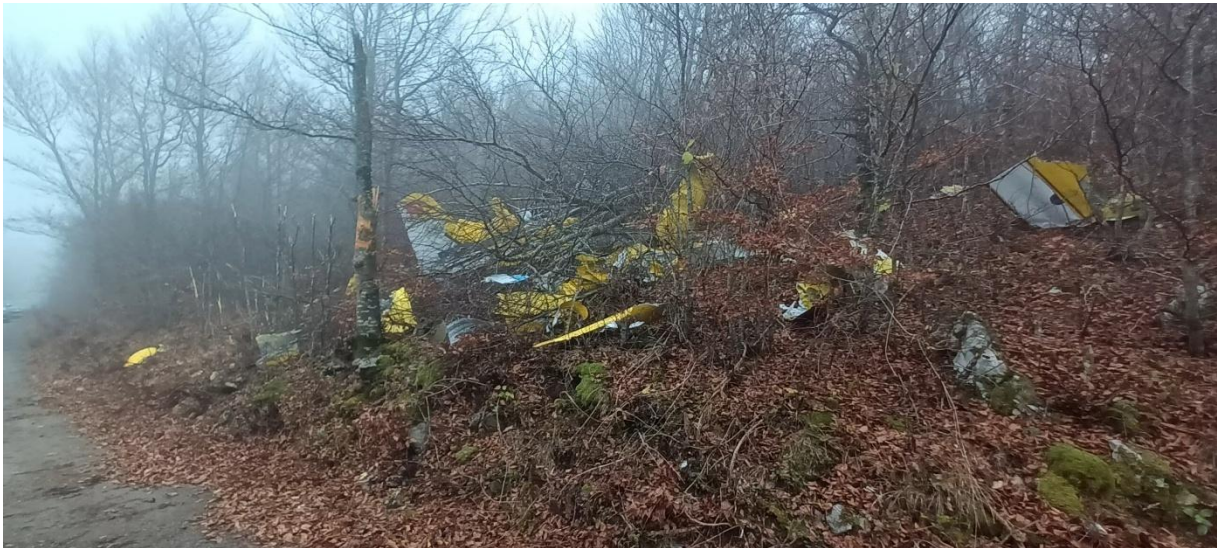
Figure 3 – wreckage at the accident site

Following the impact with the ground, the aircraft in question was completely destroyed by mechanical forces and fire.

The rear part of the fuselage, the floats and the wings were destroyed by mechanical forces. The vertical stabilizer remained almost undamaged.

The front part of the fuselage, including the cockpit, engine compartment and the parts of the wings adjacent to the fuselage, was destroyed not only by mechanical forces but also by fire.

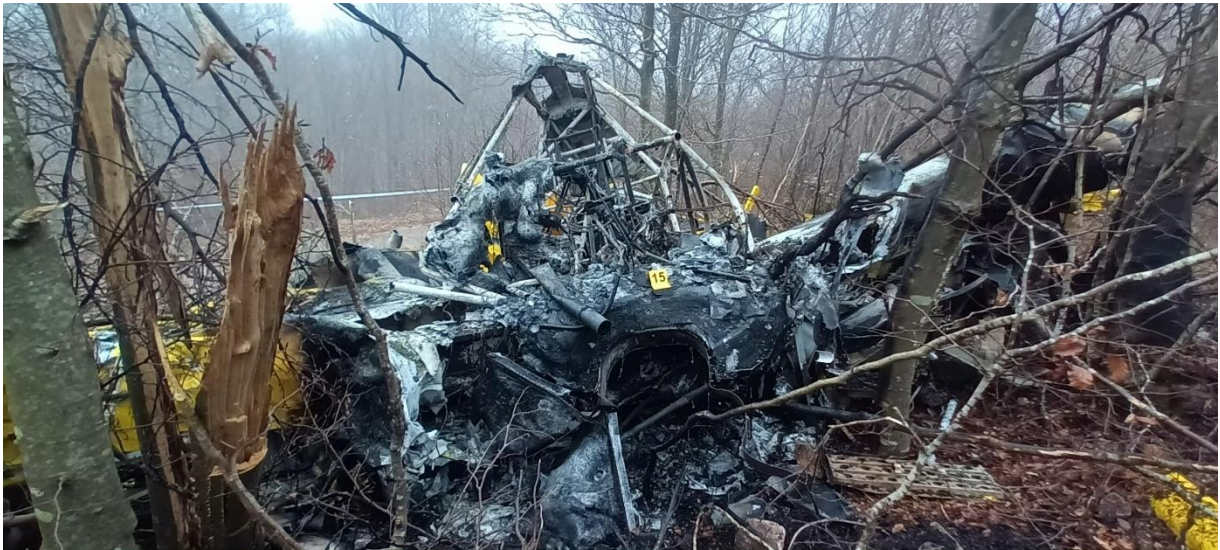
Figure 4 – front part of the wreckage

Three blades of the five-blade propeller were found beneath the front part of the fuselage, detached, deformed and covered in soot.

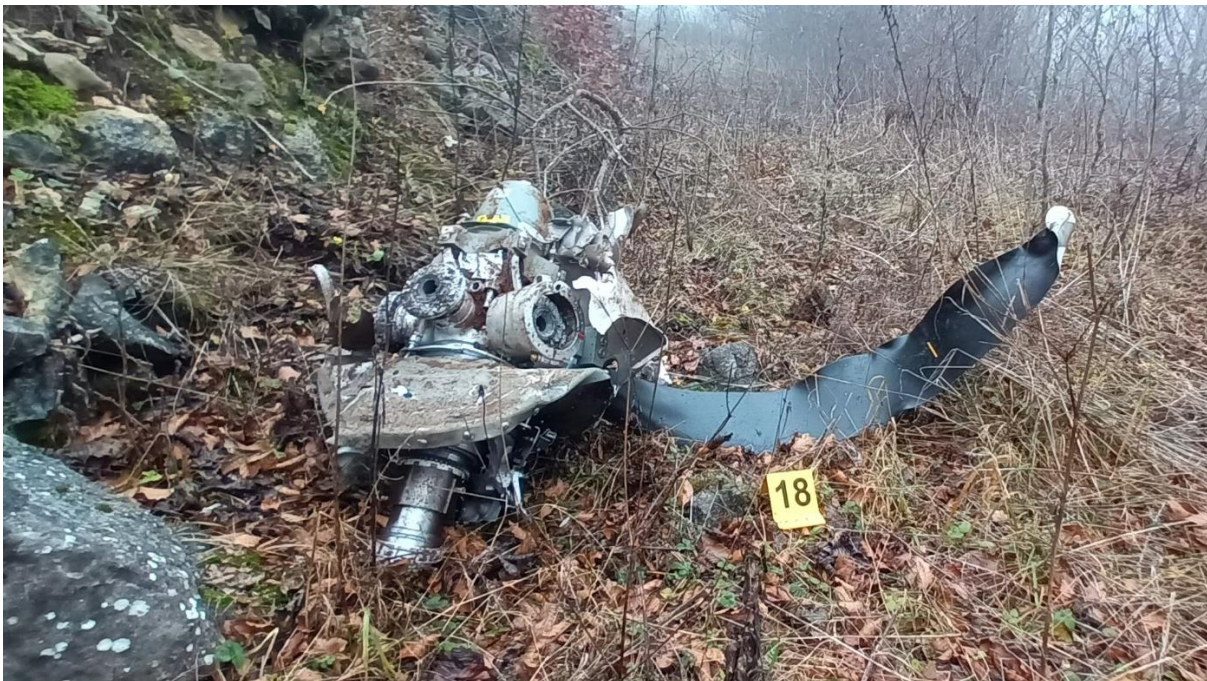
The hub with one propeller blade was found approximately twenty metres to the right of the aircraft's direction of arrival. The blade remained attached to the hub. It showed deformation indicating that the propeller had been rotating.

Figure 5 – hub with one propeller blade

The deformation of the propeller blades also indicates that the aircraft engine was operating, and at considerable power. The propeller blade that, together with the hub, was thrown approximately twenty metres to the right of the aircraft wreckage's longitudinal axis indicates significant propeller rotation and ejection due to centrifugal force after the remaining propeller blades detached and the hub, with one blade, separated from the shaft and engine.
