NIB NETWORK NEWSLETTER  
No. 3  
2026

SUMMARY OF FOUR  
LEVEL CROSSING ACCIDENT  
INVESTIGATIONS

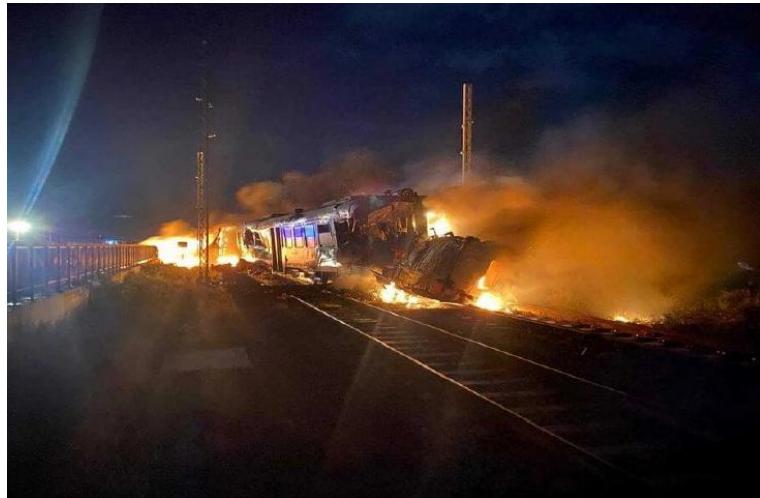
# ITALY

The final report regarding the accident at the Thurio Public Crossing (PL) at km 128+123 on the Sibari – Catanzaro line details a collision that occurred on November 28, 2023, at approximately 6:51 p.m. It involved regional train R5677, an ALn 663 series train, and a tractor-trailer truck. The level crossing was equipped with an automatic protection system including barriers, a bell, and flashing lights, activated upon the formation and release of the train's departure route.

intending to exit onto Via Erodoto. While manoeuvring within the railway crossing to avoid hitting a low wall with the trailer, the level crossing barriers began to close at 6:46:33 p.m. The train departed from Sibari at 6:47:06 p.m. after receiving a clear signal and was traveling at the permitted speed. The collision occurred at 6:50:42 p.m.

The driver of the truck and the train conductor died in the collision. None of the approximately 25 passengers or other in the train crew reported any injuries. The tractor-trailer was completely destroyed, and the train sustained significant damage to the front. The accident resulted in the interruption of railway traffic on the affected line.

The report suggests that the truck driver's maneuvering to avoid the low wall may have contributed to the truck being trapped on the crossing as the barriers closed. The report raises the possibility of disattention or panic on the part of the truck driver once the barriers started to descend. The truck driver had recently obtained his heavy vehicle driving licence and may have been unfamiliar with the specific vehicle involved and the layout of the Thurio level crossing.

The investigation did not identify any delays or obstruction by any party. The methods used included interviews with railway personnel and measurements taken at the accident site after the accident. On-site inspections were conducted two days after the accident with only some remains of the vehicles present. The level crossing has been closed since the accident. The report contains four safety recommendations and mentions the ongoing review of level crossing safety by the European Union Agency for Railways (ERA) and shares a draft of their updated guidelines, emphasizing the need for measures to prevent the obstruction of level crossings while in use by trains and the clear identification of all level crossings. The report also notes the consideration of a national toll-free number for reporting dangerous situations at level crossings.

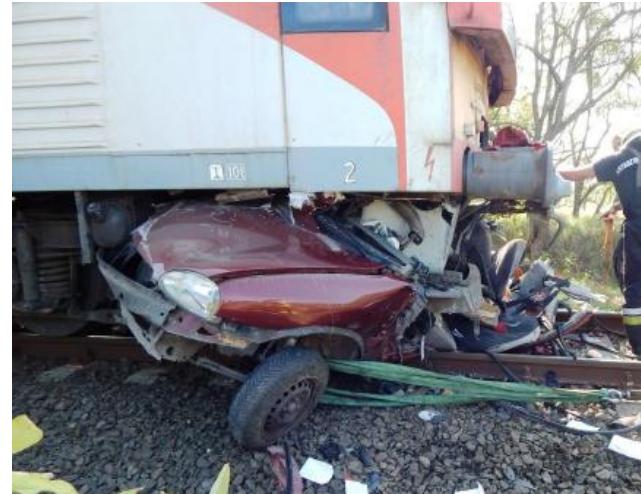
# HUNGARY

The final report 2022-0960-5 details a railway accident that occurred on September 5, 2022, at an unsecured level crossing, located the Kunfehértó – Kiskunhalas railway line in Hungary. The accident involved a passenger train and a car. 7 people in the car died as a result of the accident.

The investigation concluded that the primary cause of the accident was a human factor related to the car driver, who did not stop for the "Railway Crossing" sign and entered the level crossing while a train was approaching. At the time of the accident, the triangle of visibility was ensured in all quadrants of the level crossing.

The collision resulted in fatal injuries to the occupants of the car. The car was damaged beyond repair. The train sustained damage estimated at approximately 5.5 million HUF. The investigation also examined other similar unsecured level crossings between Kunfehértó and Kiskunhalas stations on connecting roads branching off from main road 5412. The investigation found shortcomings related to the design of these level crossings, the presence and visibility of necessary traffic signs, and visibility obstructions. In addition, the Investigating Committee found that, of the level crossings between the two stations, which involving dirt roads are not pre-indicated by road signs on Road 5412. Additionally, one level crossing did not meet regulations regarding the distance between the railway crossing and a nearby intersection. As a result of the findings, the Hungarian Transportation Safety Bureau (KBSZ) issued an immediate safety recommendation (BA2022-0960-5-01A) to the Bács-Kiskun County Government. The recommendation urged the government to obligate the road operator to review the traffic regulations for the affected crossings and implement necessary modifications to eliminate hazardous situations. It also recommended ordering the removal of trees or other vegetation obstructing the visibility triangle at the railway crossings. The Bács-Kiskun County Government responded and initiated a personal consultation with relevant authorities and stakeholders. Site inspections were conducted, and measures were initiated, including requesting the replacement of worn signs and the removal of vegetation obstructing visibility. Proposals were also made to install necessary signs on road 5412 at the level crossings. Furthermore, a notification was sent to the road operators regarding the subsequent design of the railway crossings in accordance with relevant regulations.

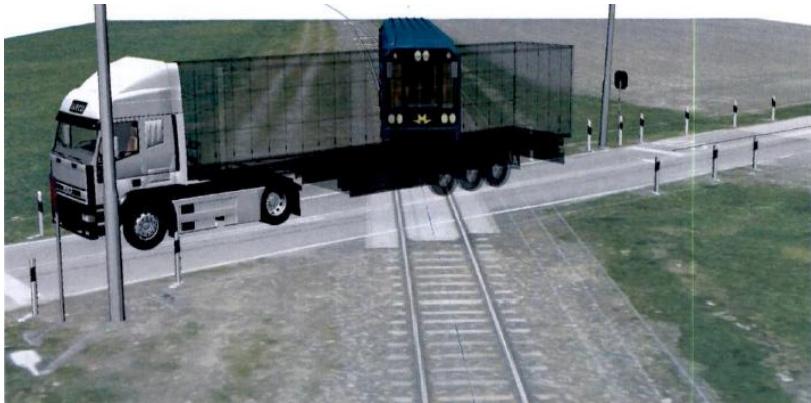
# POLAND

Report No. PKBWK 01/2025 details a serious railway accident that occurred on January 10, 2024, at 07:58 on the Rogoźno Wielkopolskie – Budzyń line, on track no. 1 at km 56.055 of railway line no. 354 Poznań Główny POD – Piła Główna. The accident involved a freight train (MOJ 87940) and a truck at an unsignaled level crossing of category D.

The accident occurred when a truck entered the level crossing directly in front of an approaching train.

Despite the train driver initiating a "Caution" signal for 12 seconds after passing the W6b indicator, the truck driver failed to stop. The collision resulted in two fatalities on the train and severe injuries to the train driver. There was significant material damage to both the train and the truck, as well as to the railway infrastructure.

The primary cause of the accident was the truck driver's failure to exercise due caution while approaching the level crossing and not ensuring that no railway vehicle was approaching before crossing. The driver also failed to obey the stop sign.

Contributing factors included that the truck driver was engaged in a phone conversation via a hands-free system, which likely distracted him. The acute angle (53°) of the road crossing the railway line and limited visibility of the approaching train from the road due to the angle and potentially the design of road vehicles were also considered contributing factors. The report notes that current regulations for determining the visibility triangle may not be fully representative of the conditions for road users. Another similar accident occurred at the same crossing on August 10, 2024.

Safety recommendations in the report include that the infrastructure manager (PKP PLK S.A.) should agree with the road manager to implement one of the following measures to improve safety at the crossing: changing the road configuration, upgrading the level crossing category, or eliminating the level crossing. Until these actions are taken, a permanent speed restriction for trains to 20 km/h should be introduced at the crossing. The report also recommends a revision of the regulations for measuring visibility at level crossings, and that railway operators should verify their forward-facing image recording systems. PKP PLK S.A. should also verify risk assessments for similar category D level crossings.

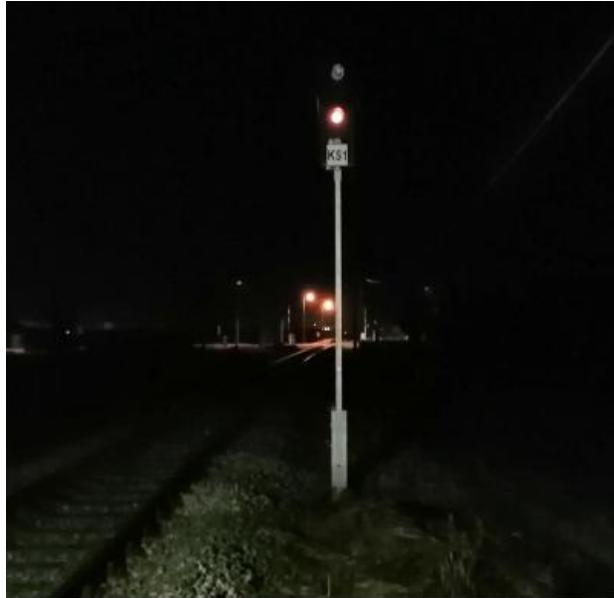
# CROATIA

The final report prepared and published on December 12, 2004, details an accident that occurred on February 15, 2024, at 4:55 p.m. at the Stare Plavnice level crossing in Croatia. The level crossing, located at km 029+865 on the L203 (Križevci – Bjelovar – Kloštar) railway line, was actively secured with light signals, sound signals, and half-barriers. The accident involved passenger train number 787 and a motor vehicle.

The investigation revealed that at the time of the accident, the level crossing safety system was malfunctioning and did not activate to warn of the approaching train (the lights, sound and half-bumpers did not activate at the level crossing). The on-site investigation of this accident determined that on the "Control signal KS1" (attached picture) from the direction of Sveti Ivan Žabno towards Bjelovar, a single yellow steady light was on, indicating the signal sign "Device at the level crossing is faulty".

The primary cause of the accident was identified as an intermittent fault in the 465-425-000 relay group within the level crossing's signalling and safety system. Following the accident, the Stare Plavnice level crossing was declared unsecured. Also, after the accident the committee carried out measurements and functional tests of the "Stare Plavnice" level crossing securing device and concluded that the control signal showed the actual state of the LC securing device in cases when the LC was not secured. Additionally, a temporary speed restriction of  $V_{max}=20$  km/h was recommended upon the level crossing's return to regular operation.

A contributing factor was that the train was traveling at a speed exceeding the maximum permitted speed of 60 km/h for that section of the line, at one point reaching 73 km/h and 65.6 km/h at the moment of impact.

The collision resulted in minor injuries to the driver of the passenger car and minor material damage to the diesel multiple unit train.

Safety recommendations issued include that the infrastructure manager should, within two years, install balises for automatic stop devices on the control signals of "Iskra KS" type automatic level crossings to prevent trains from passing a signal indicating a malfunction. For those where balises cannot be installed, event recorders should be fitted within the same timeframe. The report also suggests that the railway undertaking revise its safety management system to better address instances of train speed limit violations.
