FINAL REPORT

VERY SERIOUS MARINE CASUALTY

Grounding and Total Loss of the Livestock Carrier *Deala*

Southeastern Coast of Istria, Cape Kremen, April 16, 2024

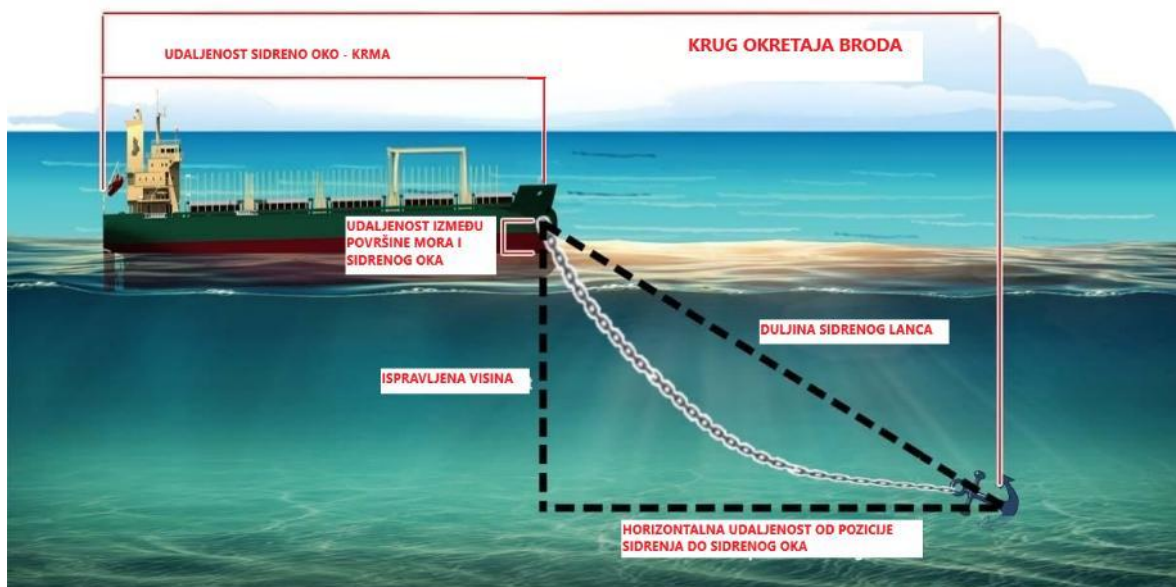
Figure 11: Visual representation of the calculation of the ship's turning circle radius (source: AIN)

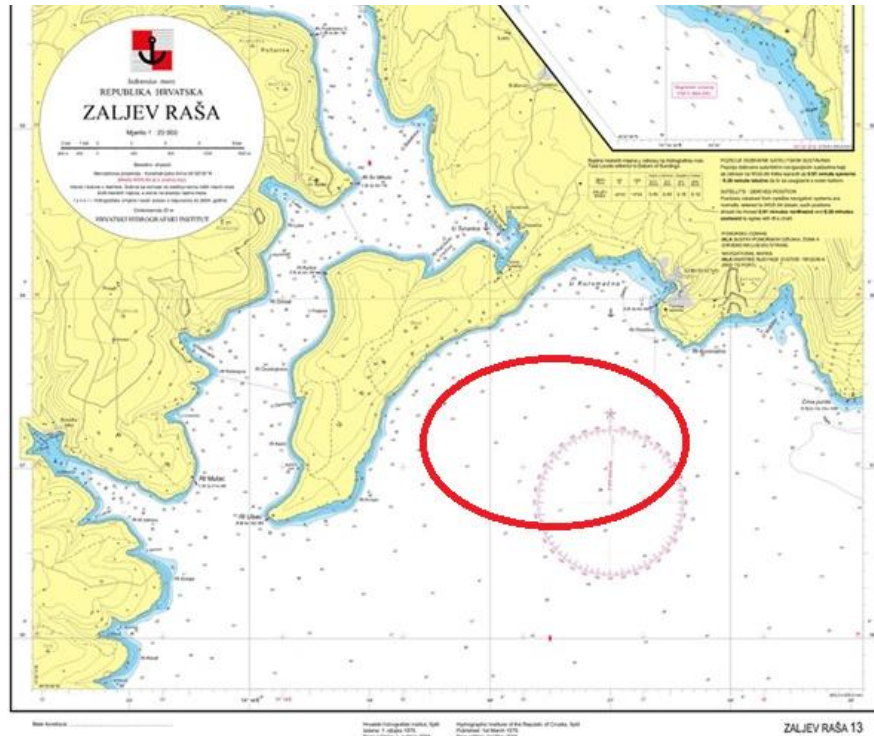
A bay extends shallowly into the mainland, extending from Koromačna Bay is regularly used as an anchorage for vessels waiting to load in the ports of *Plomin* and *Bršica* (Figure 12). Anchoring within *Raša Bay* is generally avoided due to its dense maritime traffic and other commercial activities. Additionally, the bay is deep and narrow, which limits safe anchoring options for vessels. The anchorage is not officially marked on nautical charts. *Koromačna Bay* is generally well protected from the bora wind and waves, but this protection gradually decreases as vessels anchor further southwest from the port of *Koromačno*. The wider bay area is bordered by the coastline of the Ubac Peninsula, with depths near the shore ranging from 40 to 46 meters, as indicated on nautical charts.

Due to the lack of alternatives, and despite the fact that this sea area is not designated as an official anchorage, the marked area in the image serves as an anchorage for vessels waiting to enter the ports of *Raša Bay*. Anchoring further south of the marked area is not optimal, as it is too exposed, leaving vessels vulnerable to waves from both western and eastern directions. As a result, a maximum of four vessels up to 100 meters in length typically anchor in this area simultaneously.

Figure 12: Nautical chart „Zaljev Raša - 13“, with marked anchorage (source: HHI)

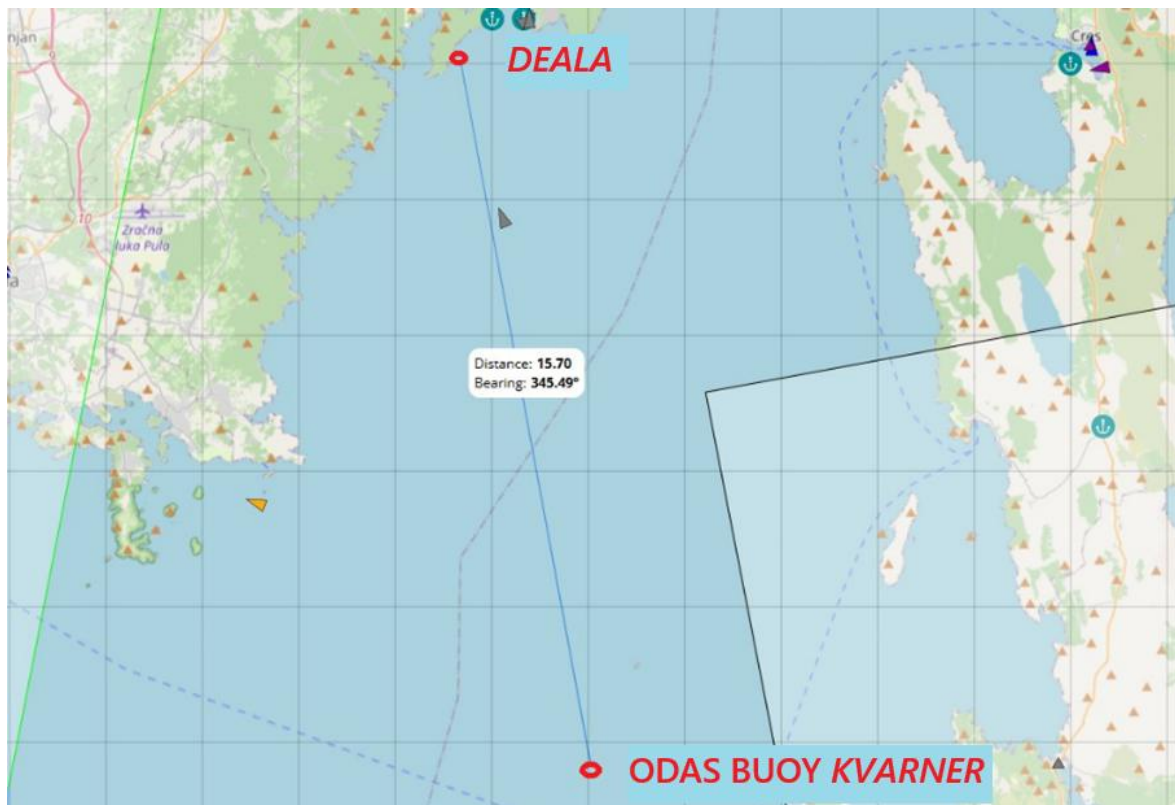
Figure 18: ODAS buoy „Kvarner“ (source: EMSA SEG system, adapted by AIN)

The *Kvarner* buoy recorded an increase in wind intensity at 4:20 PM, with maximum values reaching 14.5 m/s. Simultaneously, the wind shifted from a southeast to a northeast direction, gradually strengthening to an average wind speed of 21.7 m/s (with a maximum of 32.5 m/s) by 6:50 PM.

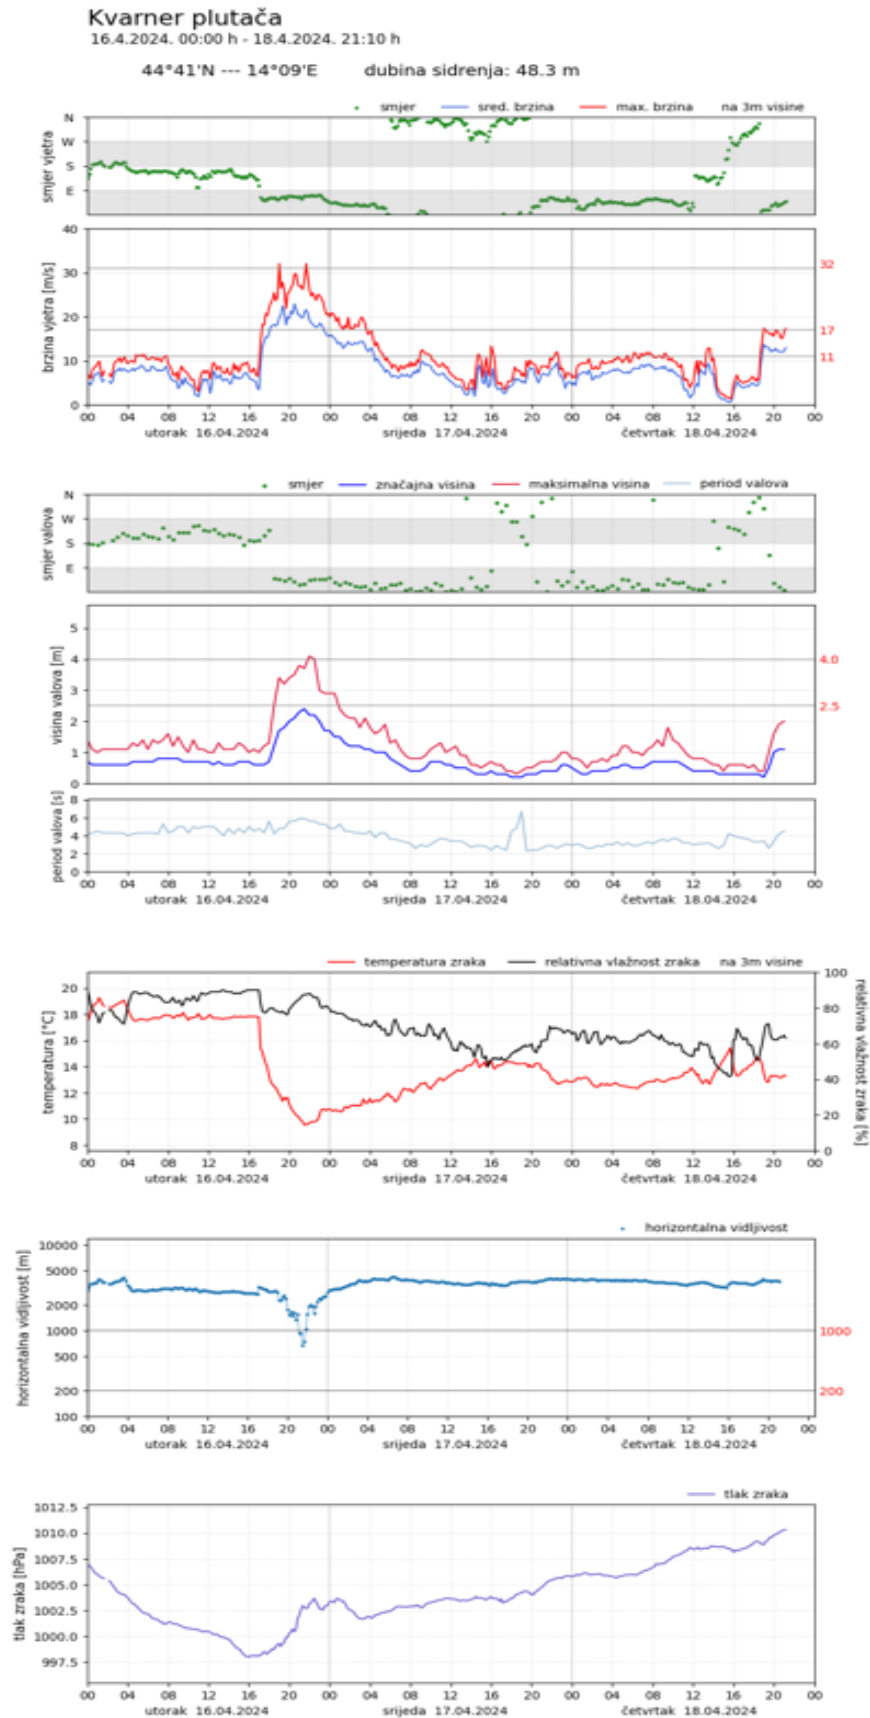
Annex II: Meteorological and hydrological data from the ODAS buoy *Kvarner* (source: DHMZ)

The worsening weather conditions are also reflected in the air pressure curve (Annex II), which clearly shows a depression forming in the afternoon hours. Data on wind strength and direction for the period between 4:00 PM and 7:30 PM are provided in Table 2.

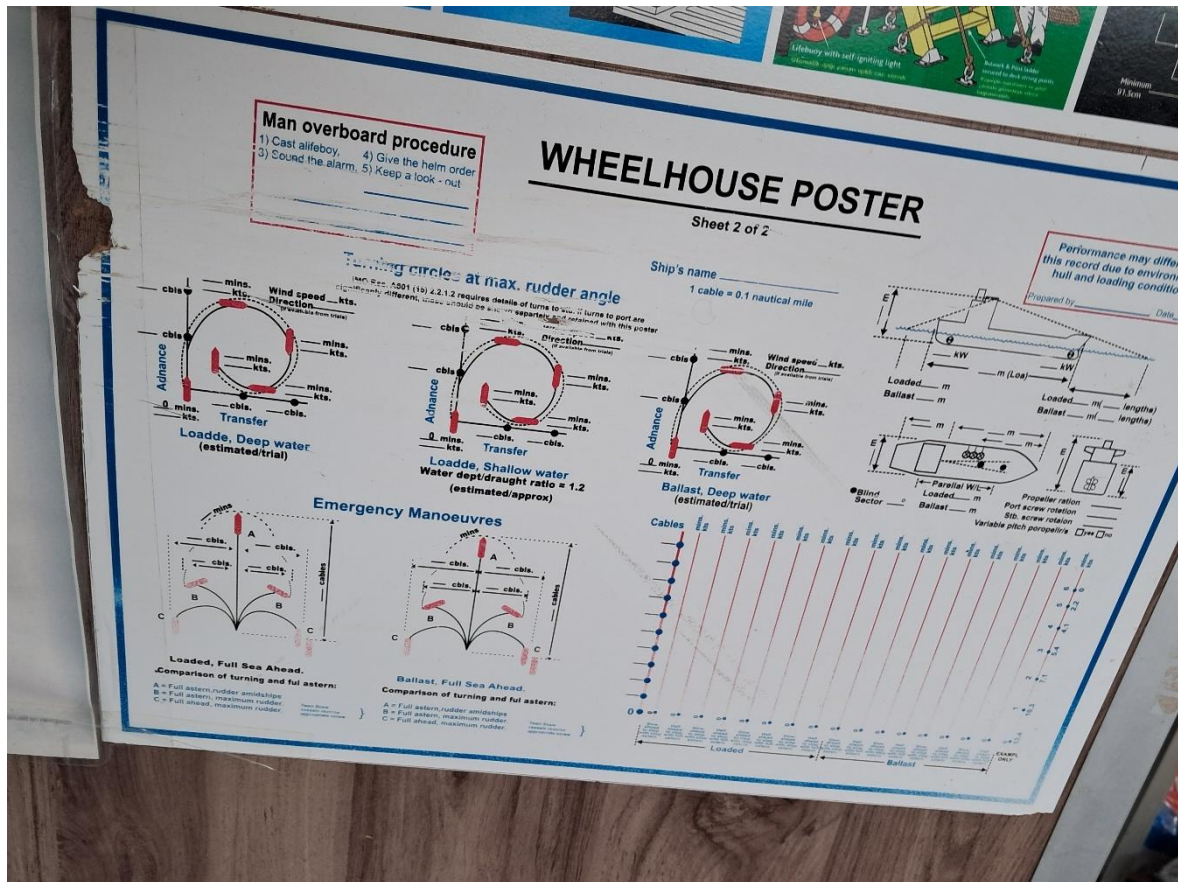
Annex XI: Wheelhouse poster (source: mb „Deala“)

The situation was further complicated by the fact that the Wheelhouse Poster, which displays the vessel's maneuvering characteristics, was not filled in and posted on the bridge (Annex XI – Wheelhouse Poster), raising a doubt about the level of understanding of the ship's manoeuvring capabilities by the responsible personnel on board. The absence of such critical information is particularly concerning in hazardous situations, as it prevents the navigating officers from quickly verifying data on the vessel's handling characteristics and making timely decisions.
