## PRELIMINARNO IZVJEŠĆE / PRELIMINARY REPORT

1. OPĆENITI PODACI / ACCIDENT/SERIOUS INCIDENT IDENTIFICATION		
a	MJESTO NESREĆE ILI OZBILJNE NEZGODE	The village of 'Krivi put', near the town of Senj, Croatia
	AREA OF ACCIDENT OR SERIOUS INCIDENT	
b	DATUM NESREĆE ILI OZBILJNE NEZGODE	13 November 2025
	DATE OF ACCIDENT OR SERIOUS INCIDENT	
c	VRIJEME NESREĆE ILI OZBILJNE NEZGODE	16:37 LT (15:37 UTC)
	TIME OF ACCIDENT OR SERIOUS INCIDENT	
d	PROIZVOĐAČ ZRAKOPLOVA	Air Tractor
	AIRCRAFT MANUFACTURER	
e	TIP ZRAKOPLOVA	
	AIRCRAFT TYPE	
f	MODEL ZRAKOPLOVA	AT 802A
	AIRCRAFT MODEL	
g	DRŽAVA PRIPADNOST ZRAKOPLOVA	Republic of Turkiye
	STATE OF REGISTRY	
h	REGISTRACIJSKE OZNAKE	OR 2025
	REGISTRATION	
i	OPERATOR ZRAKOPLOVA	Ministry of Agriculture and Forestry, Republic of Turkiye
	AIRCRAFT OPERATOR

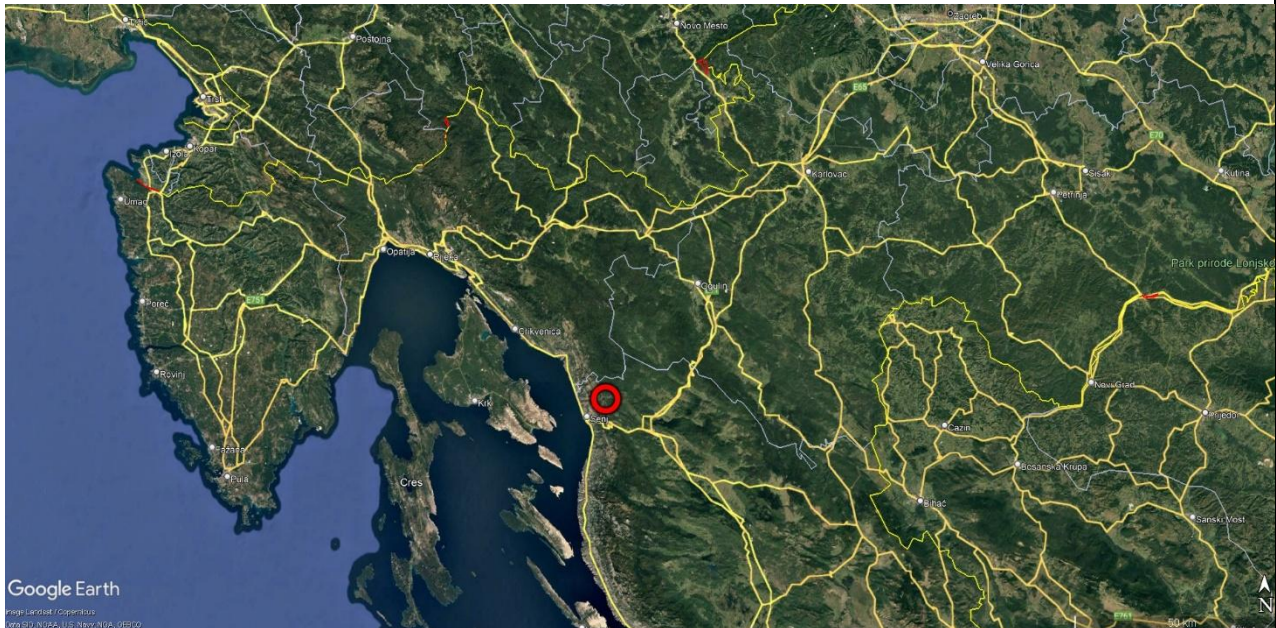
Image 1 – the accident site is marked with a red circle

AIN received notification of the missing aircraft from the Ministry of Interior Operations Center and Croatian Air Traffic Control. The wreckage was located later the same evening. The aircraft was completely destroyed by impact and post-impact fire, and the pilot died.
