# **FINAL REPORT**

## **VERY SERIOUS MARINE CASUALTY**

### **Fire and Total Loss of the Yacht *Acceptus***

**28 June 2024**

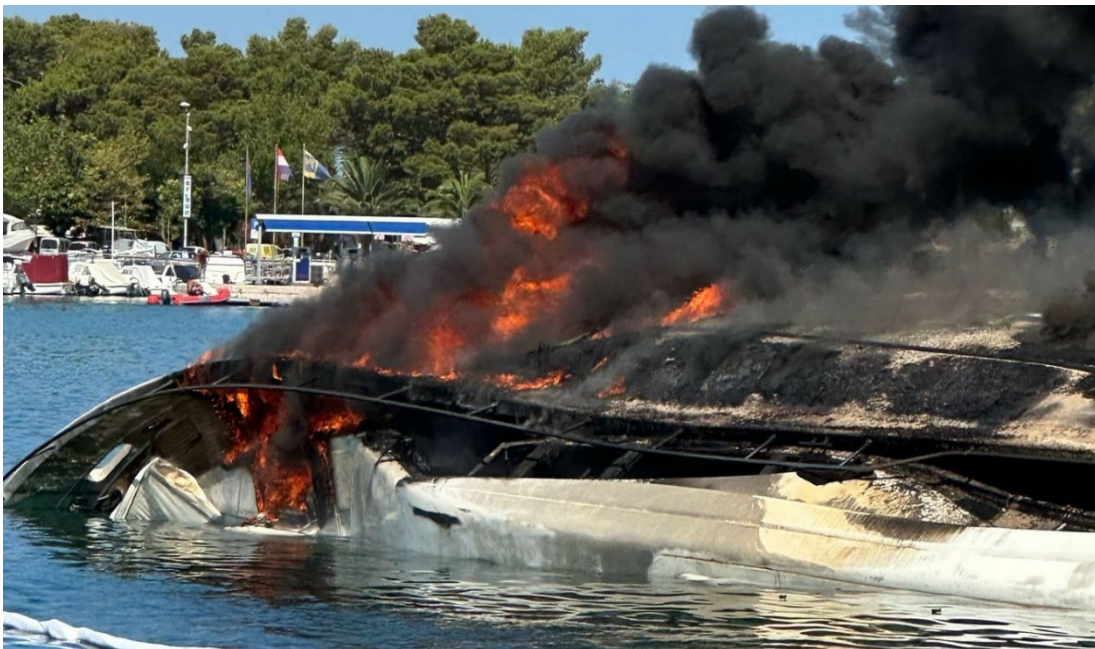
*Figure 2. Motor Yacht Acceptus 29 June 2024  
(source: crew)*

Firefighters continued to douse the starboard side of the burning hull, which continued to burn until the afternoon of 29 June 2024, when the fire self-extinguished when no burning material remained to support the fire.

Following the final cessation of burning of the portion of the hull above the waterline, the wreck of the sunken yacht was moved closer to the shore by tug and remained in that position until its eventual transfer to the *Nauta Lamjana* shipyard.

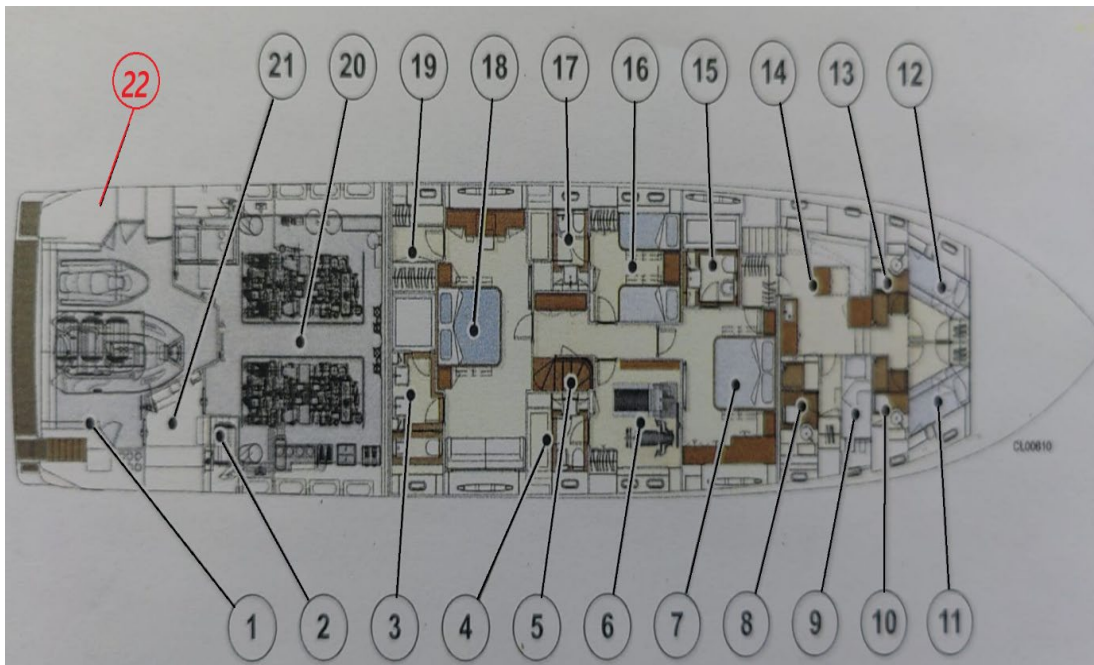
Figure 3. Plan view of the lower deck cross-section of the yacht Acceptus (source: Yacht User Manual)

The lower deck, viewed from the forward part to aft, comprises crew and guest accommodation (3–19 in Figure 3), the engine room (20), and the aft section of the vessel, which includes the control room on the starboard side (21), the lazarette (1 – jet-ski garage) amidships, and the technical area on the port side (22) (Figure 3).

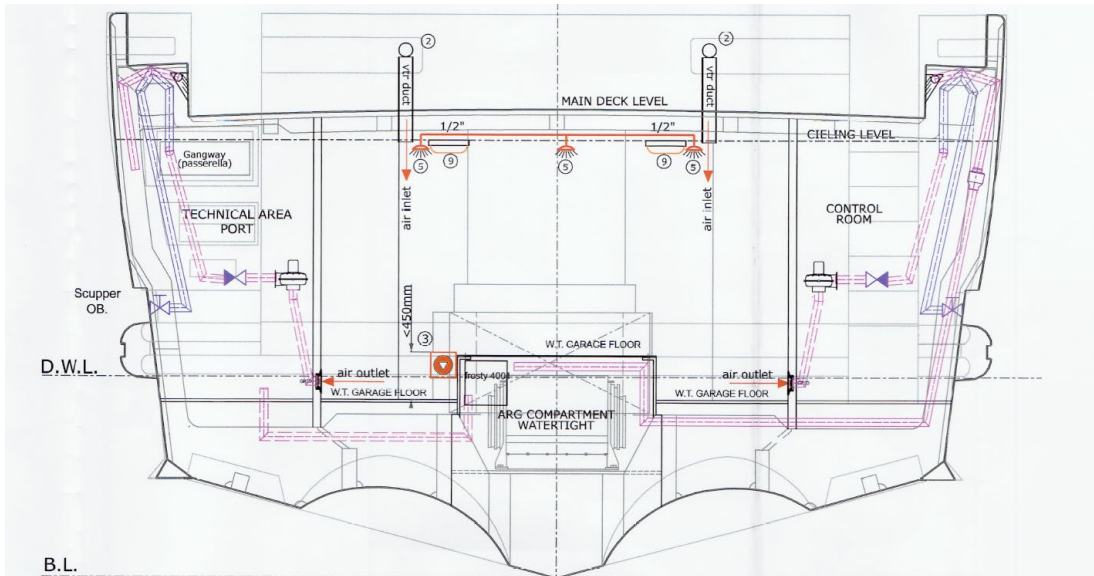
Figure 4. Transverse section of the aft lower deck (source: excerpt from the drawing “Garage Fire Safety”)

Based on the information gathered during the investigation, the focus of this investigation is on the aft section of the lower deck (Figure 4), the segments of which are described in detail later in this report.

This space, marked red “22” in Figure 3 and referred to as the “Technical Area Port” in Figure 4, is a small compartment approximately 4 metres in length, up to 1.5 metres in width, and up to 2 metres in height. It is located on the port side of the aft lower deck and is accessed directly from the lazarette, from which it is separated by an internal bulkhead (Figure 5).

This space (“21” on Figure 3; “Control Room” on Figure 4) serves as the vessel’s main control and monitoring hub for various onboard systems. It houses the transformer where the shore connection electrical cable terminates, as well as the main distribution board (MDB), which controls the vessel’s electrical system. In addition, this space contains:

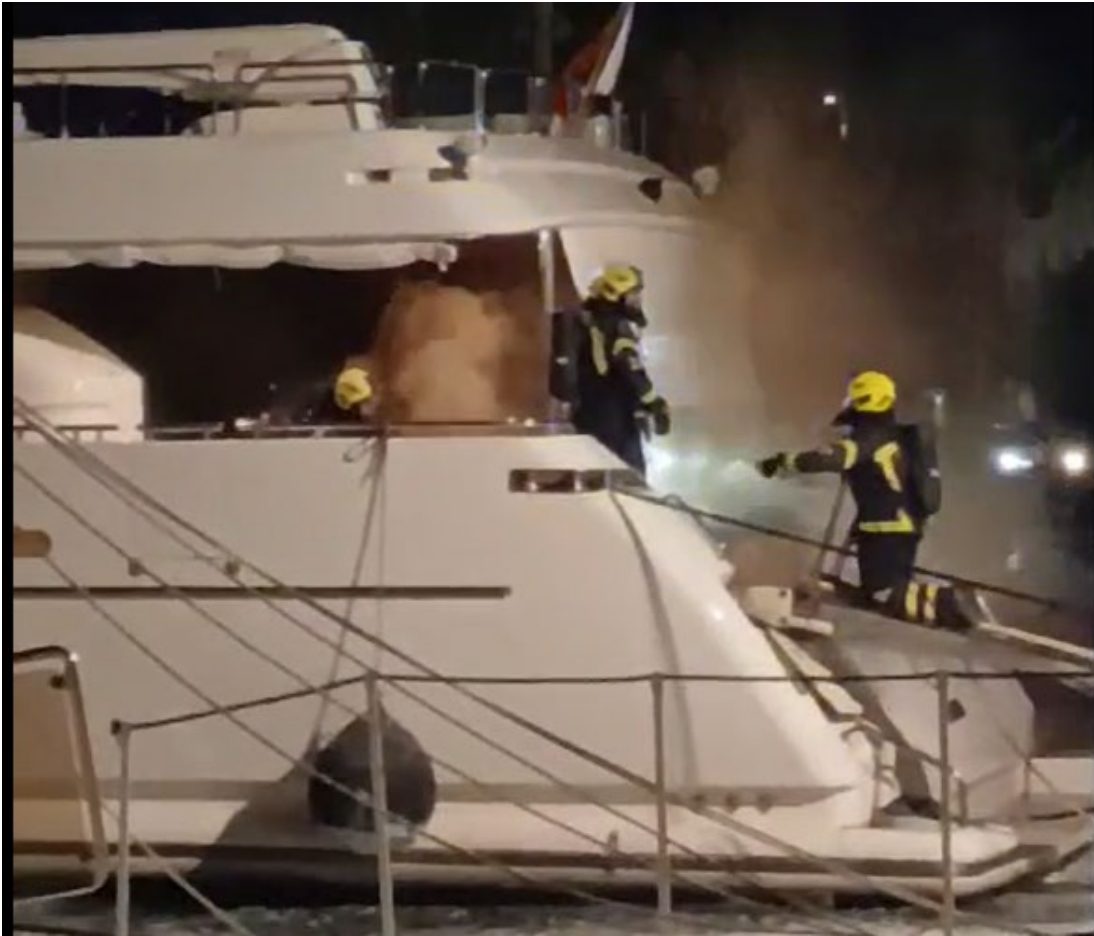
*Figure 11. Fighting the fire on Acceptus (source: crew of Acceptus)*

Seeing that the aft section of the lower deck was filled with smoke, the chief engineer attempted to extinguish the fire using carbon dioxide and dry powder extinguishers, through a small opening at the stern from which smoke was coming out.

Firefighters, who arrived on the scene very quickly, also immediately attempted to access the source of the fire, which they assumed was located in the area from which the smoke was coming (Figure 11). In the initial phase of the fire, the service hatch on the main deck leading into the engine room was opened, where it was visually confirmed that the source of the fire was not located in this space.

Access to the technical area was possible only through the lazarette, where at the time of the fire recreational crafts were stored, obstructing access to the port side of the lower deck, particularly under conditions of severely reduced visibility in the control room and lazarette due to heavy smoke accumulation.

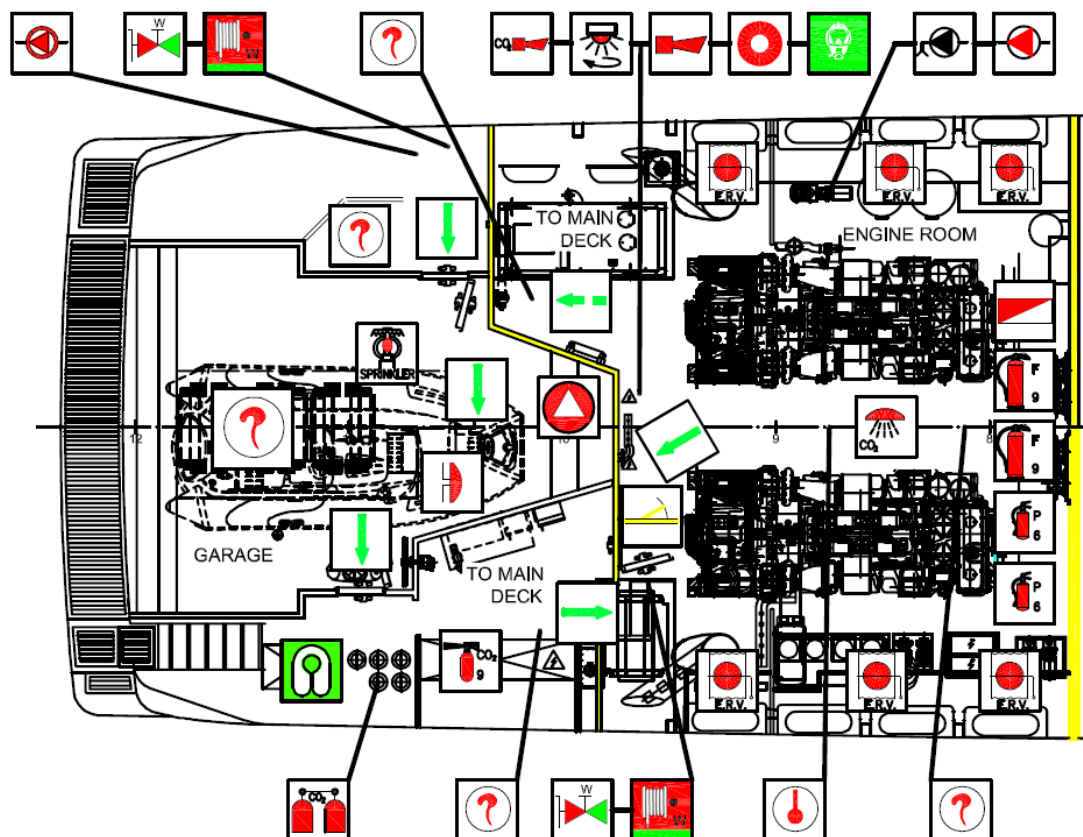
Figure 13. Extract from Fire Control and Safety Plan (source: yacht Acceptus)

Among the fixed systems, the yacht is fitted with a fixed carbon dioxide fire-extinguishing system for the engine room, which is separated from other spaces by B15 fire bulkheads, including a fire door leading to the control room. There is also a fixed sprinkler system covering the lazarette.

The yacht is equipped with portable fire extinguishers of various sizes and extinguishing media (carbon dioxide, dry chemical powder, foam), distributed across all decks in accordance with the approved fire and safety plan (Figure 13).
