**Air, Maritime and Railway Traffic Accident Investigation Agency**

## **FINAL REPORT**

### **ON THE ACCIDENT OF THE AIRCRAFT Air Tractor 802A, OR-2025**

**Krivi put, City of Senj, 13 November 2025**

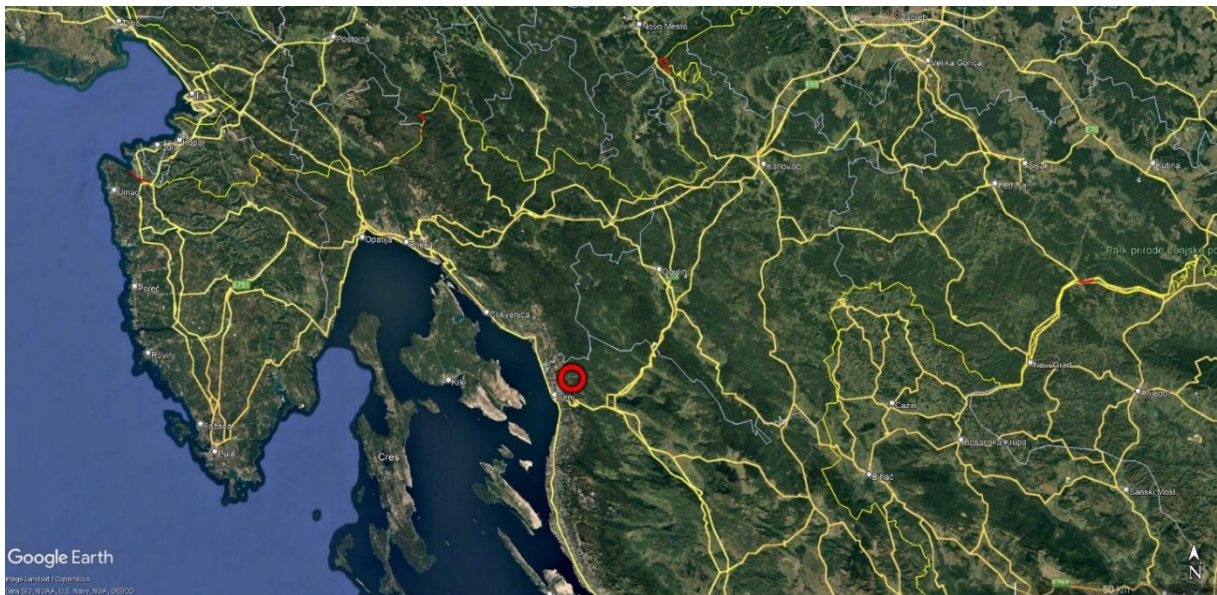
Figure 1 – accident site marked by a red circle

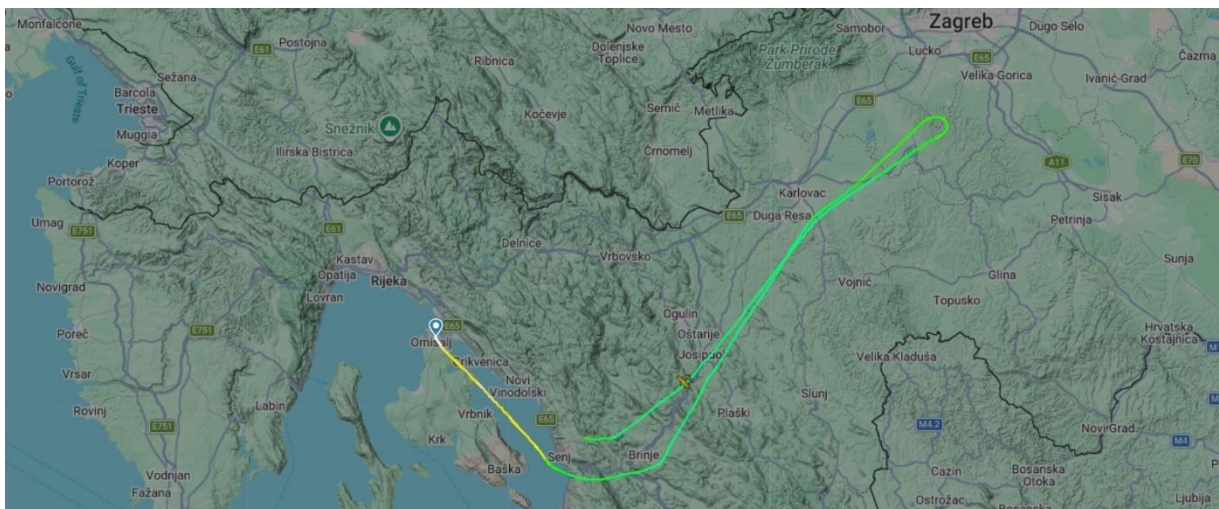
The return flight proceeded without difficulty until the mountain ridge separating inland Croatia from the coast. The ridge was enveloped in cloud, and the pilots decided to fly through it and emerge from the cloud on the coastal side, where visual meteorological conditions again prevailed.

Figure 2 – flight path

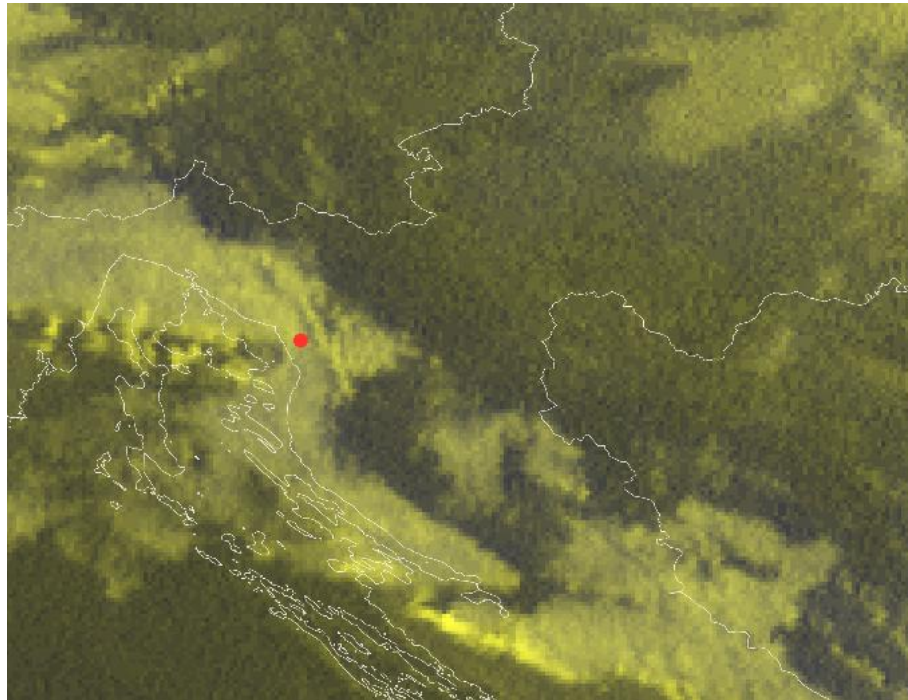
The satellite image (Figure 7) shows cloud cover over Croatia at the time of the accident. This situation had persisted for days. A band of cloud is visible along the mountain ridge near the coast. The red dot marks the accident site. Fog formed in some inland areas.

Figure 7 – satellite image of cloud cover over Croatia at the time of the accident

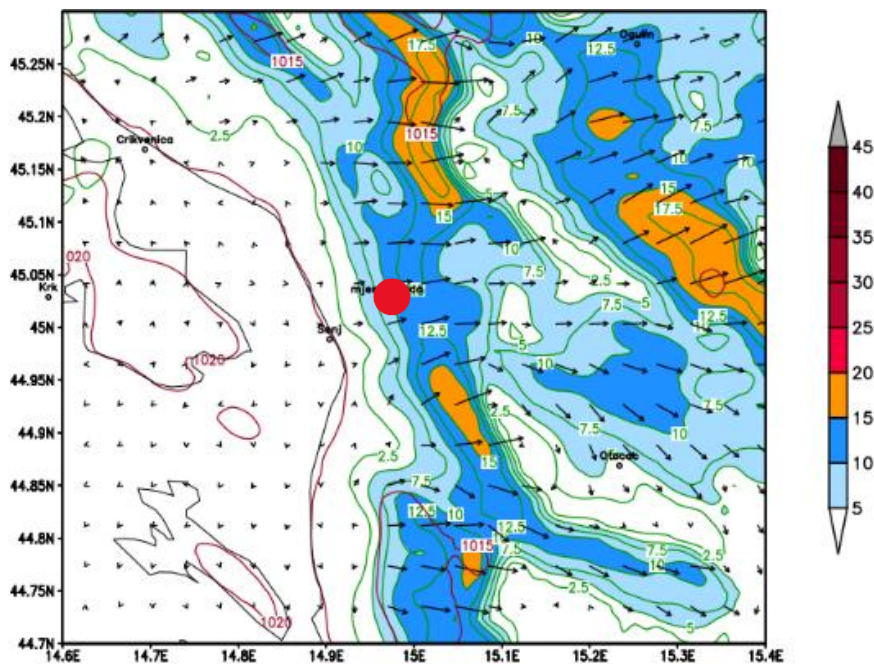
Winds were predominantly westerly and generally light. The highest wind speeds occurred directly above the mountain ridges, where the terrain caused the airflow to accelerate. This acceleration occurred in the lower layers above the ridge (Figure 8). At higher altitudes (above 2.000 m ASL), wind speed decreased with altitude (Figure 9). At an altitude of 3.000 m ASL, the terrain no longer had any effect, and the wind speed at that altitude was uniform and lower than in the lower layers above the mountain ridge (Figure 10).

Figure 8 – wind direction and speed (m/s) in the layer 80 m above the ground. The accident site is marked by a red dot

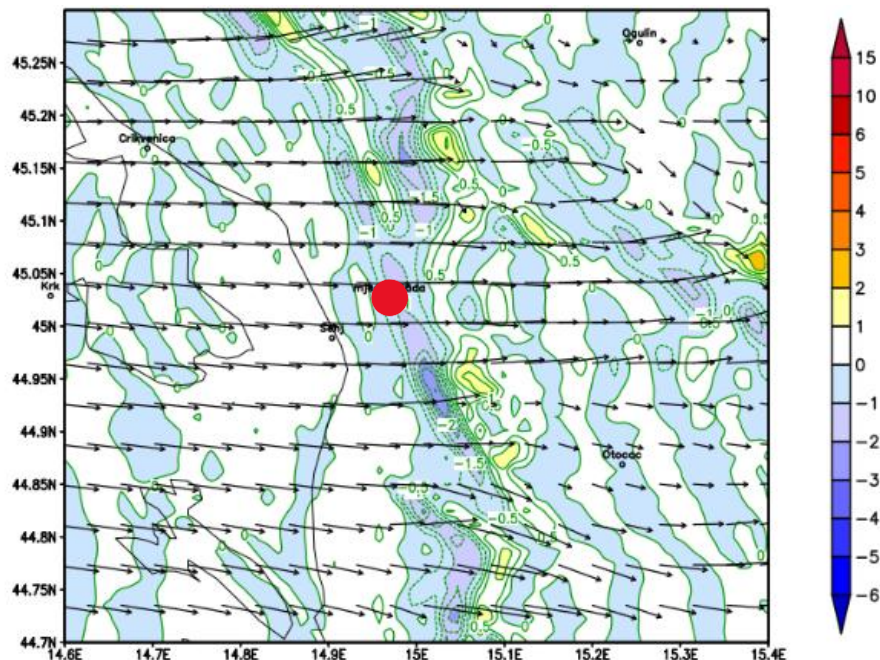
In addition, the airflow in the layer above the ridge also had a vertical component. On the leeward side, this component was downward. At an altitude of 1.500 m ASL, it amounted to as much as -3 m/s (Figure 11), and it may have been even greater in the lower layer.

Figure 11 – vertical wind speed at an altitude of 1.500 m
