PRELIMINARNO IZVJEŠĆE / PRELIMINARY REPORT

1. OPĆENITI PODACI / ACCIDENT/SERIOUS INCIDENT IDENTIFICATION		
a	MJESTO NESREĆE ILI OZBILJNE NEZGODE	Broćanac, Slunj, Croatia
	AREA OF ACCIDENT OR SERIOUS INCIDENT	
b	DATUM NESREĆE ILI OZBILJNE NEZGODE	29.05.2022
	DATE OF ACCIDENT OR SERIOUS INCIDENT	
c	VRIJEME NESREĆE ILI OZBILJNE NEZGODE	09:24 UTC
	TIME OF ACCIDENT OR SERIOUS INCIDENT	
d	PROIZVOĐAČ ZRAKOPLOVA	Cessna Aircraft
	AIRCRAFT MANUFACTURER	
e	TIP ZRAKOPLOVA	Cessna 182
	AIRCRAFT TYPE	
f	MODEL ZRAKOPLOVA	FR 182 RG, Skylane
	AIRCRAFT MODEL	
g	DRŽAVA PRIPADNOST ZRAKOPLOVA	Germany
	STATE OF REGISTRY	
h	REGISTRACIJSKE OZNAKE	D-EGLF
	REGISTRATION	
i	OPERATOR ZRAKOPLOVA	LSC Bayer Leverkusen
	AIRCRAFT OPERATOR

6. OPIS NESREĆE ILI OZBILJNE NEZGODE / DESCRIPTION OF ACCIDENT OR SERIOUS INCIDENT

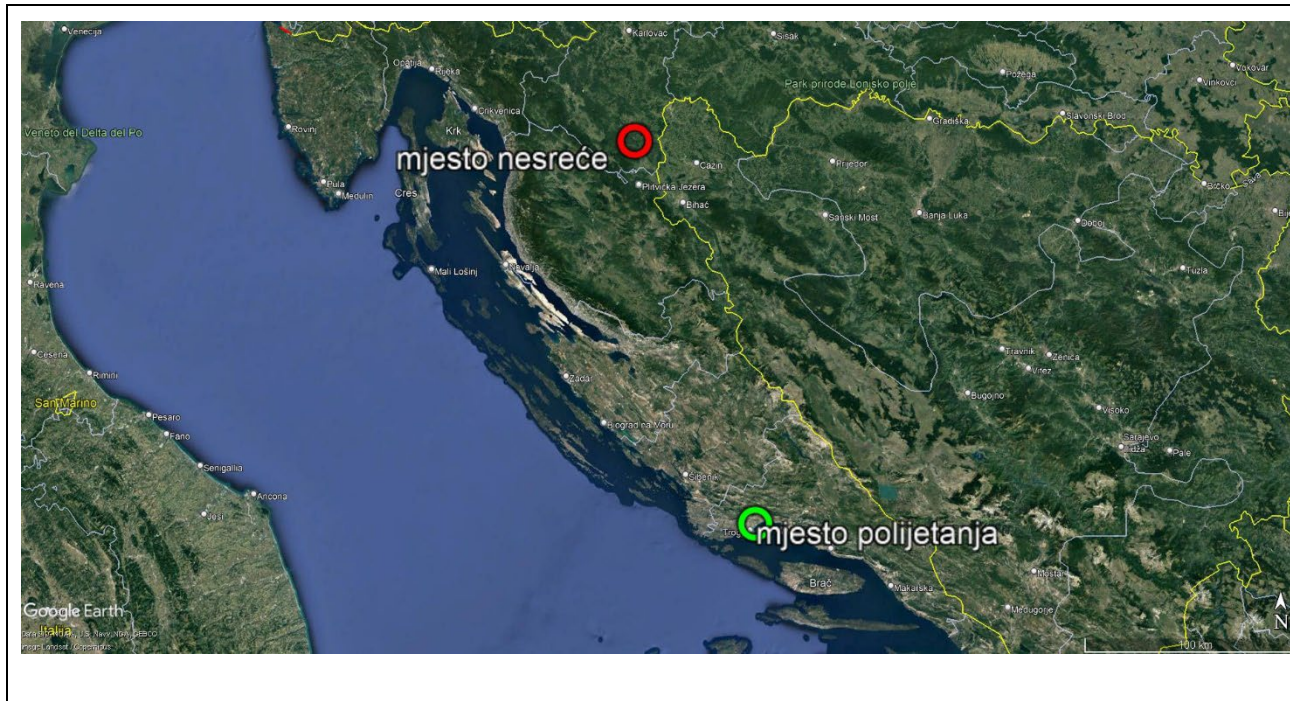
All four persons on board the aircraft were killed in a crash. Aircraft was destroyed due to ground collision and fire.

Day after on sight investigation was completed, aircraft wreck was removed with the military helicopter.
